# Automated SiPM Surface Imperfection Analysis

*Jesse Lior - Summer High School Intern at Wright Lab, RHIG Yale*

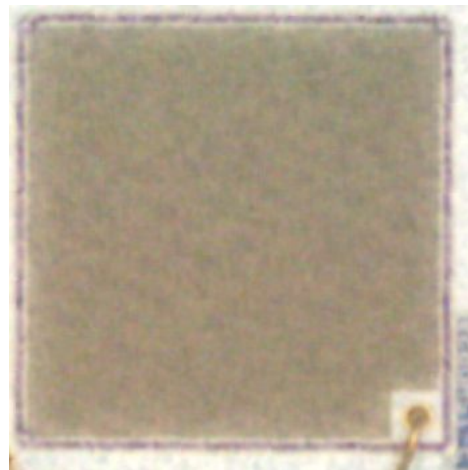
Pristine SiPM

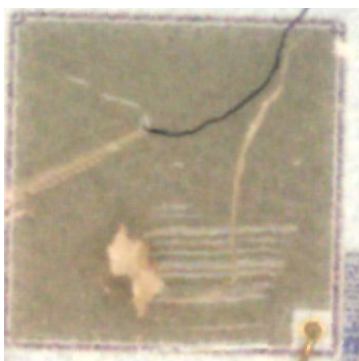
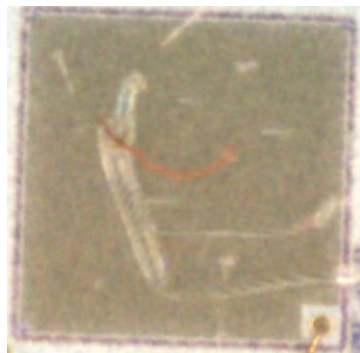
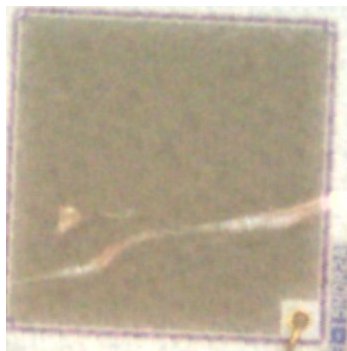
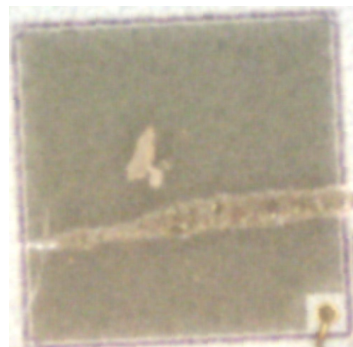
# CNN Outputs For 4 Different SiPMs

Extremely accurate analysis from CNN overall - the model correctly classified 95% of the 43 damaged SiPMs on the held out tray 260409-1702

Using a U-Net with a ResNet-34 Encoder to automatically analyze SiPMs for surface imperfections is significantly effective- **95%** validation accuracy on the training dataset
