MICROPHONICS STUDY OF ARIEL ACM1 TWO CAVITIES CRYOMODULE

Yanyun Ma
TRIUMF

2018-10-24

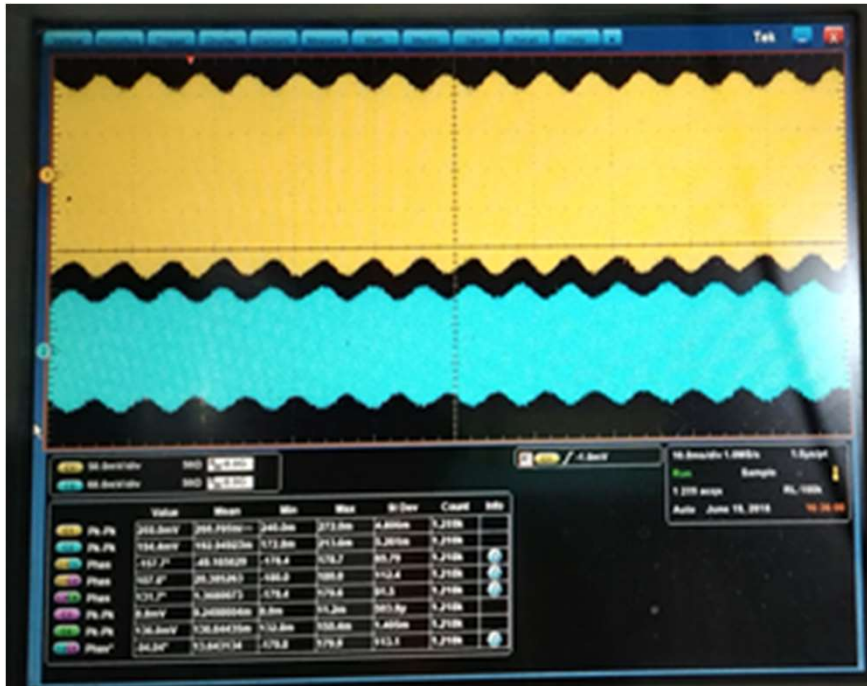
Pondermotive effect

Oscillation in counterphase under vector-sum regulations. Yellow: 1st cavity pickup signal; Green : 2nd cavity pickup signal.

Microphonics excite mechanical resonances in one cavity, coupling to the other cavity via vector-sum regulation.

The modulations of the RF field between the two cavities can drive a ponderomotive instability through Lorentz force detuning.

The threshold for excitation of this instability is impacted both by ambient microphonic noise and the precise settings of the two cavity phase loops.

The coupled oscillation deteriorates the e-Linac final energy stability.

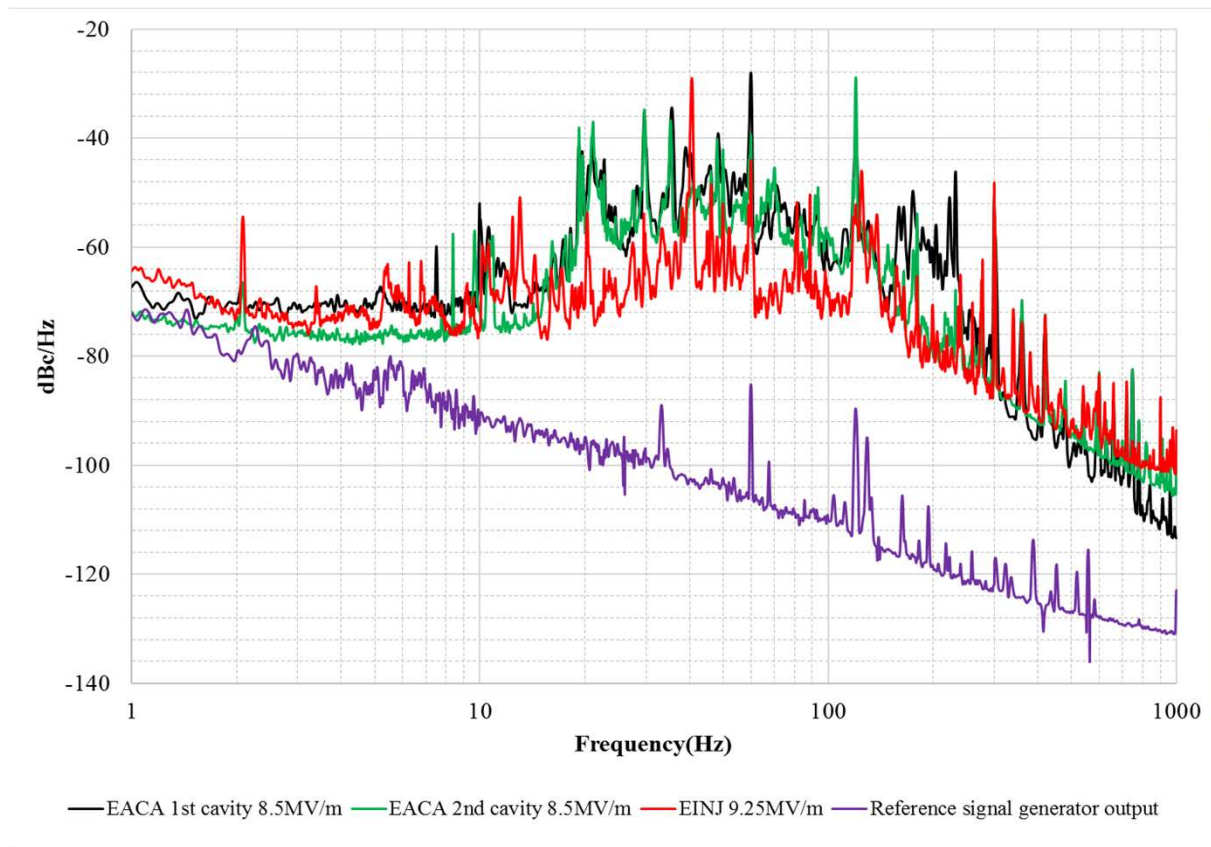
Phase noise spectrum of each cavity

ACM1 was under single cavity mode with low proportion gain

Noise hump (10~ 400Hz) in each pickup signal indicates the noise sources are universal for 2 cryomodules and all three cavities

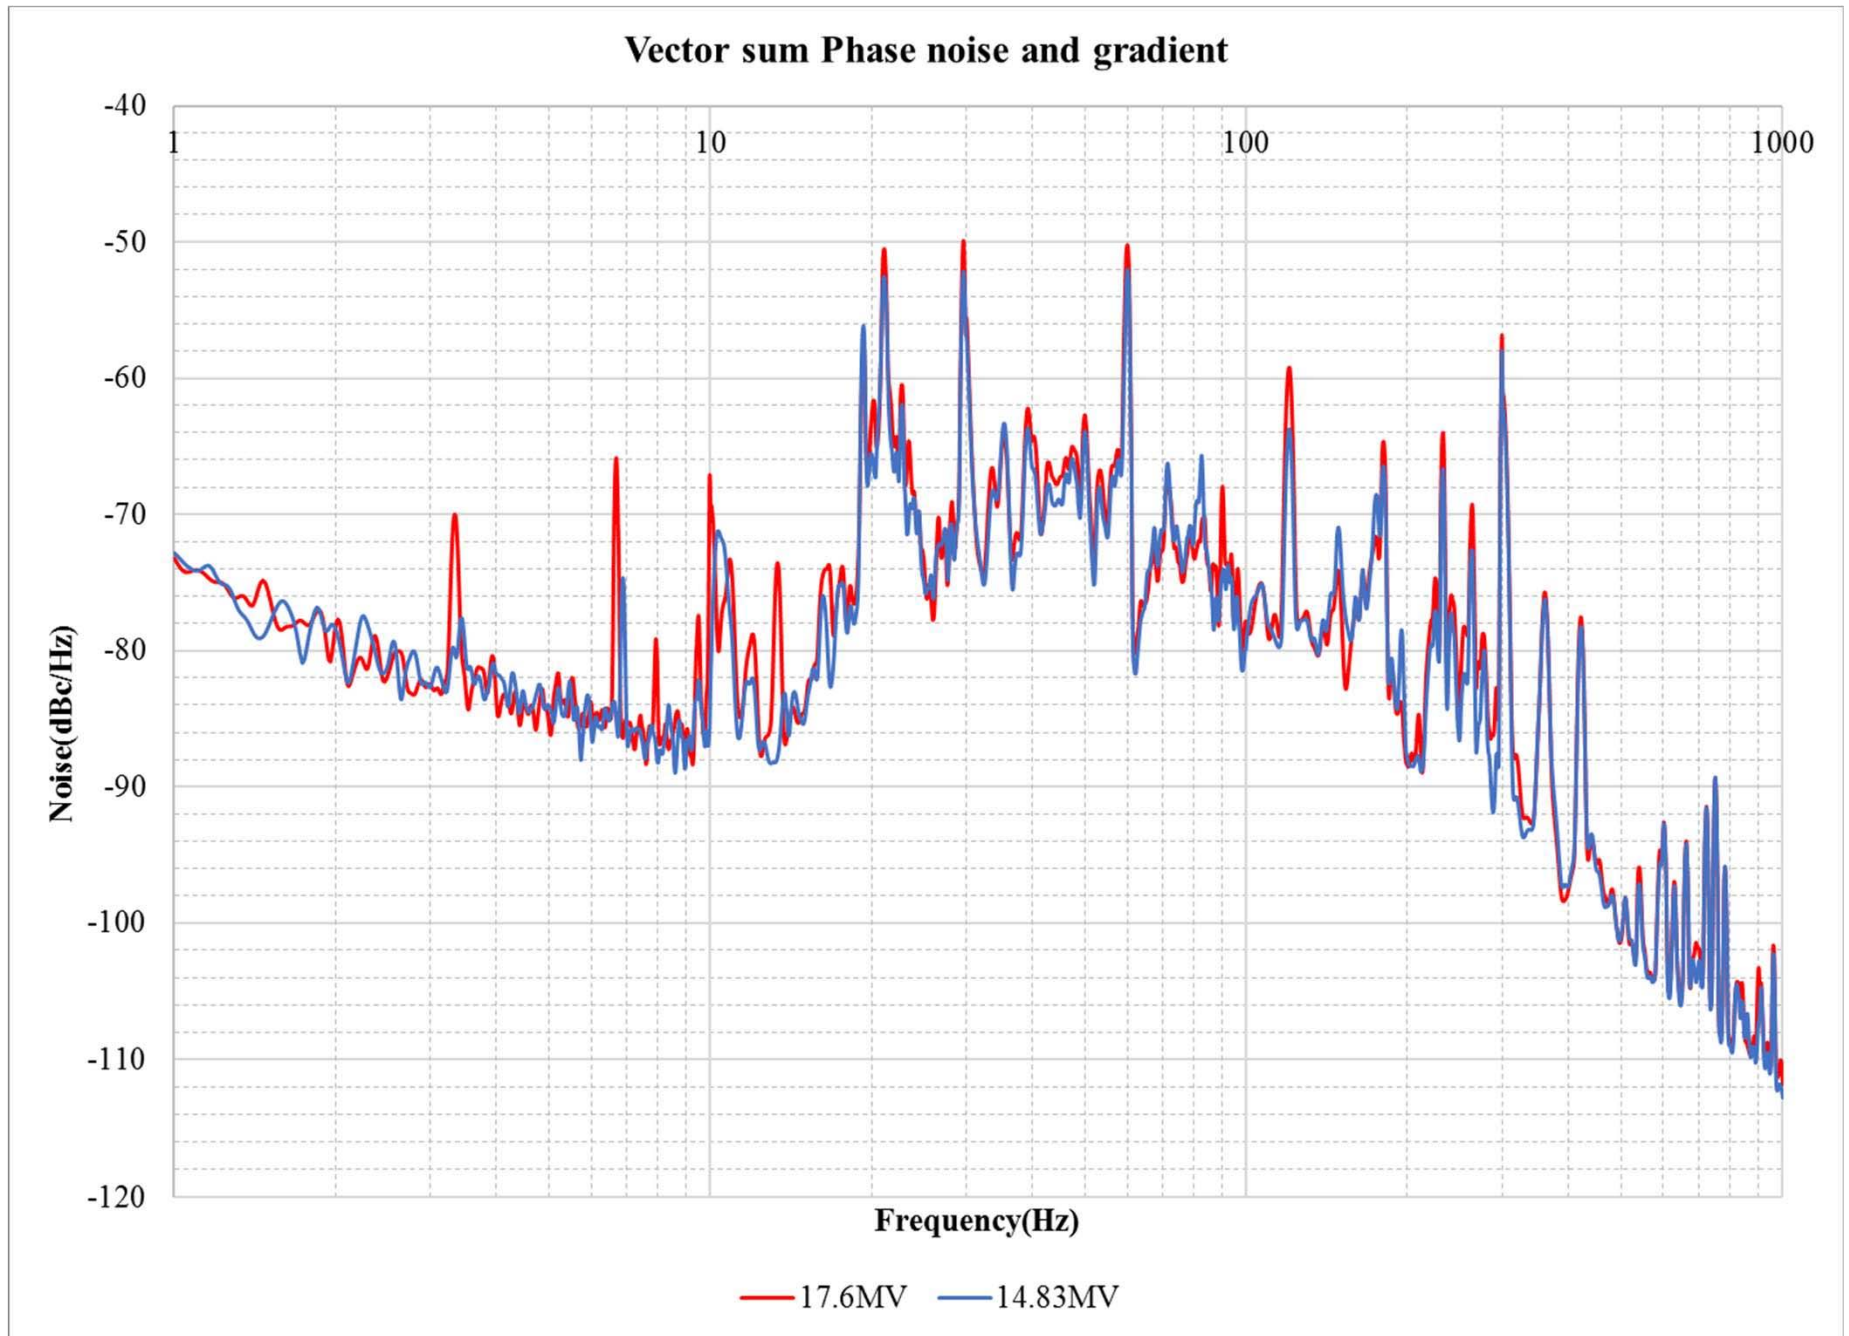
The noise become stronger with higher gradient

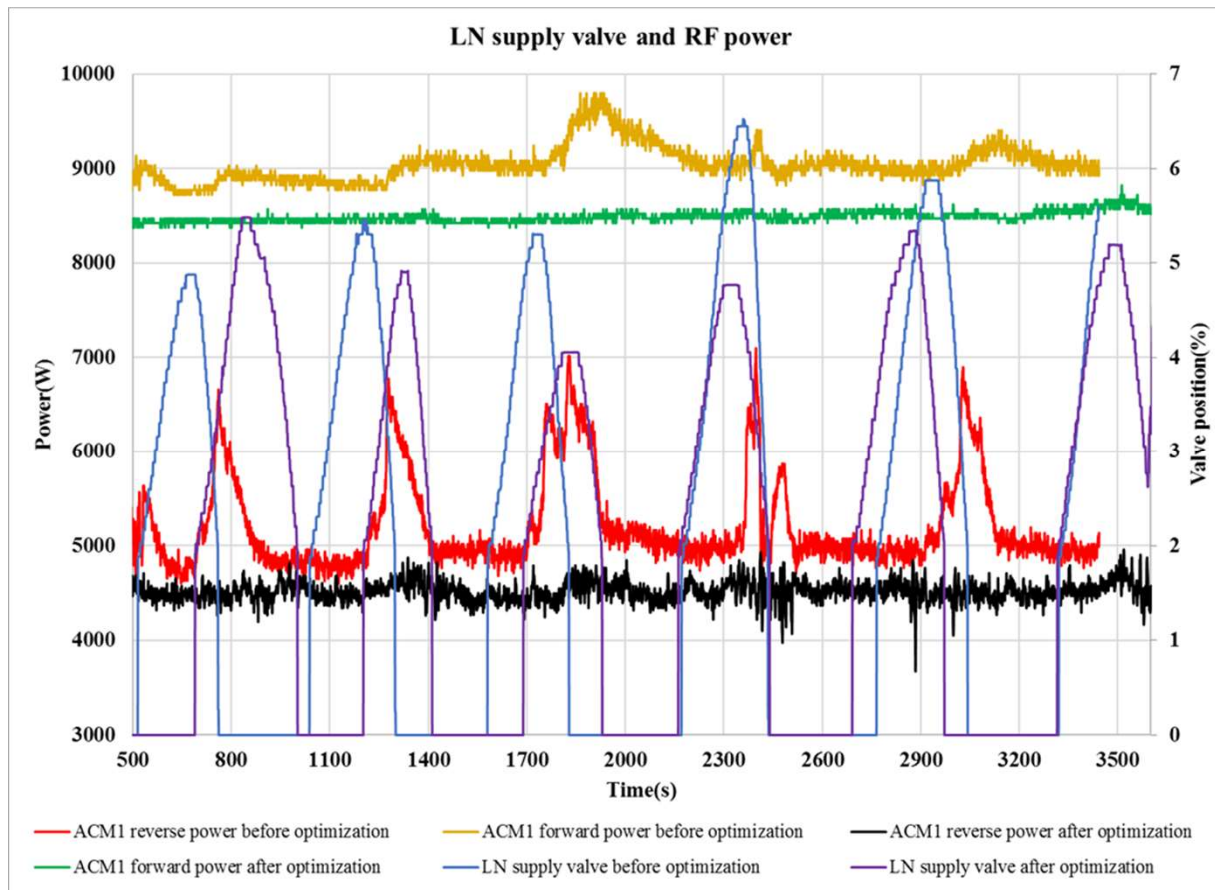
Disturbance caused by LN system

- The RF power fluctuation with LN₂ supply valve.
 - Initial regulated temperature was 130K
 - Reverse power showed 2 kW fluctuation
- Changed Regulated temperature to 120 K
 - the RF power fluctuation has been reduced

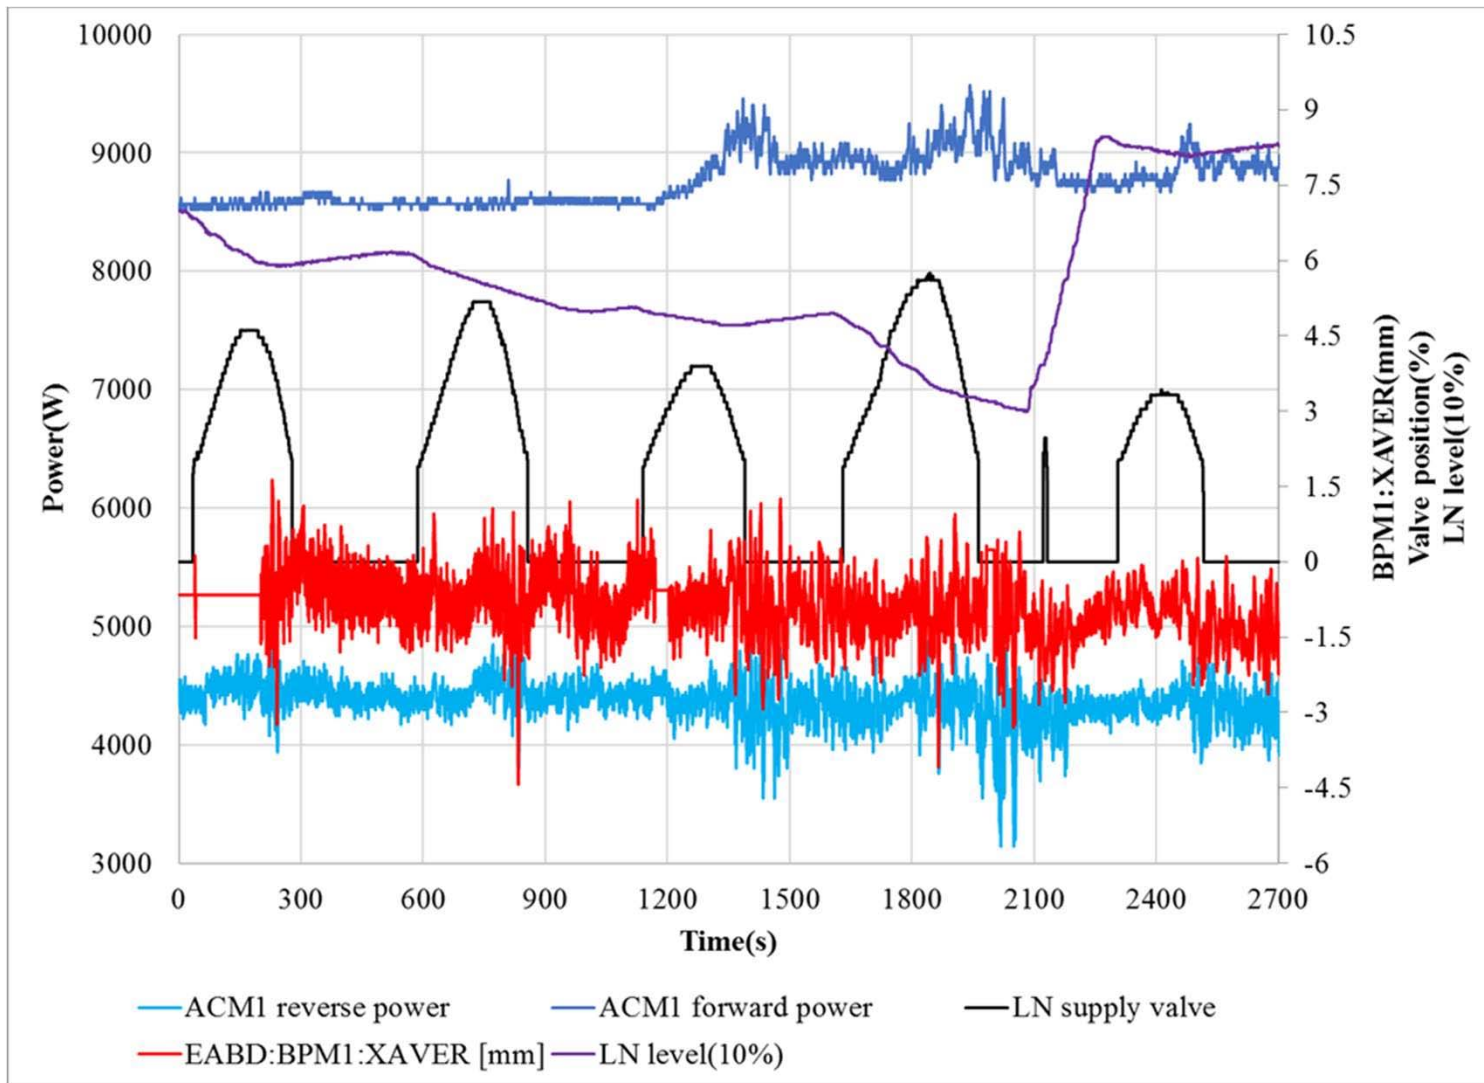
LN system disturbance during beam test

- Beam energy had disturbance which correlated with LN valve status.
- 1mm beam fluctuating $\sim 0.12\%$ of energy fluctuating

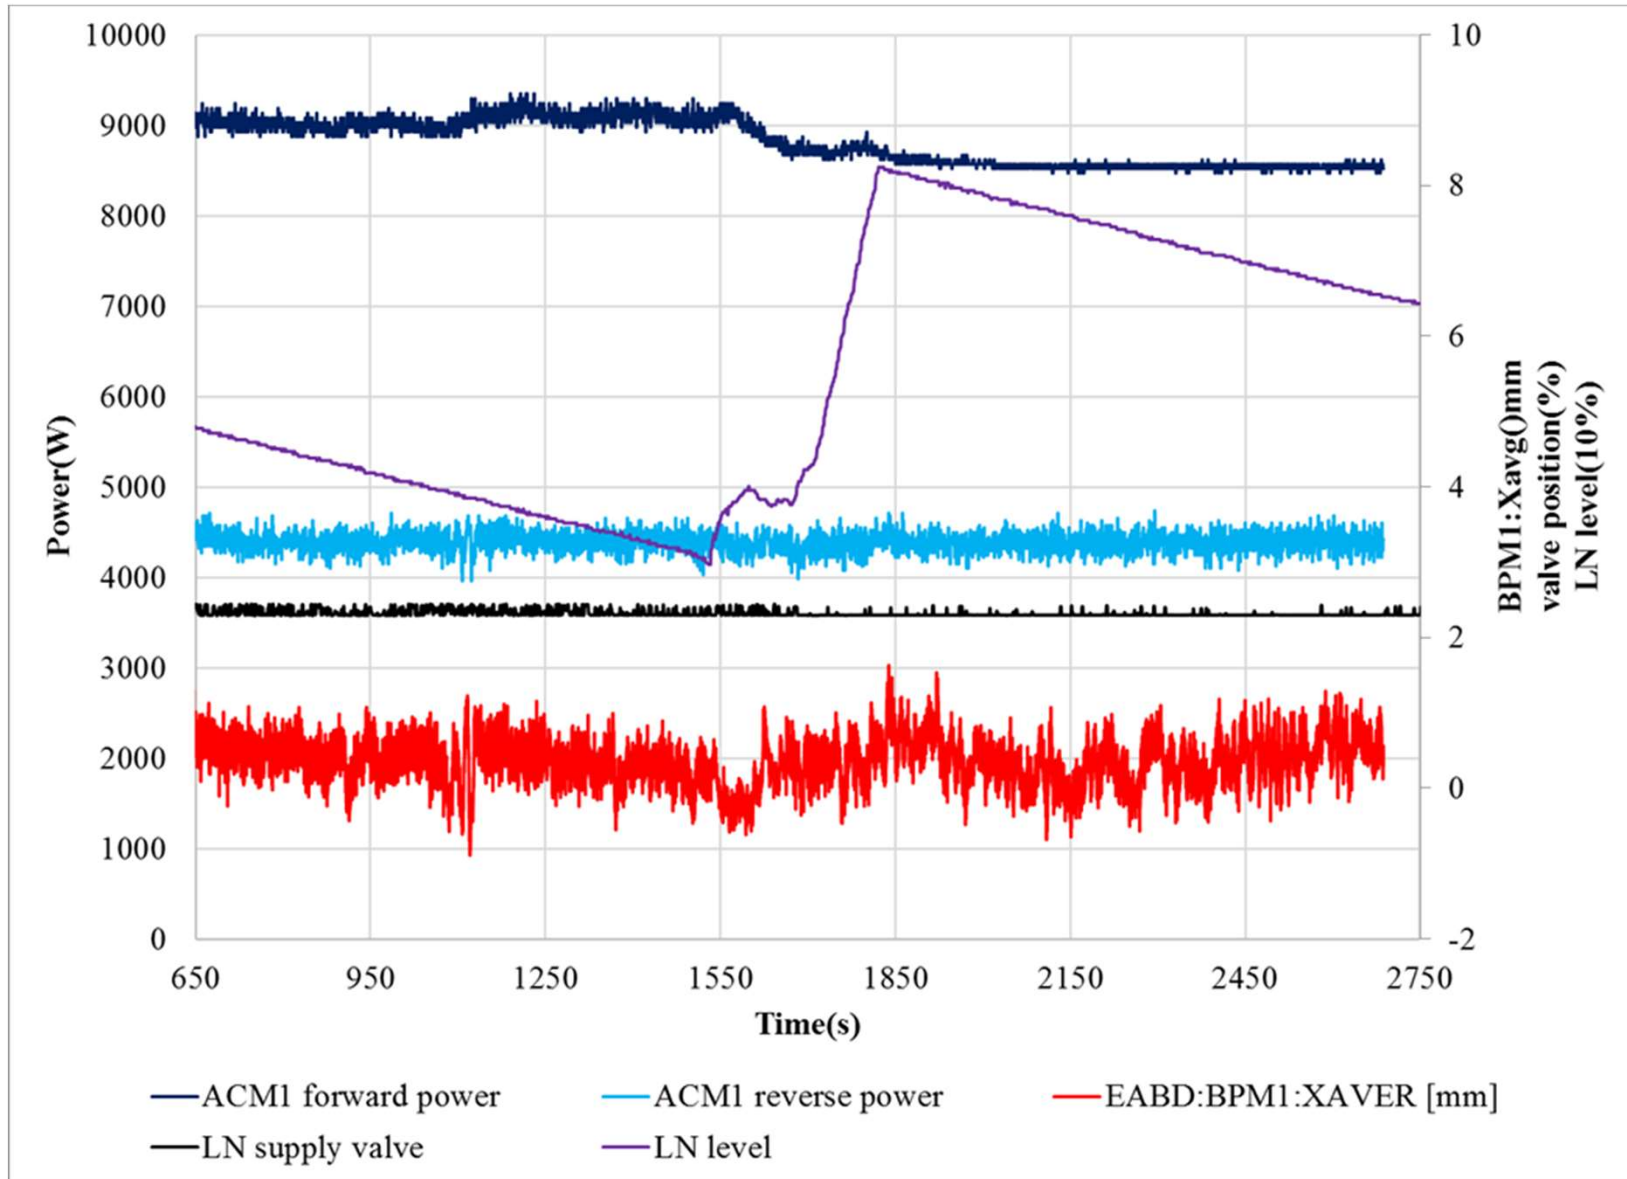
- Change LN supply valve to constant opening mode. The overall beam energy stability is about $\pm 0.1\%$ with 22 MeV (14MV energy gain from ACM1) final energy.
- The LN refilling process still affects beam energy and RF power.

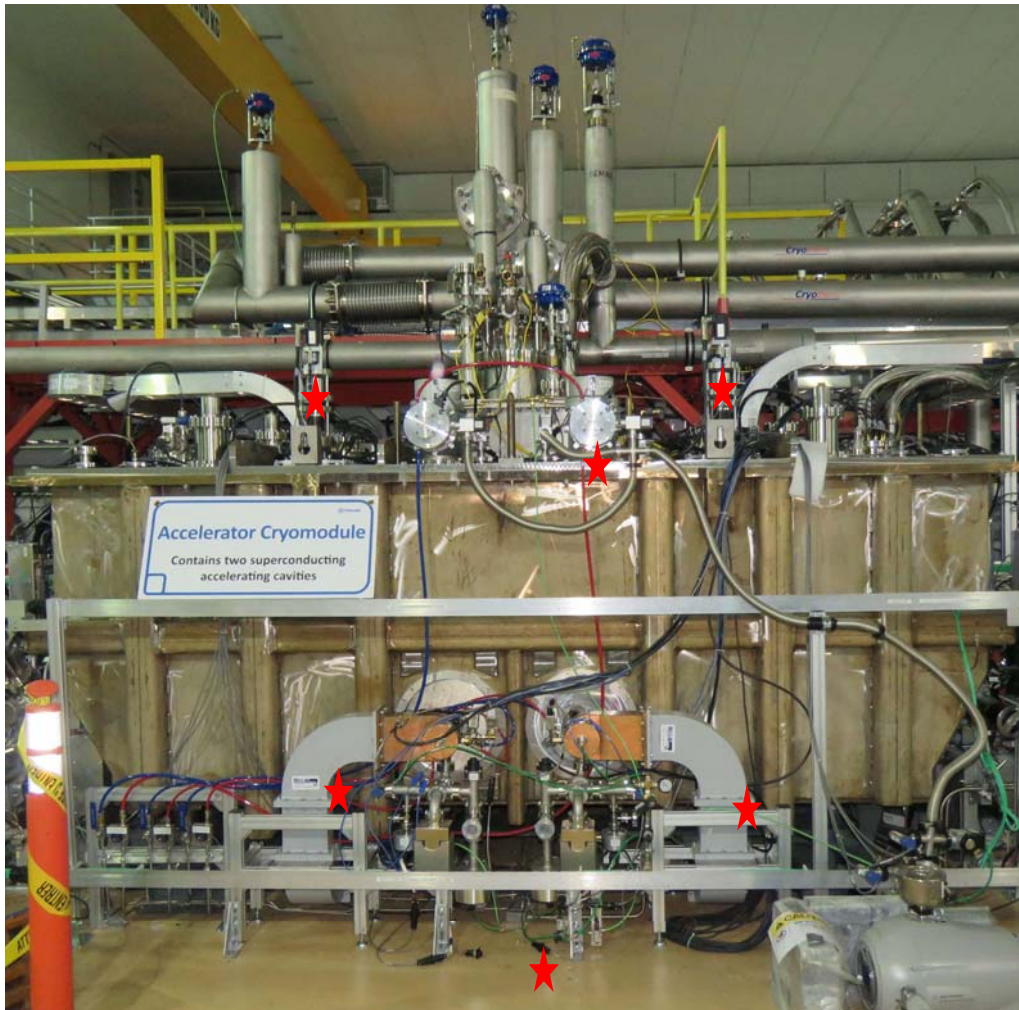
Sensors position

Turned on each noise source step by step

- Background----all pumps off
- turn on vacuum roughing pump
- Turbo pumps on
- B3 level pumps recovered
 - Provide waveguide parts cooling and Turbo pump cooling
- Both Klystron pumps on
- Couplers air cooling on
- Equipment used:
 - Accelerometer Dytran 3100D24T
 - Agilent 35670A

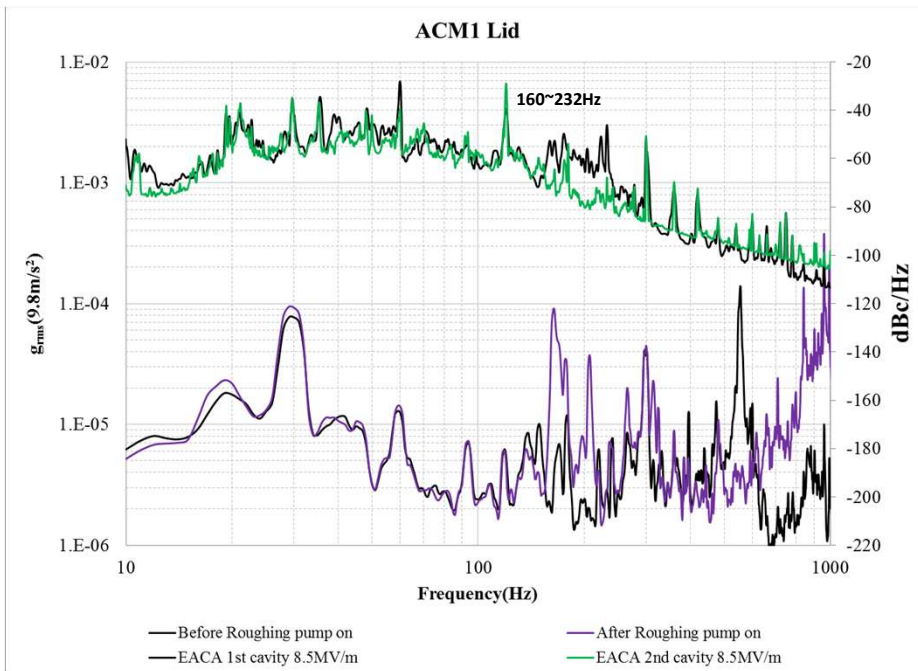
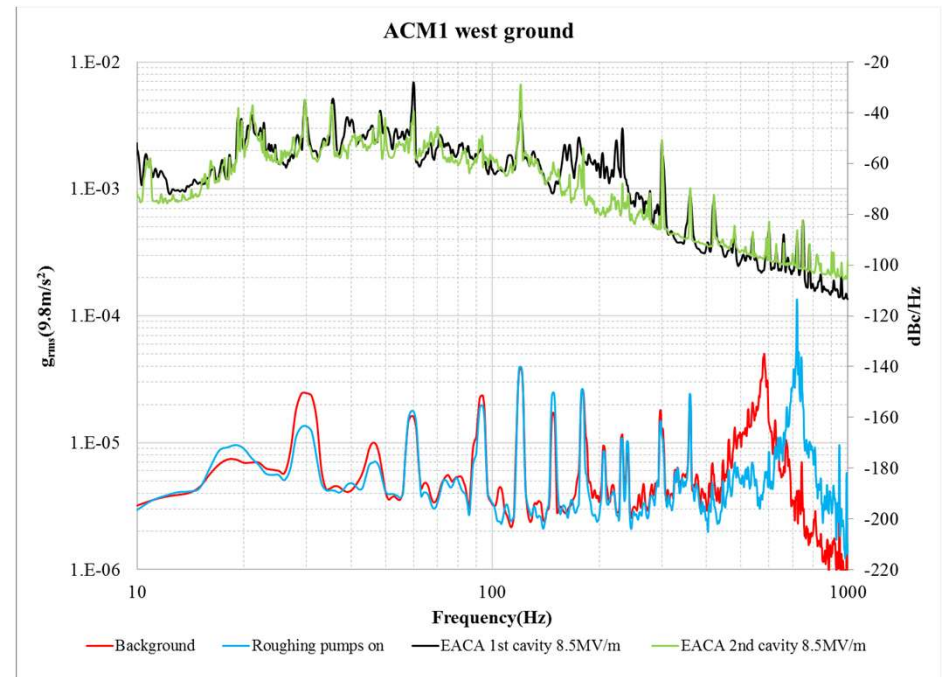
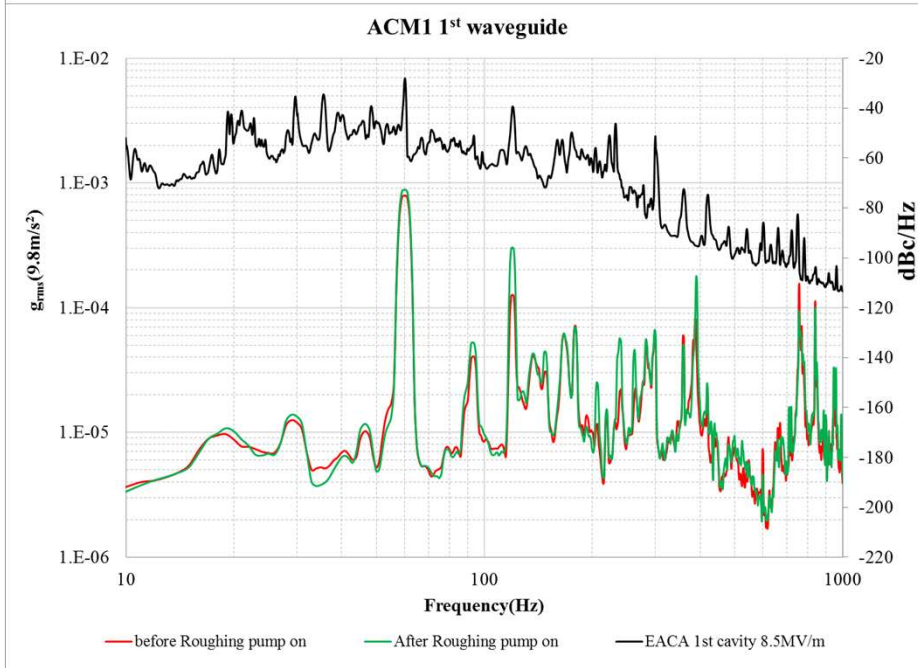
Roughing pump

- During beam test
 - The roughing pumping bellow has been fixed;
 - The damping pad has been insert under roughing pump;
- The lid results show the pumping bellow need more damping;

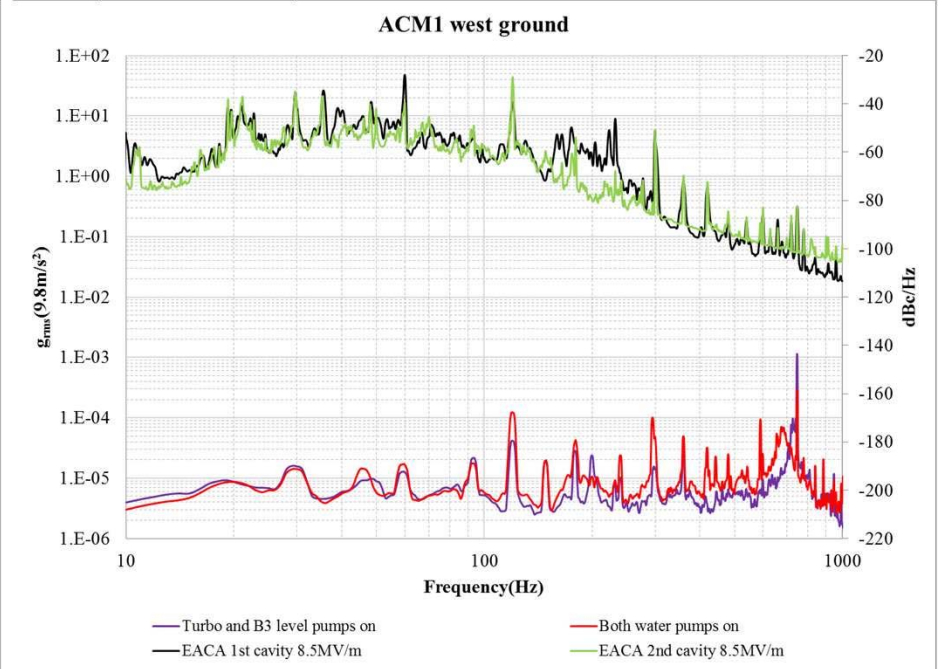
Both Klystron pumps on

vibration becomes stronger
with water pumps on

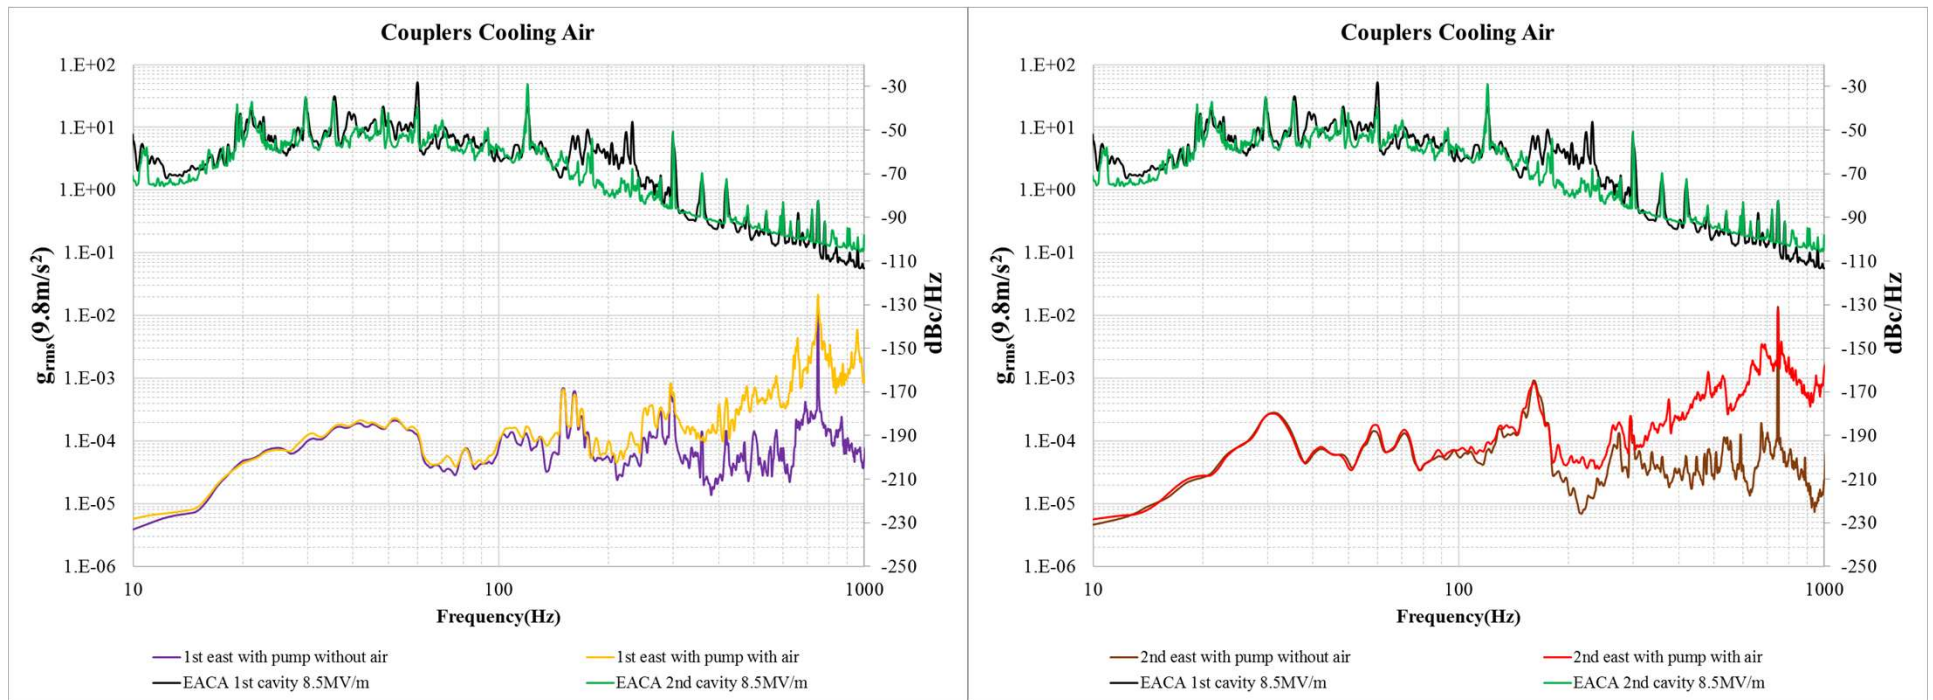
The coupler cooling air

For the 1st east coupler, the coupler cooling air flow will increase noise at higher than 180Hz range

For 2nd east coupler ,the coupler cooling air flow will increase 60 and 72Hz peak. It increases noise at higher than 180Hz range

The B3 level pump and vacuum system are normal

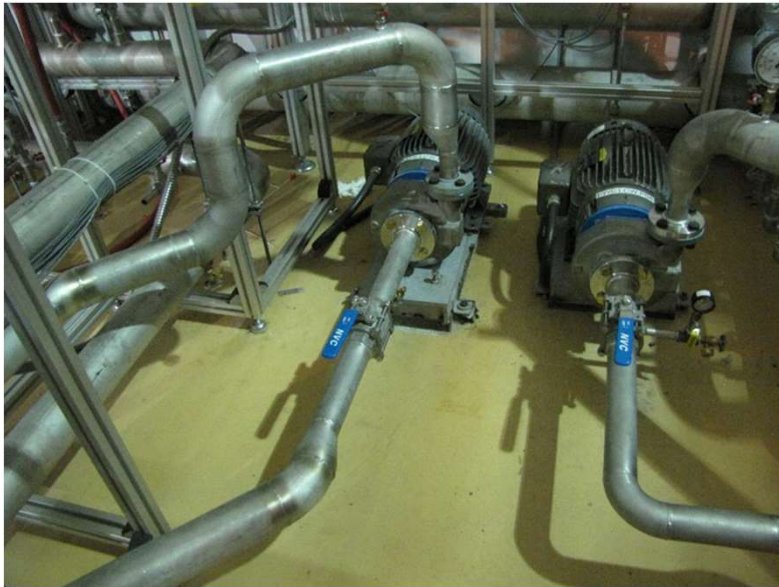
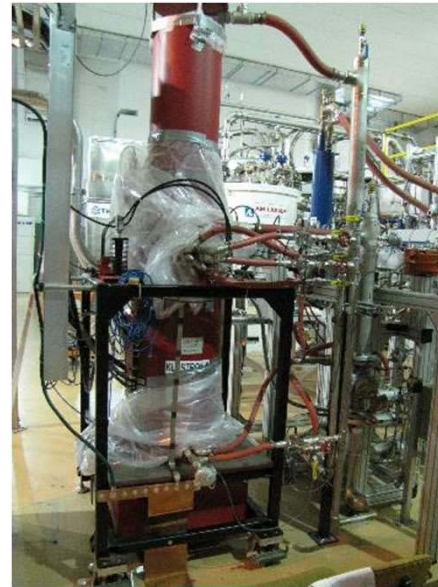
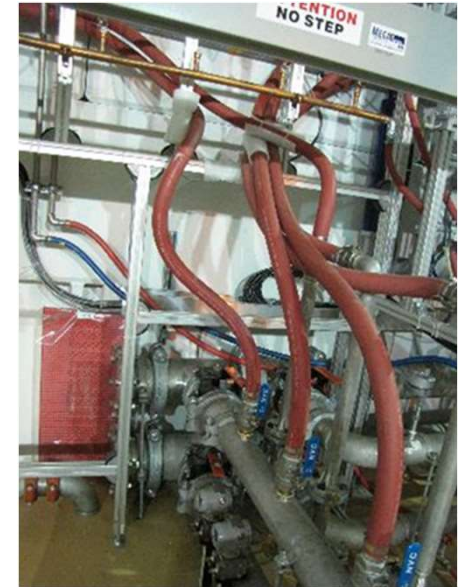
Water system

- Klystrons cooling water system consists two pumps;
- Klystron cooling water hoses are short;
- Rubber hoses of dummy loads are touched wave guide frame;
- Kly1 water supply pipe is supported by waveguide frame ;

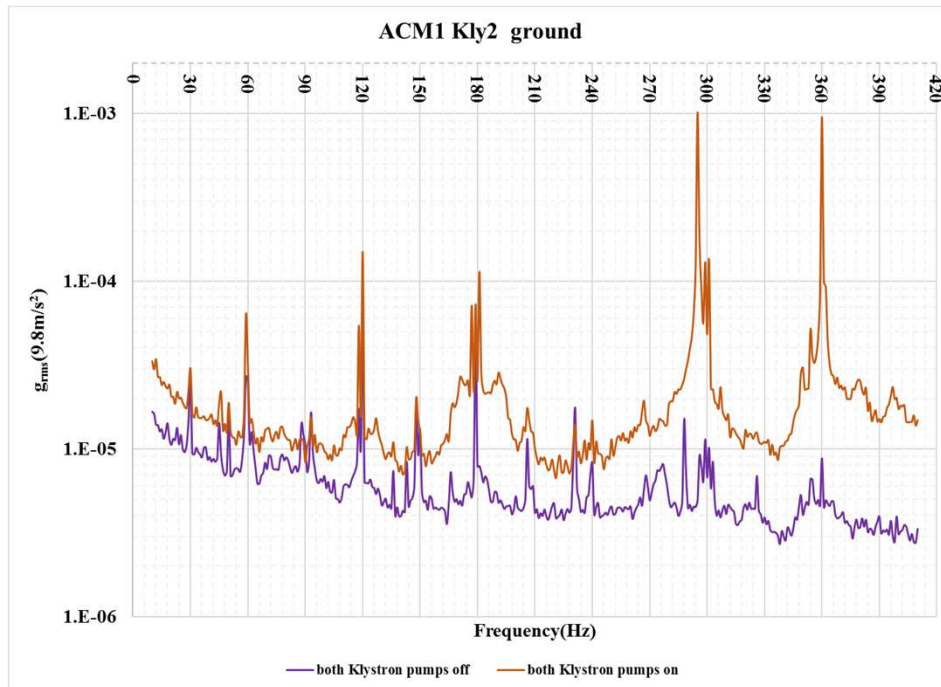
ACM1 Klystron ground

- The ground vibration becomes stronger with water pumps on

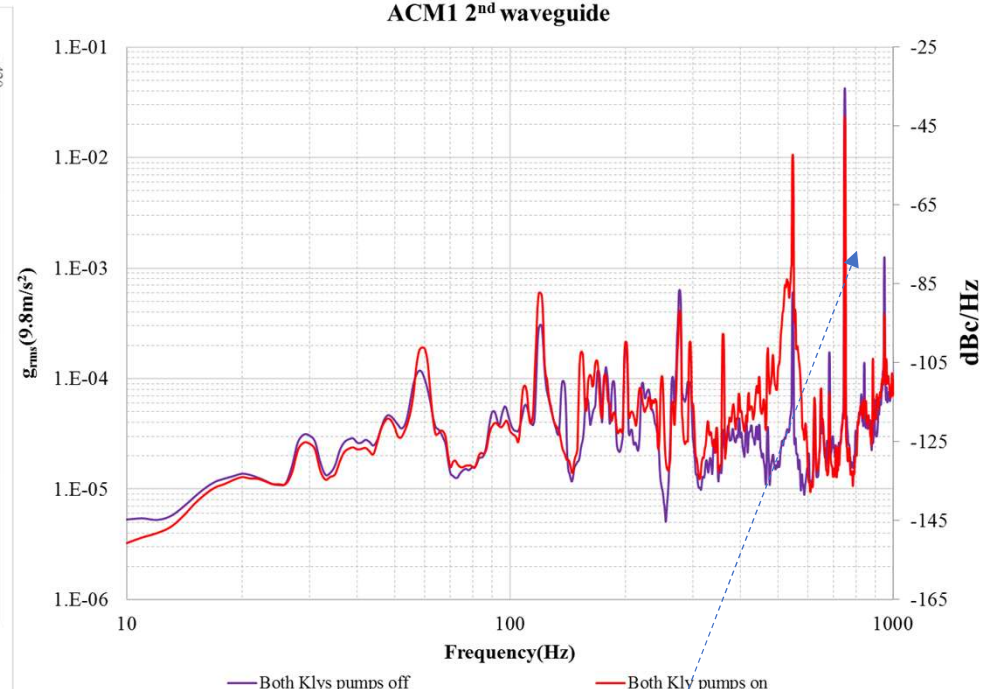
Waveguide Vibration

- The waveguide vibration becomes stronger with water pumps on

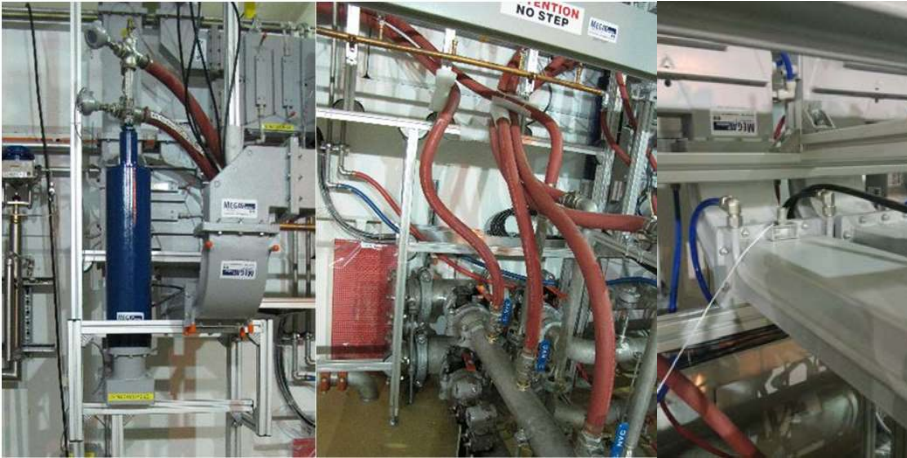
Waveguide Vibration

- Six 50 ohm loads are cooled by “B3 level” pump
- “B3 level” pump contribute <180Hz and ~410Hz noise
- the water pumps contribute the noise higher than 180Hz (except 410Hz) and the peaks valve higher as well.

These peaks by water pumps: 180,297,360Hz

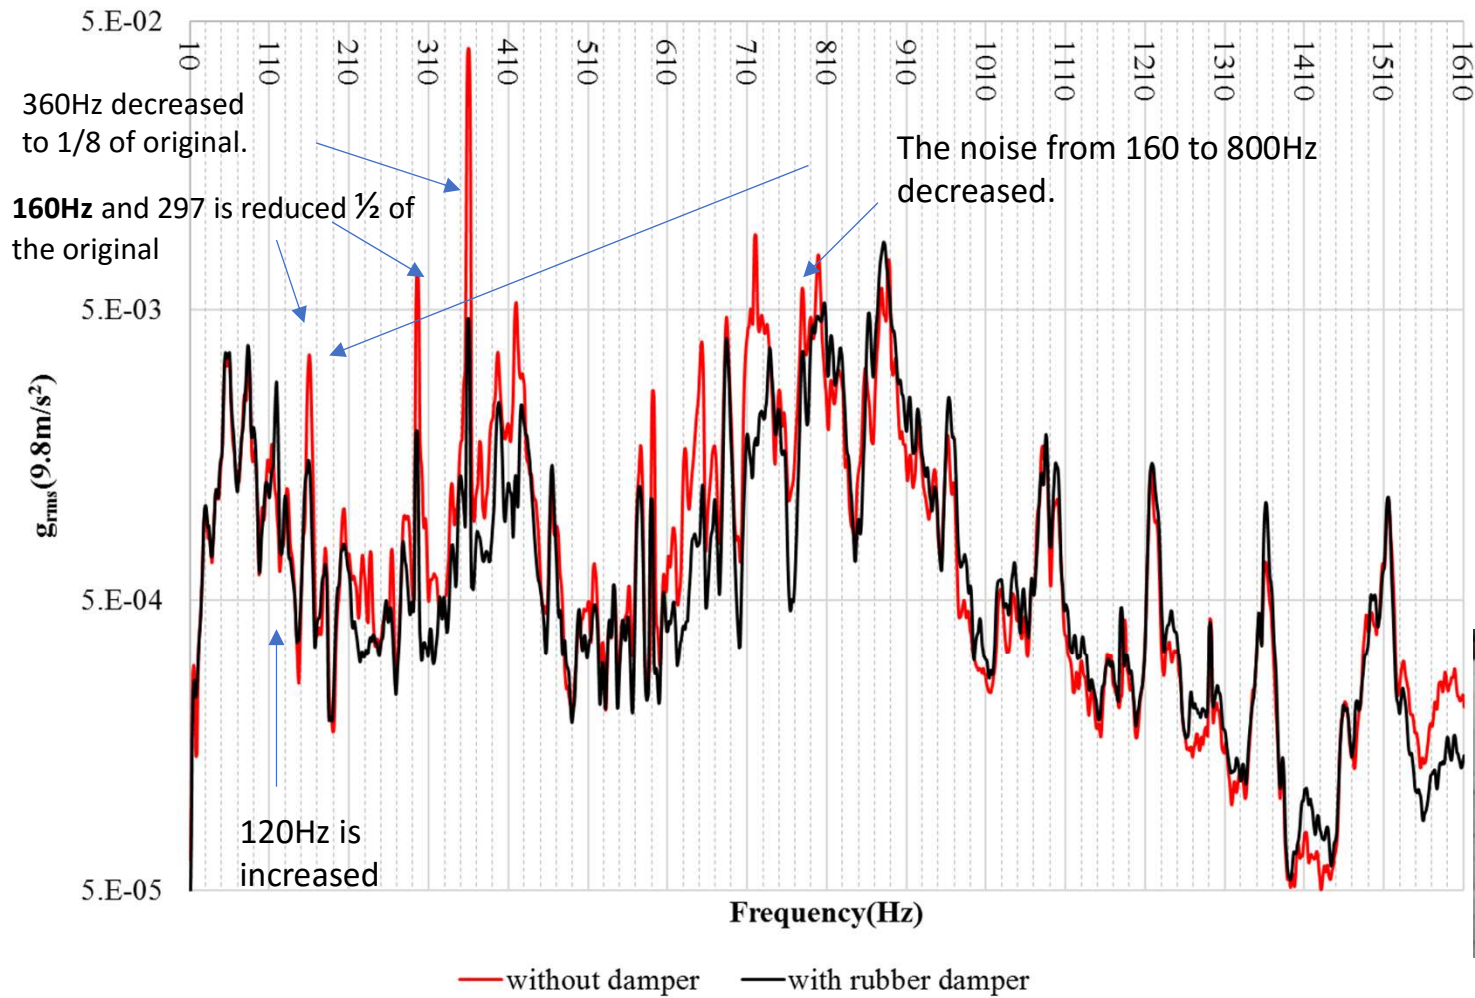
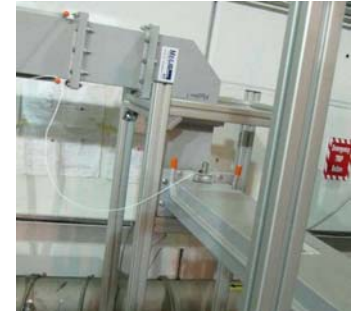
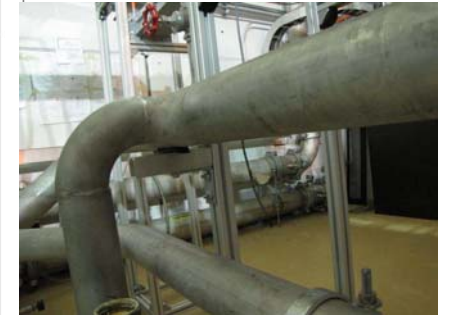
Add damper on ICM KLY water supply pipe

Sensor

1st damper

2nd damper

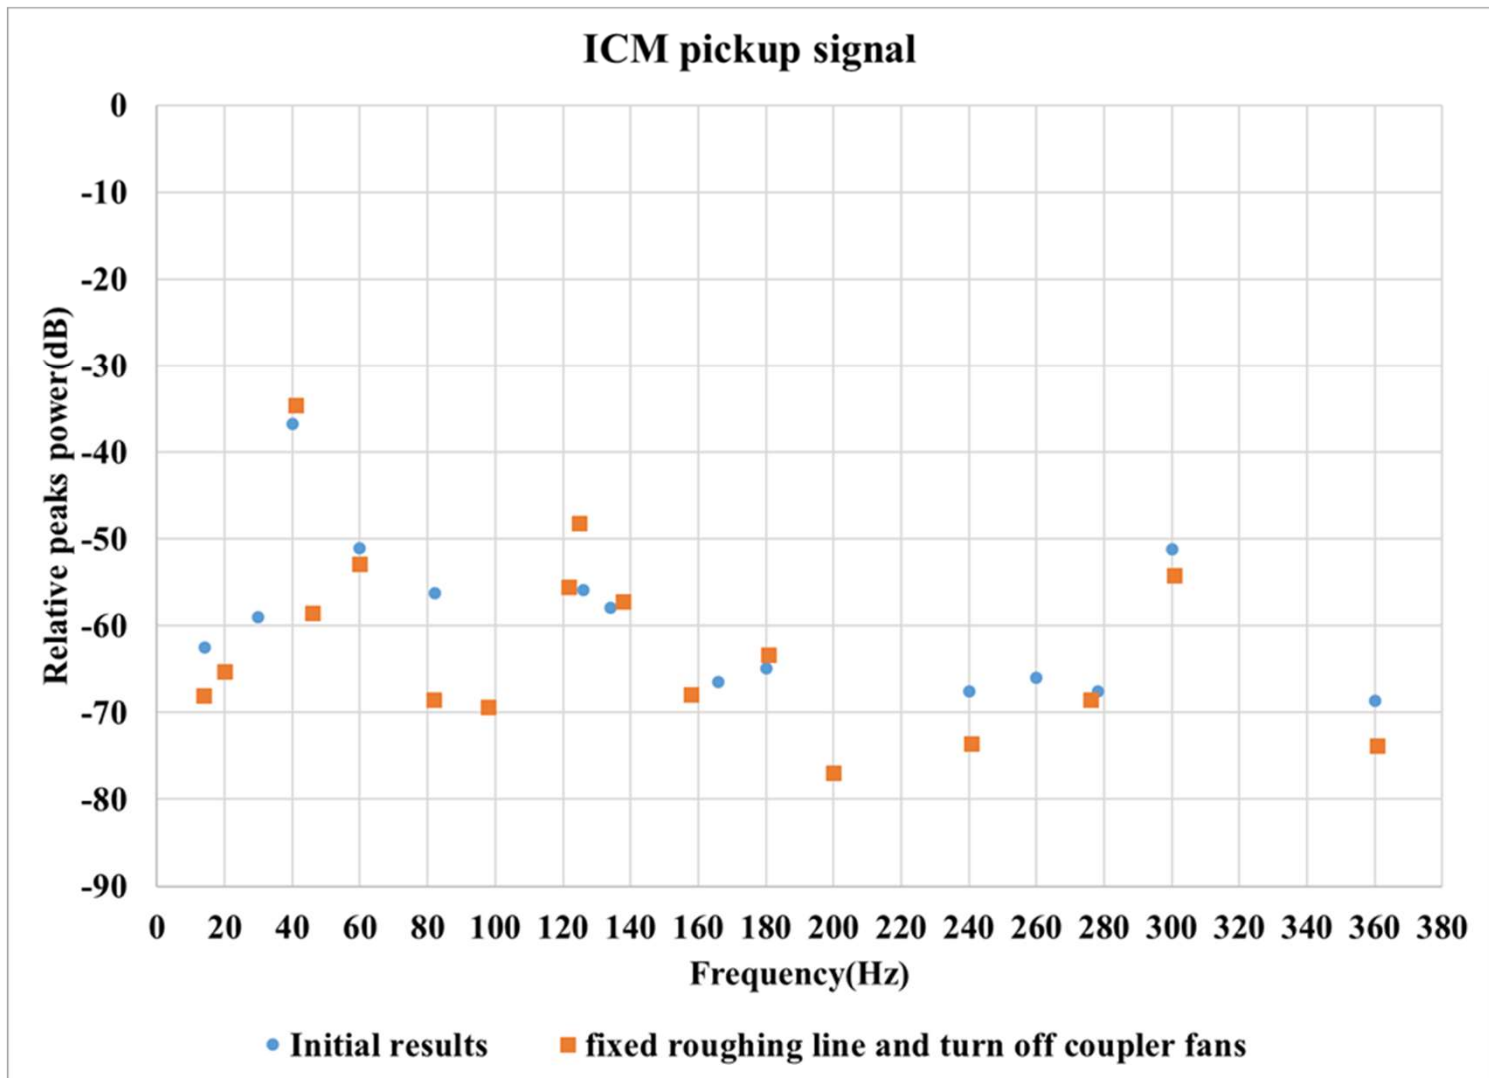
ICM vibration damping

The ICM is working under SEL PLL mode. The similar vibration damping will be done.
