Microphonics experience in HIE-ISOLDE at CERN

A. Miyazaki^{1,2} D. Valuch¹, and W. Venturini Delsolaro¹

LLRF2018 topical Workshop on Microphonics @ NY

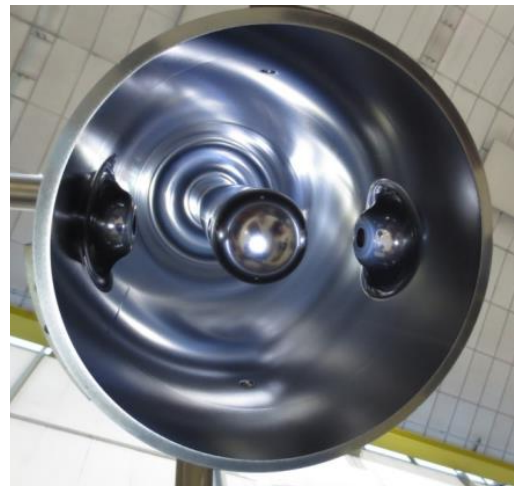
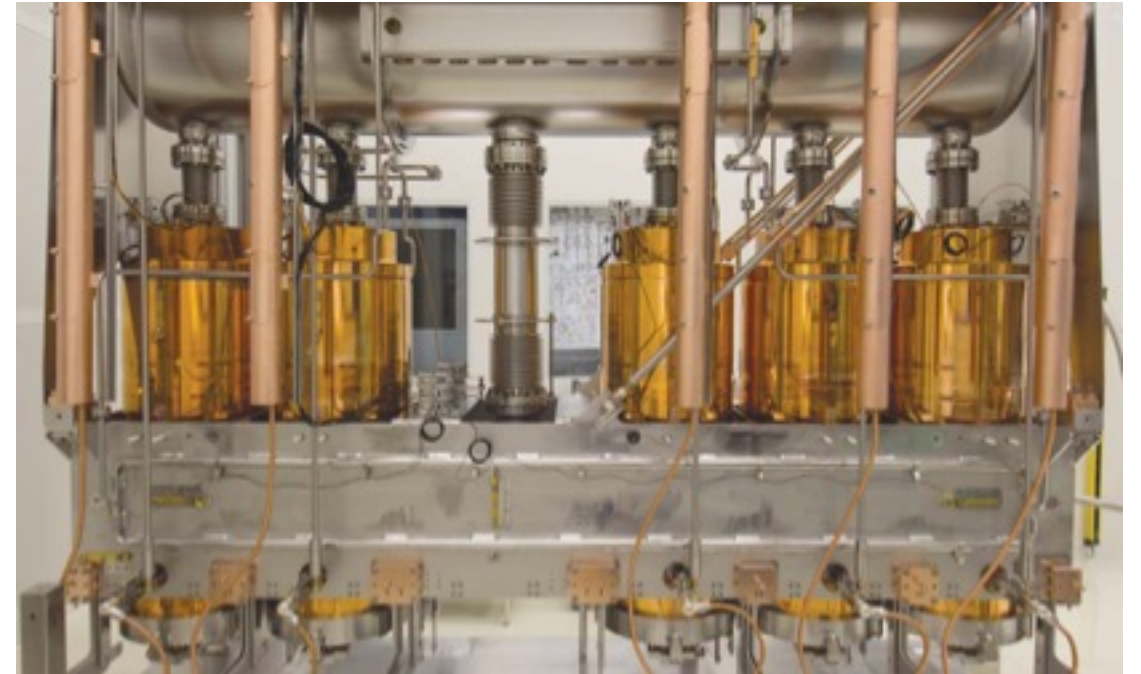
HIE-ISOLDE Cryomodule

- 5 Quarter-wave resonators (QWR) in 1 CM
- Nb film sputtered on Cu substrate (**10 mm thick**)
 - Cf. bulk Nb cavities 3 mm thick
- Conduction cooling through Cu
- Common vacuum inside and outside the cavity
- Pressure sensitivity **0.01 Hz/mbar**
- Nb/Cu cavities can be robust against microphonics
- Thermal issue in coupler → Operation **BW 5-10² Hz**

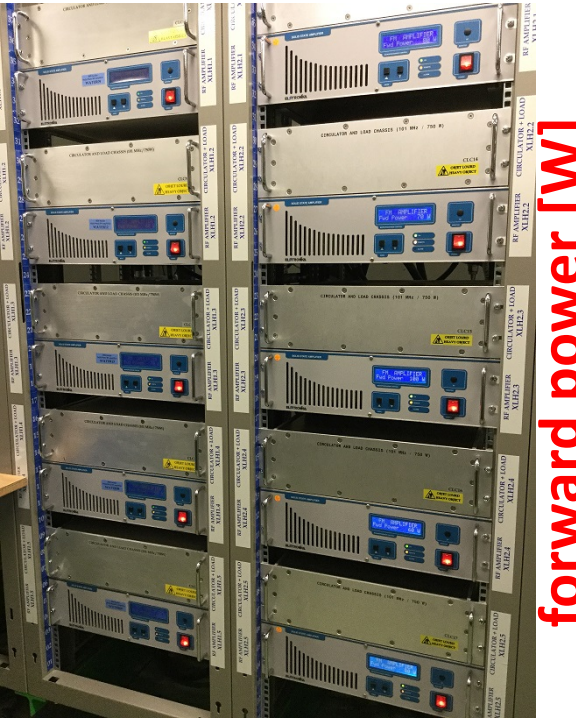
forward power [W]

$$\Delta f = \frac{1}{2} BW \frac{|V_{fwd}|}{|V_{ant}|} \sin(\varphi_{ant} - \varphi_{fwd}) \quad \Delta f \text{ [Hz]}$$

- No stepper-motor motion
- Compensated by forward power (RMS 100W, max 750W)
- Solid-state amplifiers (750W) can still handle the system

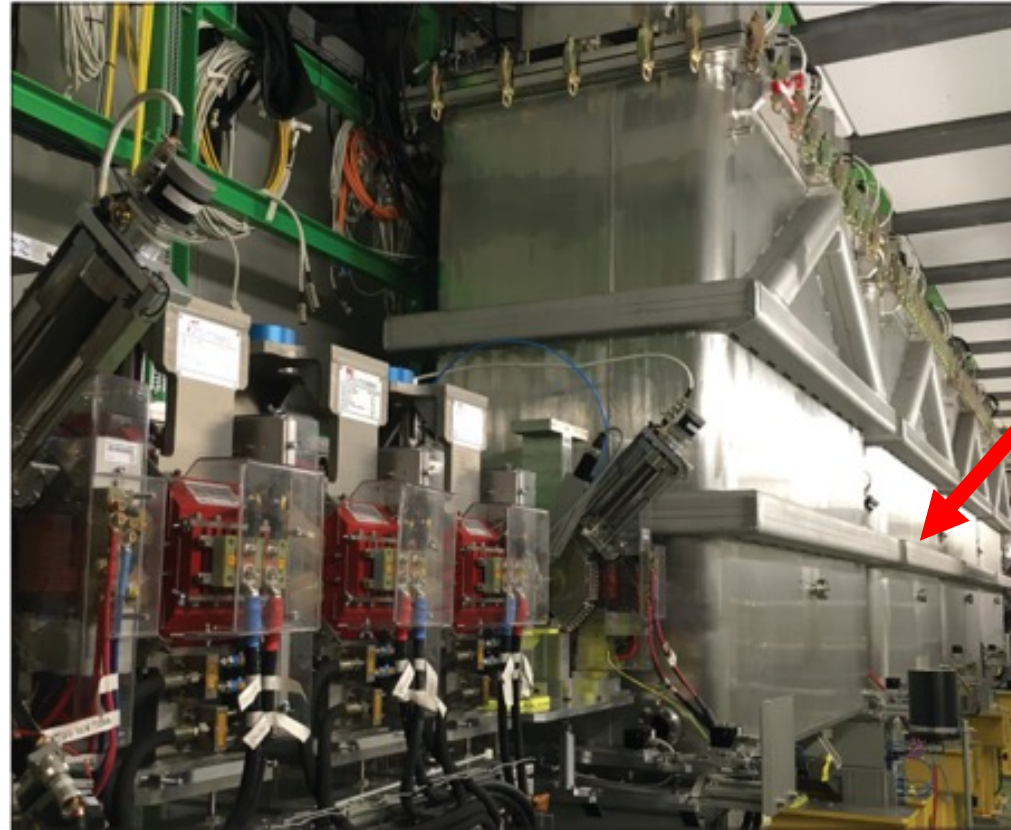
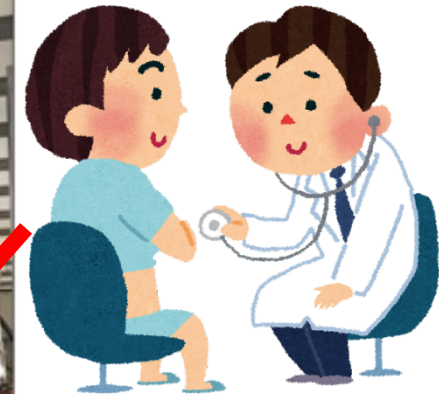
78 Hz noise

We felt obvious vibration on the vessel in this particular CM

- The FB operation required much higher power than other cavities (400W >>RMS 40W)
- Demodulation of spectrum analyzer signal showed 78 Hz vibration in resonant frequency
- Tunnel access → obvious vibration was detected *by hand* in one cryomodule
- Stop active pumping → vibration and correspondingly frequency modulation stopped

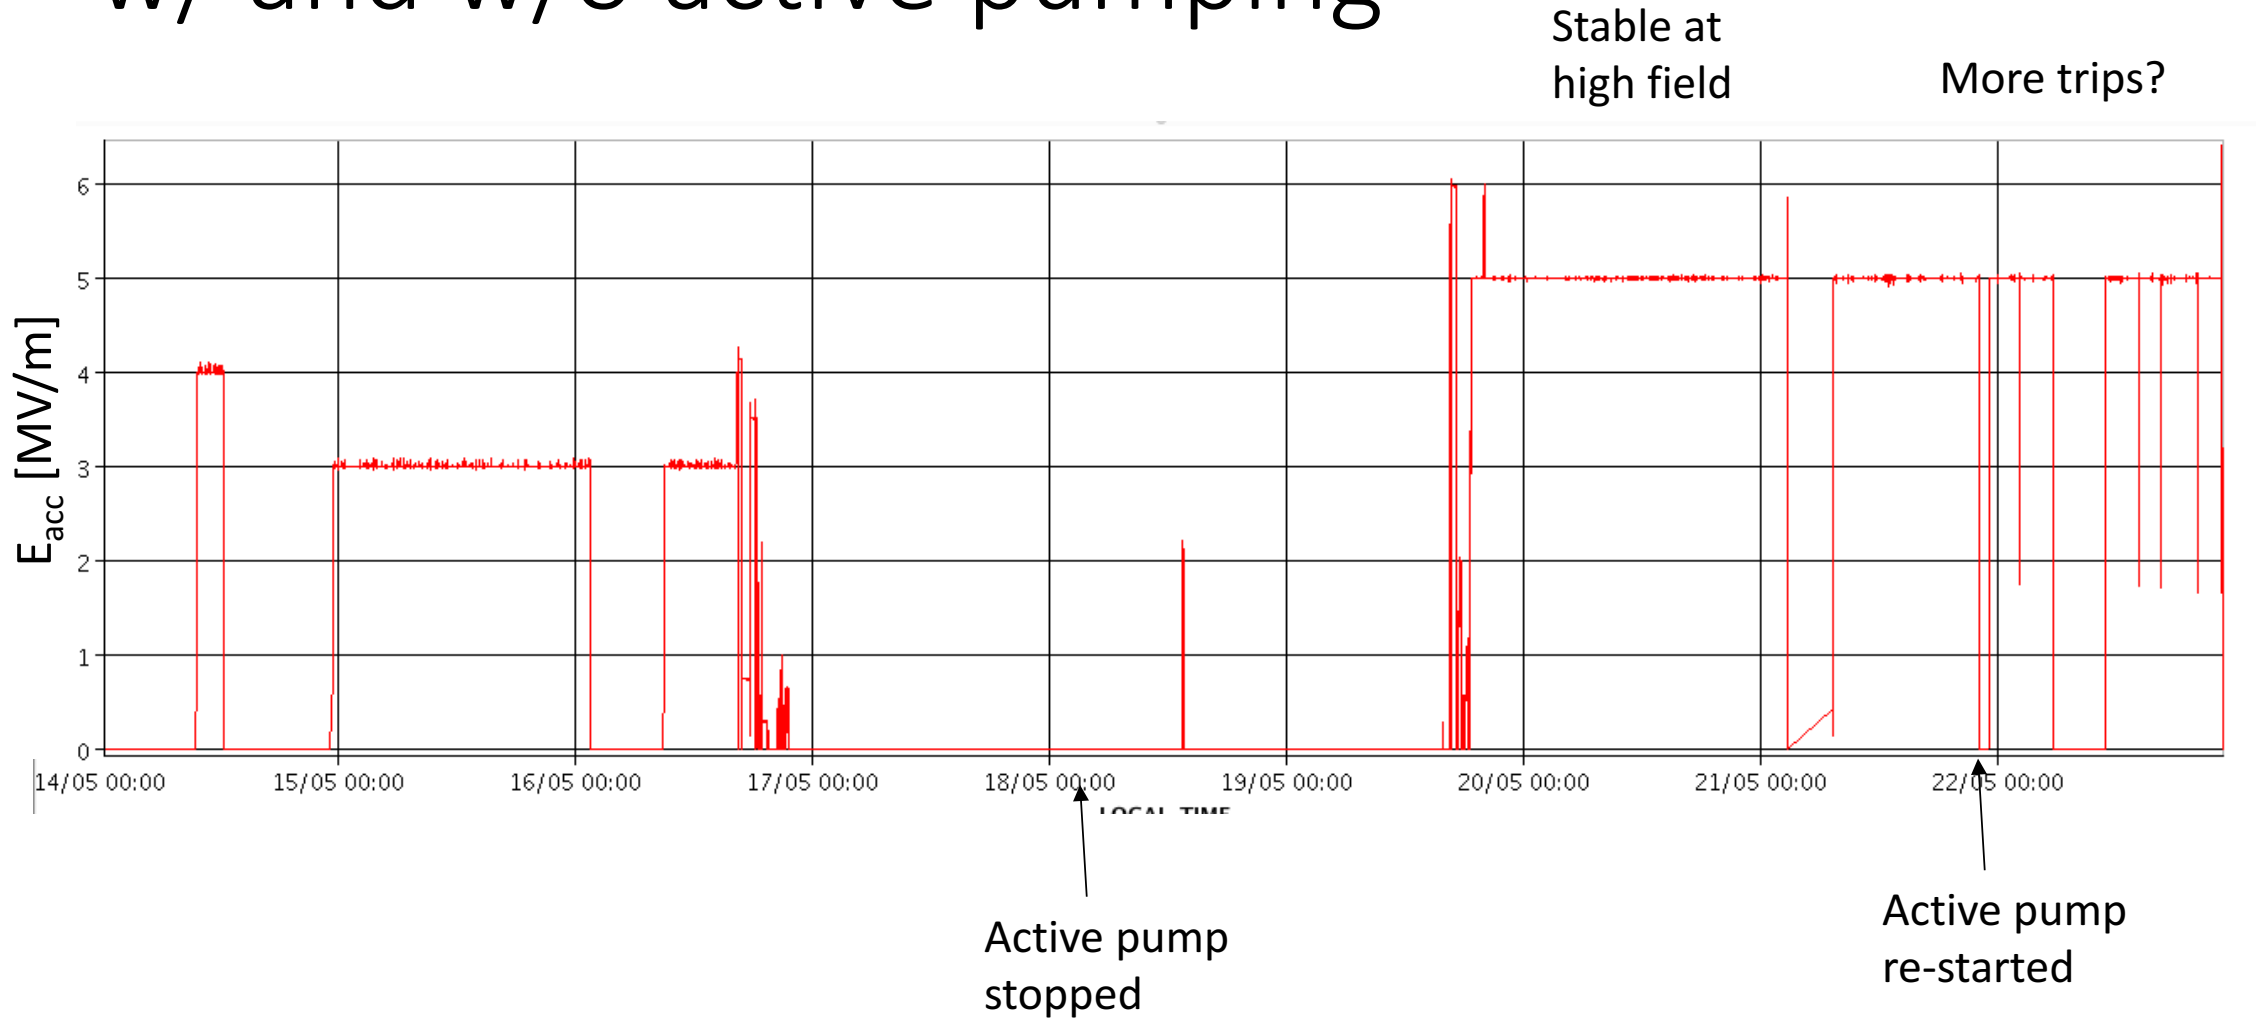
w/ and w/o active pumping

- Intuitively, more trips with active pumping but not enough time to do statistical testing during RF commissioning
- We decided to keep active pumping and limit the field level of this cavity ($4\text{MV/m} < \text{nominal } 6\text{MV/m}$)

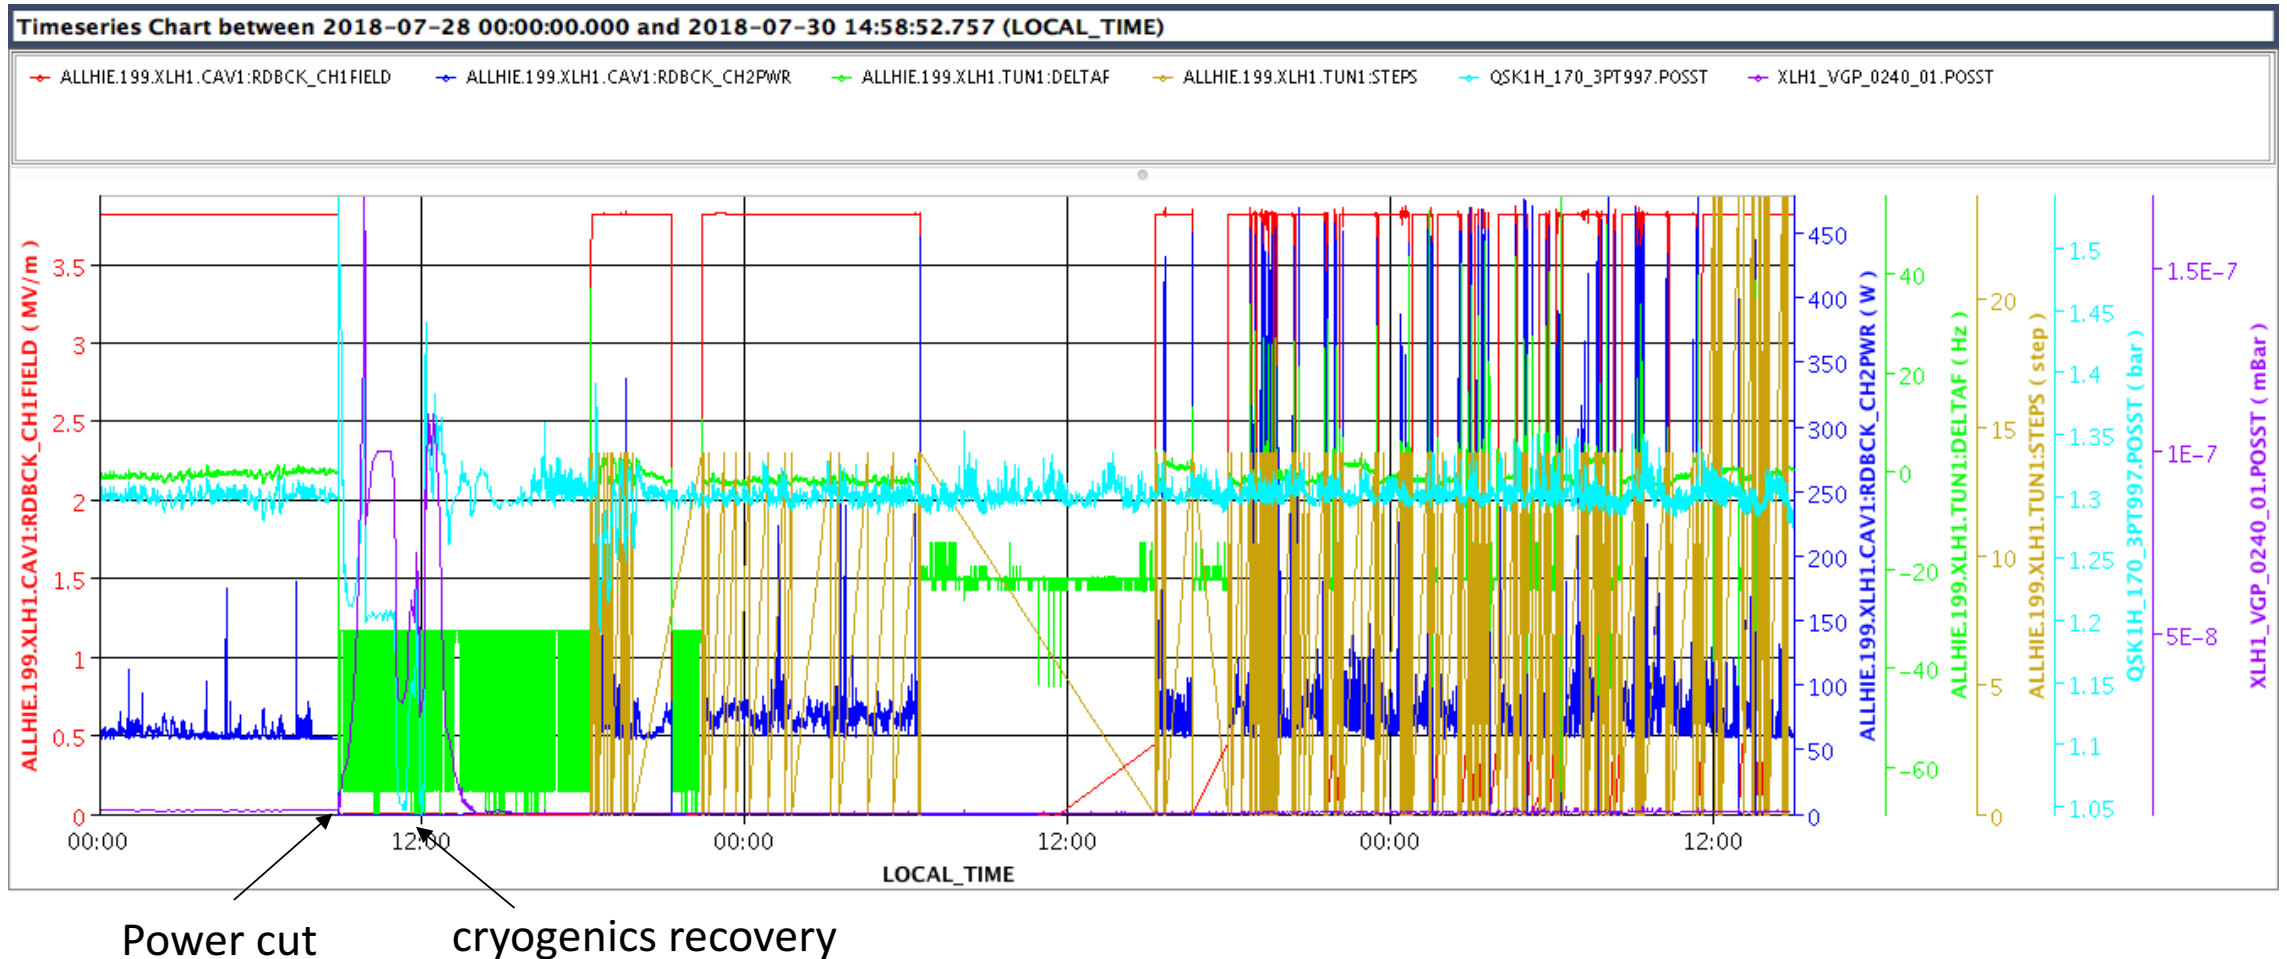
Impact of power cut (July 28th)

- The cryogenic plant stopped by (short) power cut and took 6 hours to restart sending LHe
- A sensitive cavity was affected by the cryogenic instability **for a couple of days**
- We skipped the cavity for the physics run during that week

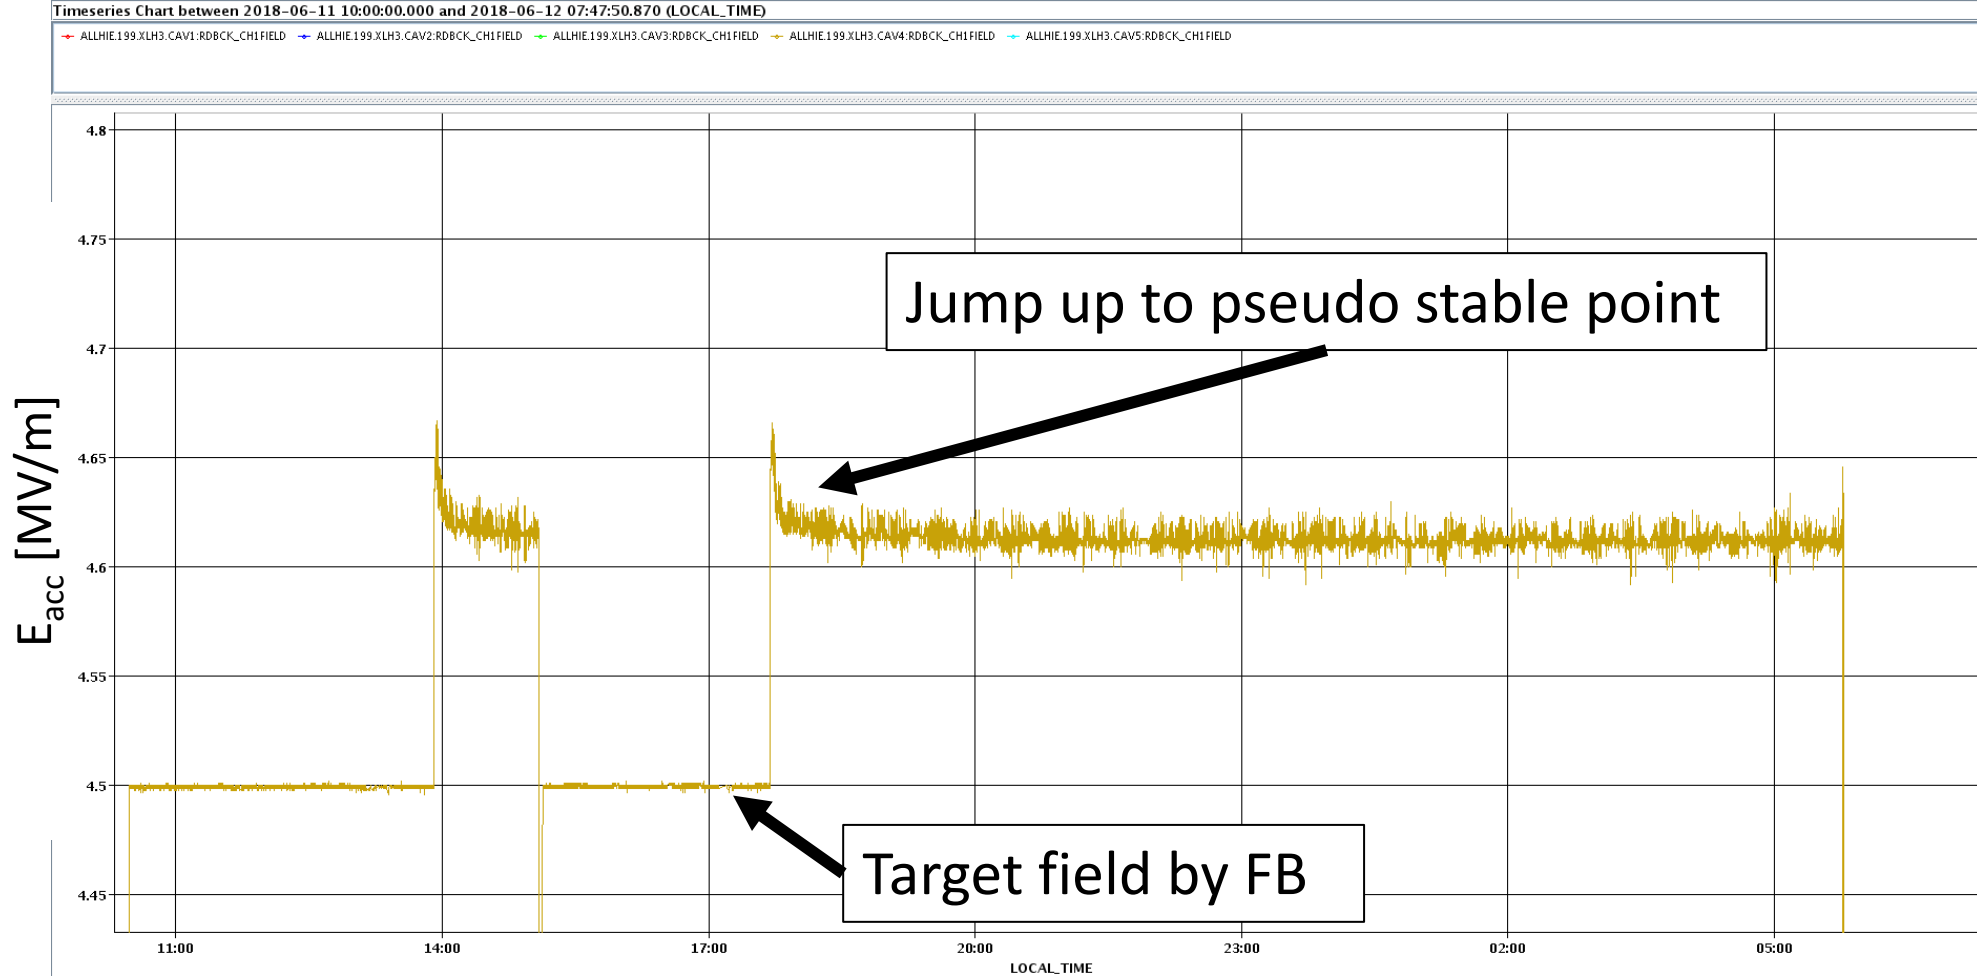
Rare events

Observed twice during 2018 summer

19th cavity on June 12th : lasted 1 week and disappeared

9th cavity on September 6th : lasted 1 week and disappeared

We did not change any parameters!

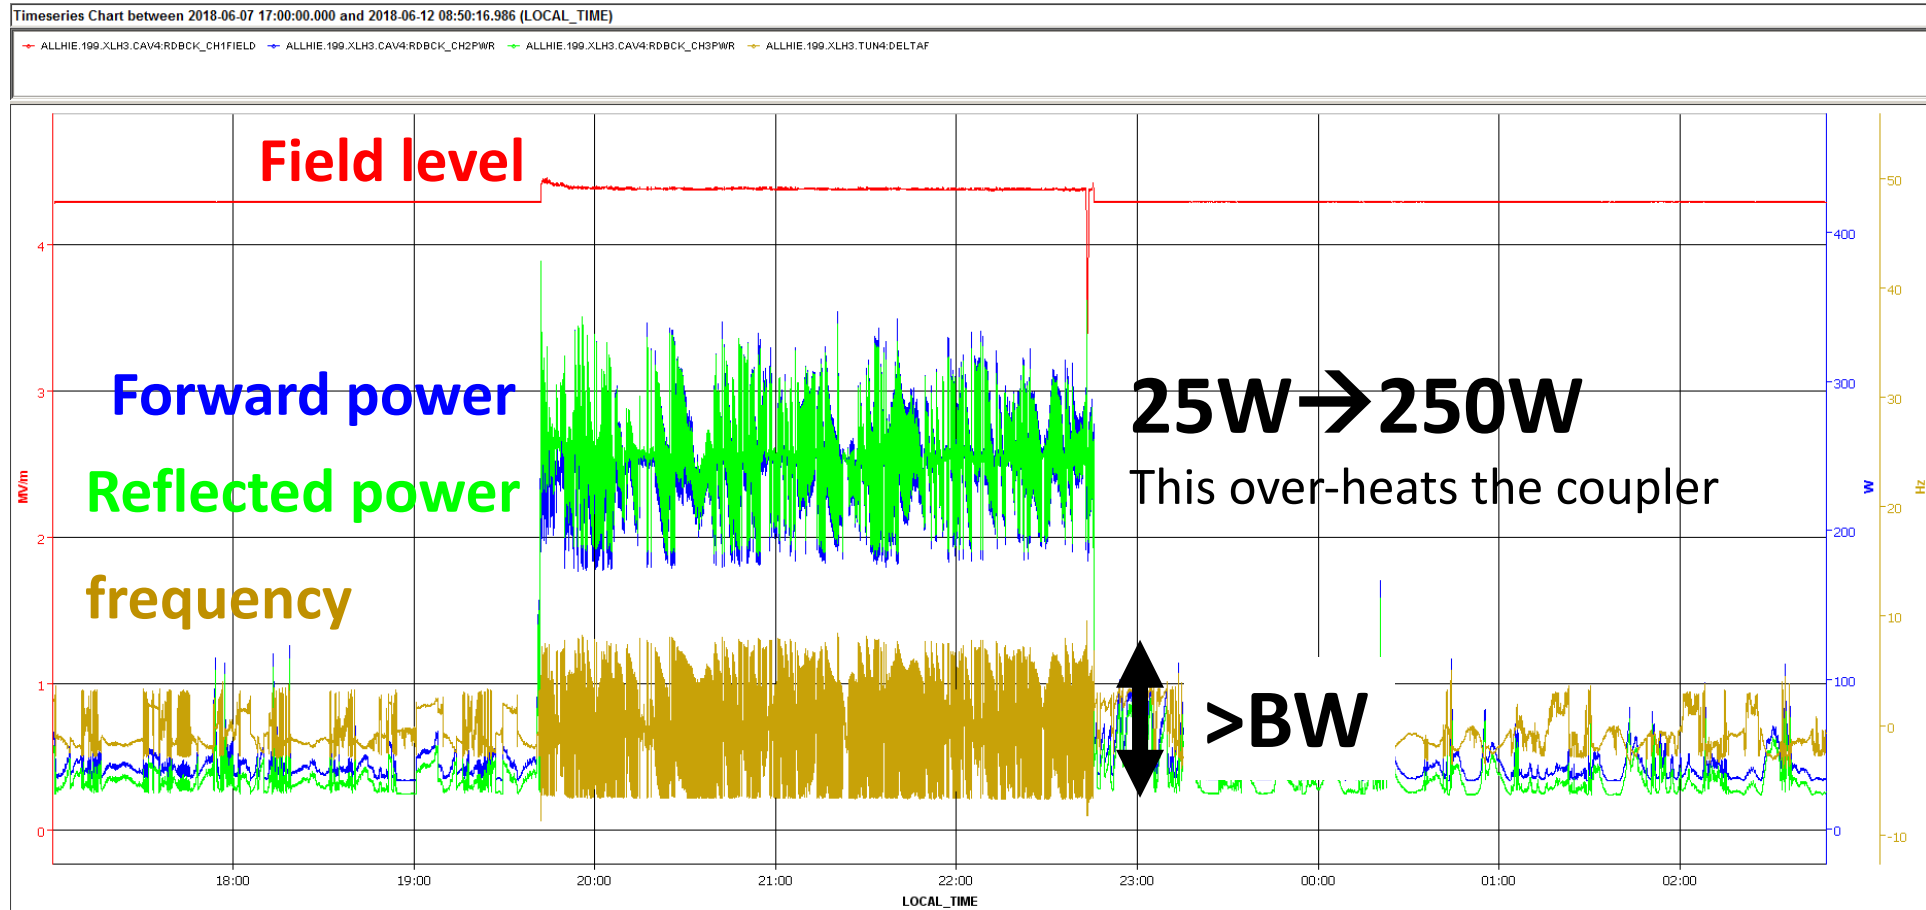
Rare events

- Apparently, FB algorithm found strange “operation point” where the tuner loop cannot fix the resonance
- No field emission in the cavity, cryogenics is stable, ...
- The LLRF card was replaced → no impact
- We suspect field-induced vibration of probably the tuning plate → dedicated test in vertical cryostat is planned

- The thick Cu wall is very insensitive to pressure variation but the thin tuning plate is an issue when operation BW is extremely low
 - Thicker TP is recommended for the future project (better understanding of pre-tuning)
- HIE-ISOLDE cryomodules suffer from three different “vibrations”
 - Slow but significant ($>BW$) mechanical detuning per 1-2min
 - Fast microphonics probably due to active pumping
 - Maybe very rare field-induced vibration when certain condition is fulfilled
- LLRF system compensate the oscillation by the margin of 750W solid-state amplifier, and is operational if cryogenic system is quiet enough
- Sometimes we face rare events which cannot be just solved by LLRF and we pragmatically either limit the field level or skip the cavity
 - The users during very precious beam time never wait us!
