Response to a Recommendation

**Department of Energy Office of Nuclear Physics
Biennial Science and Technology Review**

Relativistic Heavy Ion Collider (RHIC)

26 January 2017

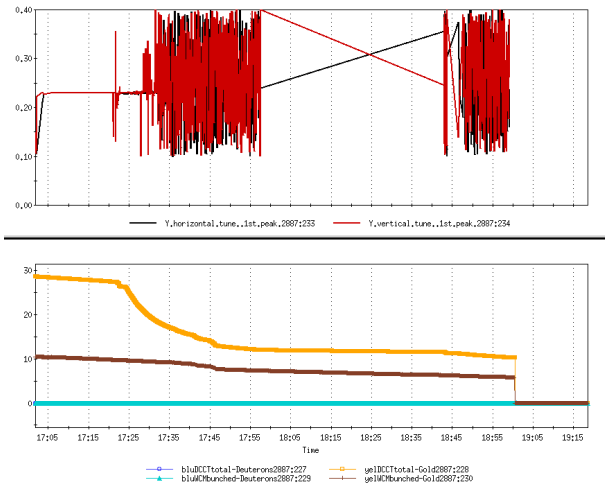
Figure 6: Top: Tune measurements as a function of time during the end of store 2887, Feb. 03 03. Bottom: Bunched and total yellow beam current as a function of time during the same store.

Figure 6, bottom, shows the RHIC yellow beam currents at the end of store 2887. The difference between the total beam, measured by the DCCT [5] and the bunched beam current, measured by the WCM [6], corresponds to the debunched beam. It amounts to $17.5 \cdot 10^9$ Au ions or 63% when the cleaning procedure is started around 17:20. The procedure is stopped after about 35 minutes. Every tune measurement (top of fig. 6) indicates a trigger event for the beam excitation in the abort gap. Note that during the beginning of the procedure, tunes can actually be measured by coherent oscillations of the debunched beam. Tunes are in the order of 0.23 during this example. The cleaning rate here is a record of $0.44 \cdot 10^9$ ions/minute. After pausing for about one hour gap cleaning is resumed and the beam is dumped without problems around 19:00. In general, cleaning rates in 2003 were around $0.22 \cdot 10^9$ for Au ions and around $0.15 \cdot 10^{11}$ for d. The rates vary from fill to fill and depend strongly on the cleaning efficiency. However, the average for heavy ions could be increased by a factor of

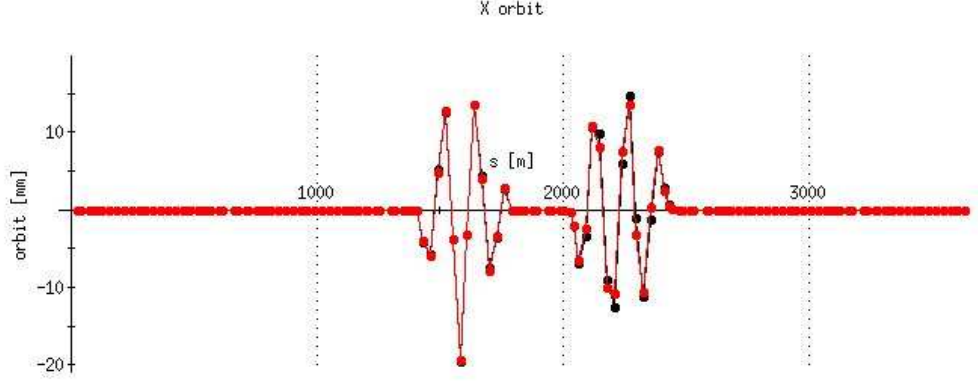
Figure 3: 20 mm orbit bumps installed in the blue ring for run 2014 prefire protection.
