Production Status

RIKEN/RBRC
Itaru Nakagawa

INTT Production Status

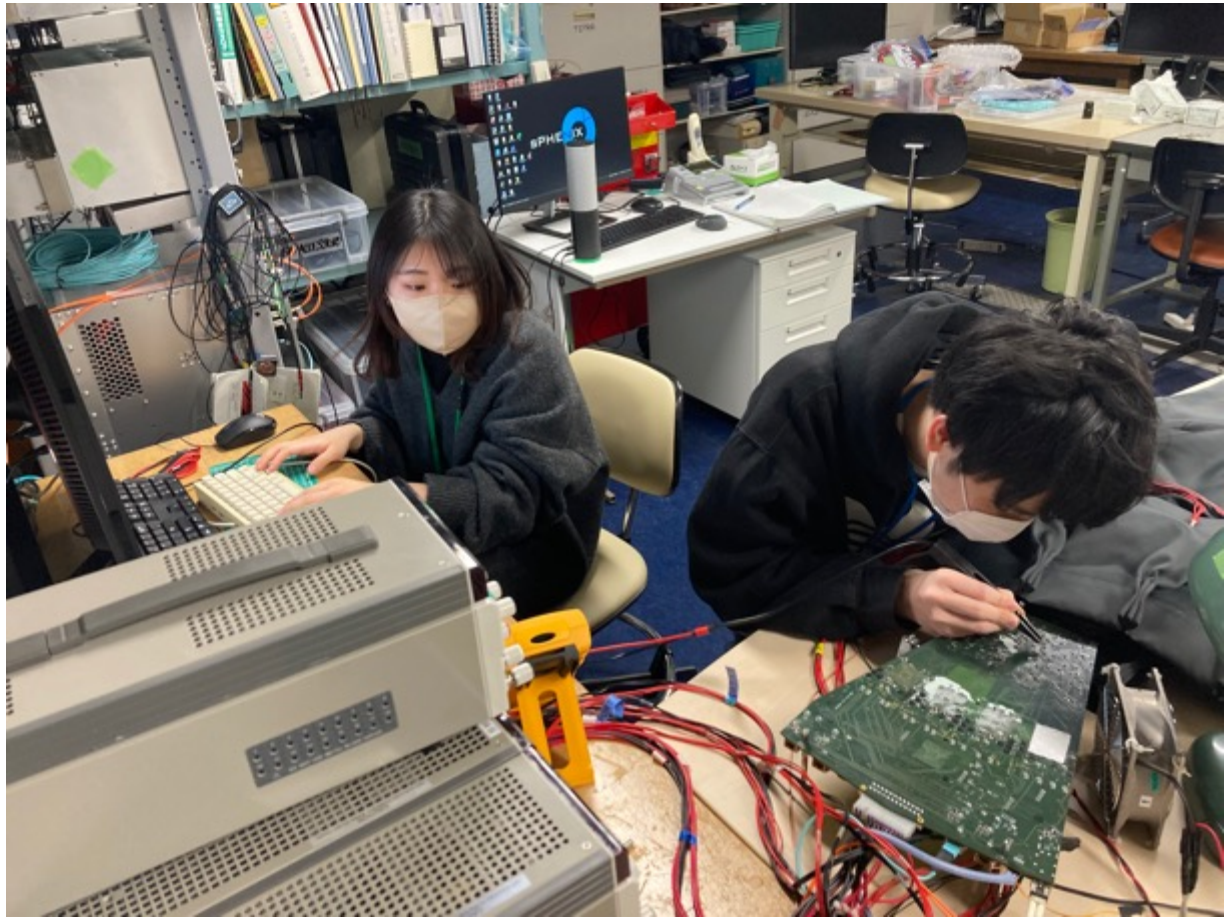
1008 ROC Test ongoing @ RIKEN

Testing 1 ROC/day

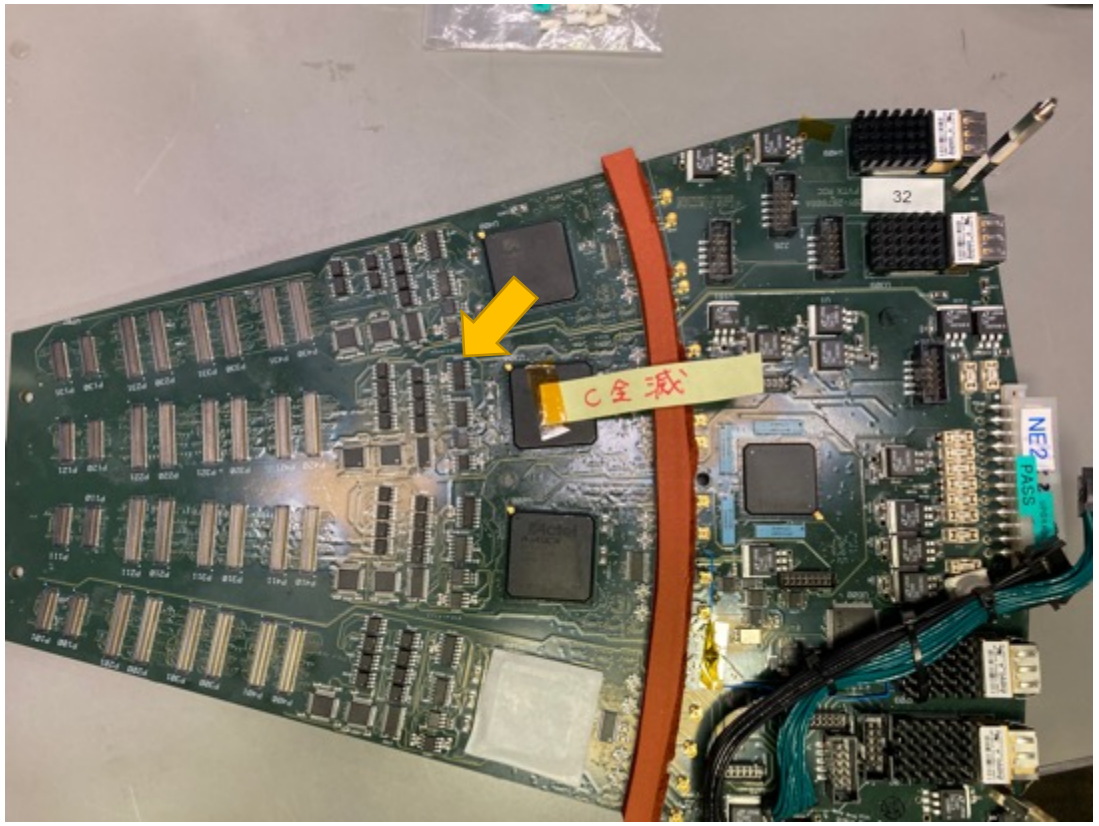
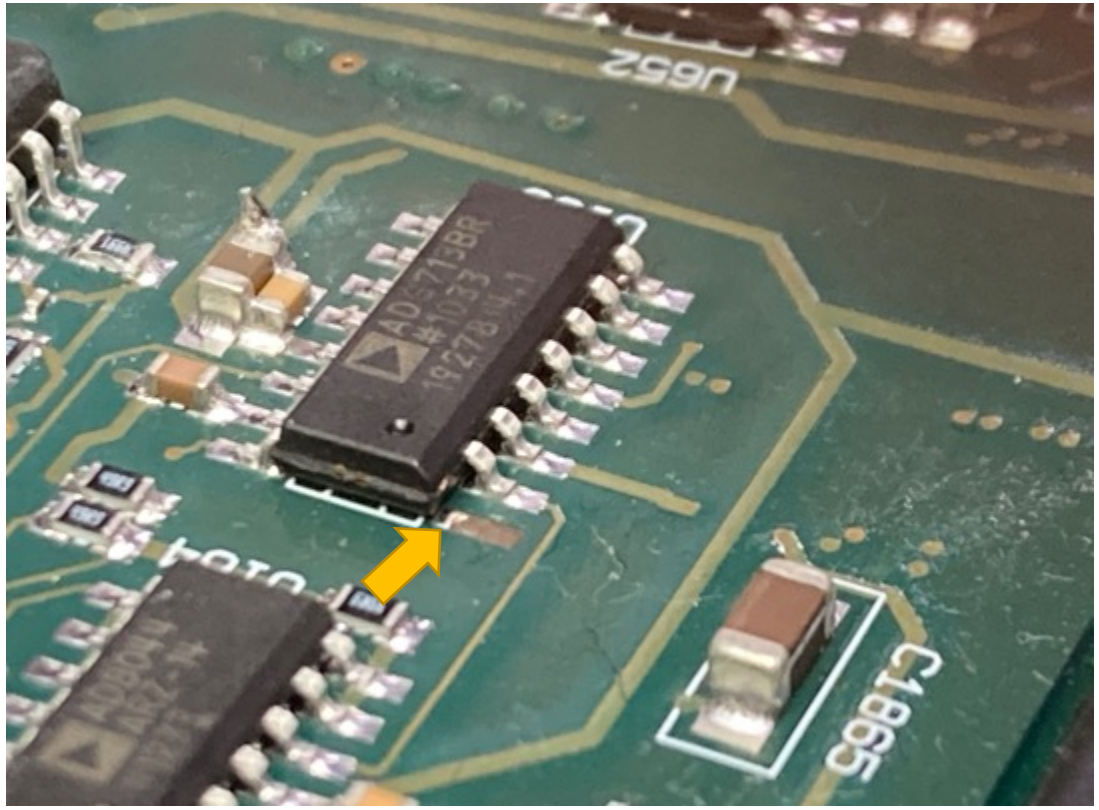
ROC Board NE2 (Failed all Column-C)

Missing Pin#1 (Leg is completely gone), pad metal is also gone.

- Continue testing ROCs at RIKEN.
- Try to fix damaged ROCs accordingly and re-test them once they are fixed.
- Plan to ship ~8 good ROCs to BNL by the end of March.

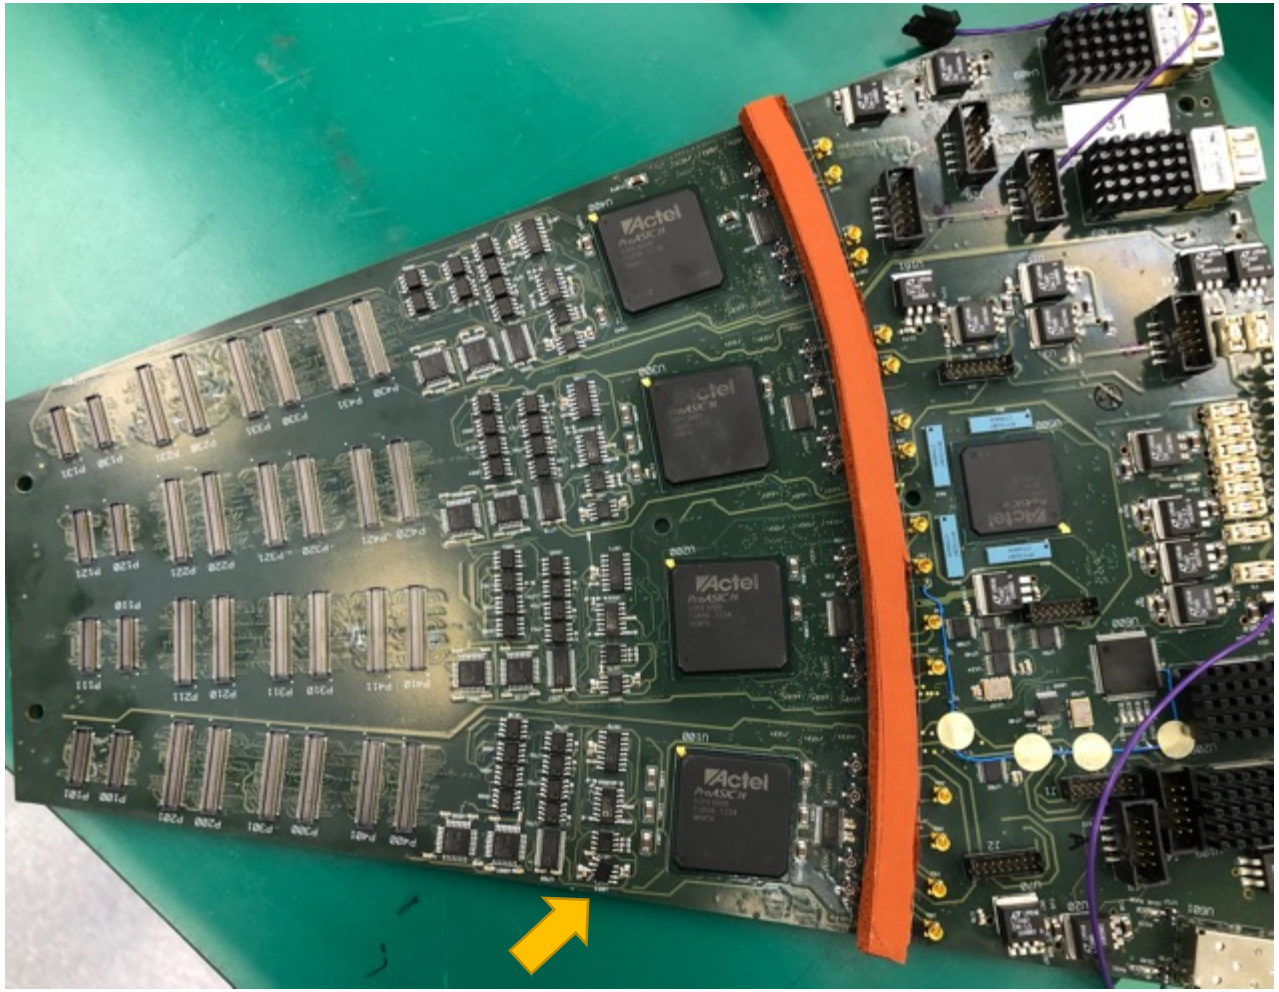
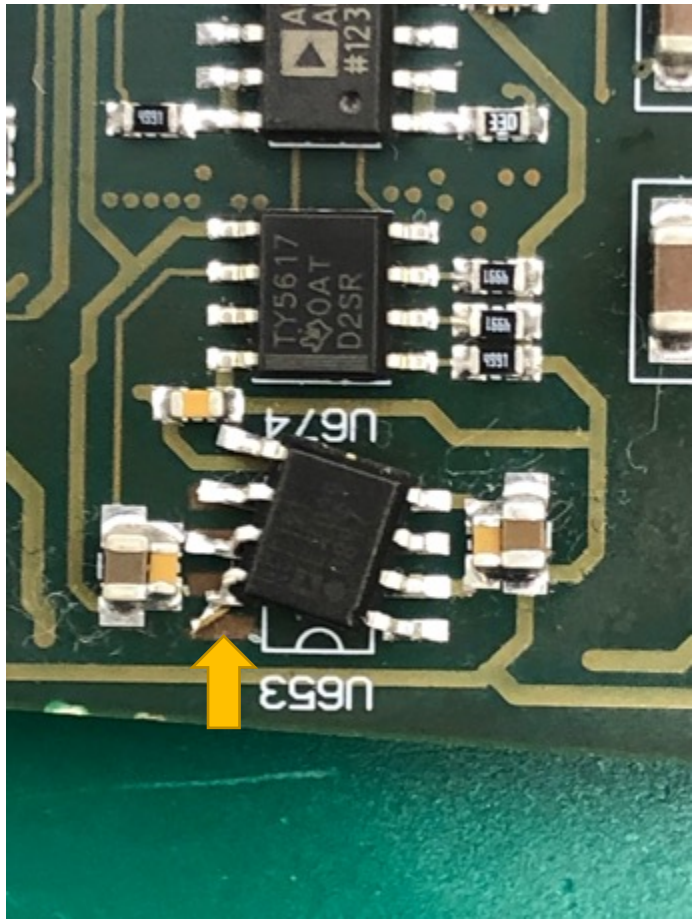
Damaged Chip on NW1

Pad‘s metal is peeled off. It may not be able to restore. Too bad.
