Report on the Task Force on RHIC Detector Operations

On April 16, 2016 Associate Lab Director Berndt Mueller formed a task force to investigate the operational processes that were in place during the 2015 RHIC Run to ensure that the RHIC detectors were making optimal use of the resources devoted to their operation. The formation of the task force was occasioned by the recent realization that two recently installed subsystems, the PHENIX MPC-EX and STAR HFT, had major issues in their operational configurations during the entirety of RHIC Run 15, extending into the first few weeks of RHIC Run 16 in the case of the STAR HFT. The task force was charged with identifying the root causes of the failures and recommending appropriate changes and improvements in the way the readiness and performance of detector systems at RHIC are monitored before and after RHIC runs in order to avoid similar failures in the future. The task force was composed of James Dunlop (chair), Michael Begel, Mickey Chiu, Bill Christie, Leo Greiner, John Lajoie, Laurence Littenberg, David Morrison, and Zhangbu Xu.

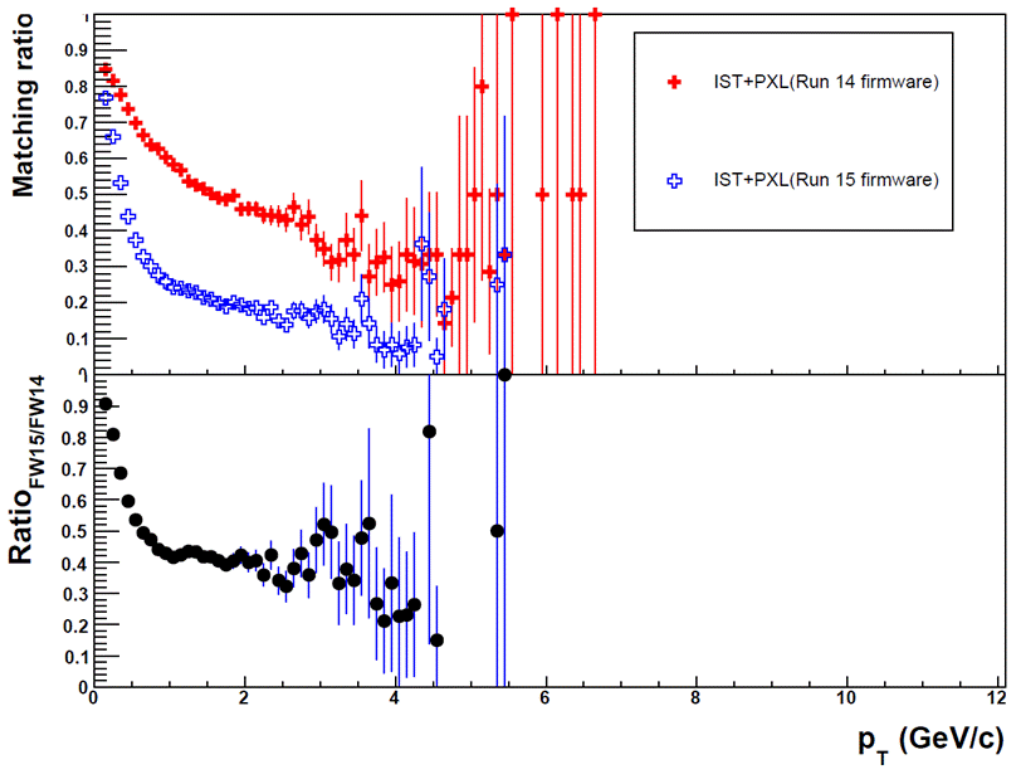
A fast analysis of STAR Run16 Au+Au data taken near the beginning of the run showed a (tracks with at least 3 HFT hits / TPC tracks) matching ratio lower than the ratio observed in the Au+Au Run14 data set. The difference was significant, more than a factor of two (see figure below). This observation triggered a series of checks on the PXL detector configuration and data processing chain. By switching between different PXL firmware versions and taking data during the early part of the current RHIC Run in similar conditions of luminosity and trigger rate, it was found that the data taken with the firmware used during Run15 and in the first 3 weeks of Run16 (revision r865) displays a significant drop in the tracking efficiency with respect to the data taken with the firmware used during Run14 (revision r700).

FIGURE 1: HFT/TPC TRACK MATCHING RATIO AS A FUNCTION OF THE TRACK MOMENTUM. ALL PLOTS MADE WITH RUN 16 DATA. THE RED SOLID CROSSES REFER TO THE DATA TAKEN WITH THE FIRMWARE USED IN RUN 14 (R700), BLUE OPEN CROSSES TO THE RUN 15 FIRMWARE (R865). THE RUN 15 FIRMWARE MATCHING EFFICIENCY NORMALIZED TO THE RUN 14 FIRMWARE EFFICIENCY IS SHOWN IN THE BOTTOM PANEL.

When spotted, as remediation to the observed effect, STAR immediately rolled back to Run14 firmware (r700) for the rest of Run16 data taking. At our current state of knowledge, this is the most efficient and safest PXL configuration and allows for a track matching efficiency as large as the one observed in Run14. Recent simulations reproduce the current PXL performance within 5%.

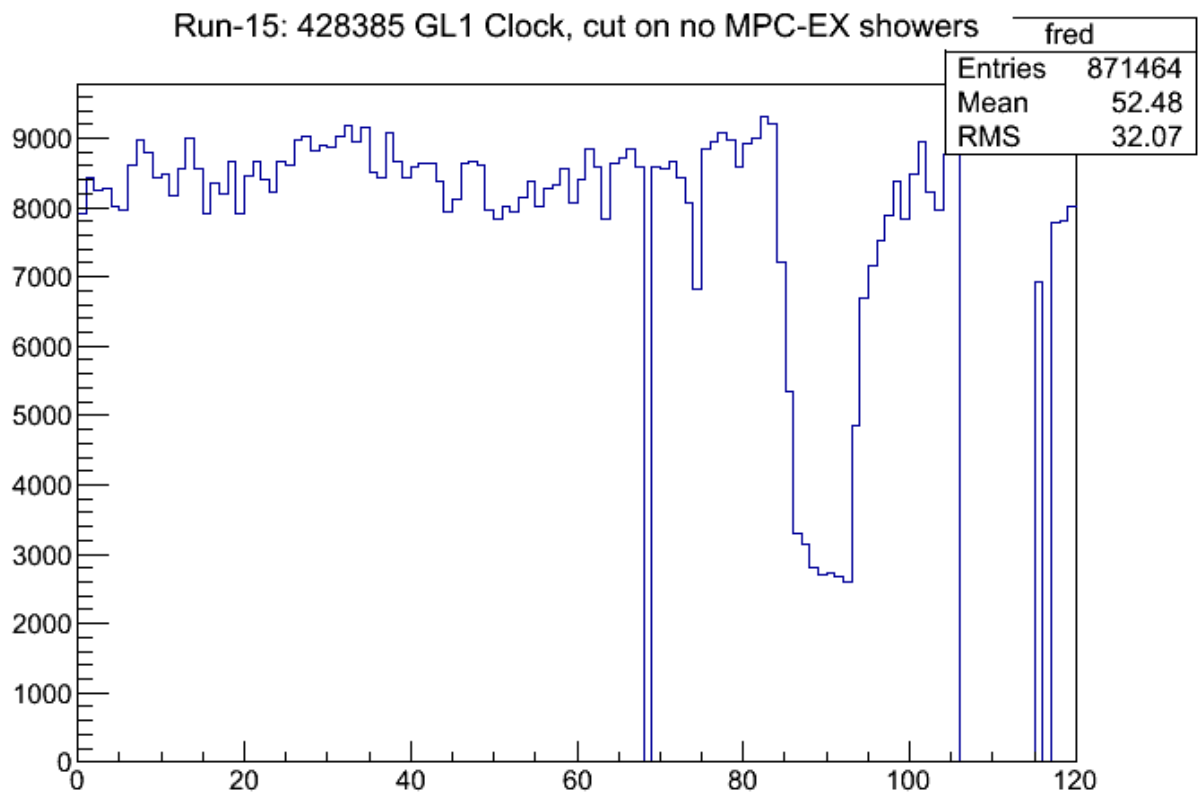
Figure 2 shows the distribution of events with at least one MPC-EX shower found by the offline reconstruction software as a function of the GL1 crossing number. The mistiming of the detector can be seen as a "reflection" of the abort gap in this distribution, approximately 20BCLKs earlier than the true abort gap.

FIGURE 2: THIS IS THE NUMBER OF EVENTS WITH AT LEAST ONE MPC-EX SHOWER AS A FUNCTION OF THE GL1 CROSSING NUMBER. THE ABORT GAP IS CLEARLY VISIBLE STARTING AT CROSSING 107. THIS REGION IS DEPOPULATED BECAUSE THERE ARE NO TRIGGERS IN THIS REGION. THE REDUCTION OF SHOWERS ROUGHLY 20 BCLKS EARLIER IS THE REFLECTION OF THE ABORT GAP AS SEEN BY THE MPC-EX TIMING, AND THE REDUCTION OF SHOWERS IS DUE TO THE LACK OF COLLISIONS IN THE ABORT GAP. THIS IS STRONG EVIDENCE FOR THE MISTIMING OF THE MPC-EX.

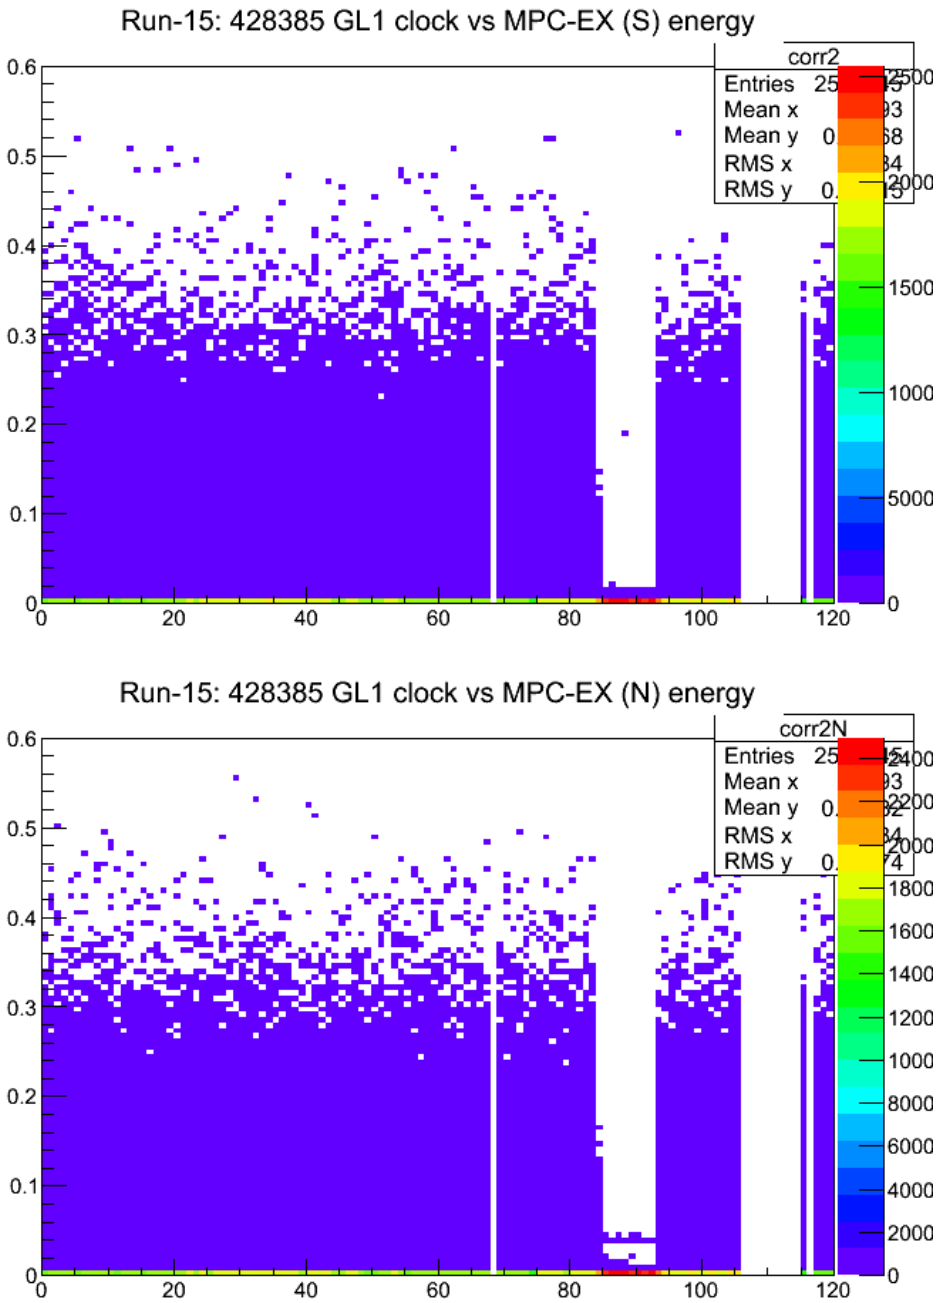
Figure 3 shows the MPC-EX minipad energy distribution (vertical axis, in arbitrary units) as a function of the GL1 crossing number. This is a less "processed" value than the number of showers found by the reconstruction software, and it clearly shows a depletion on the energy distribution in a region 20BCLKs prior to the abort gap, indicating the loss of showers in Figure 1 is not an issue with the shower reconstruction software but is seen in the energy measured in the detector.

FIGURE 3: THIS FIGURE SHOWS THE MPC-EX MINIPAD ENERGY DISTRIBUTION (VERTICAL AXIS, IN ARBITRARY UNITS) AS A FUNCTION OF THE GL1 CROSSING NUMBER. THIS IS A LESS "PROCESSED" VALUE THAN THE NUMBER OF SHOWERS FOUND BY THE RECONSTRUCTION SOFTWARE, AND IT CLEARLY SHOWS A DEPLETION ON THE ENERGY DISTRIBUTION IN A REGION 20BCLKS PRIOR TO THE ABORT GAP, INDICATING THE LOSS OF SHOWERS IN FIGURE 1 IS NOT AN ISSUE WITH THE SHOWER RECONSTRUCTION SOFTWARE BUT IS SEEN IN THE ENERGY MEASURED IN THE DETECTOR.

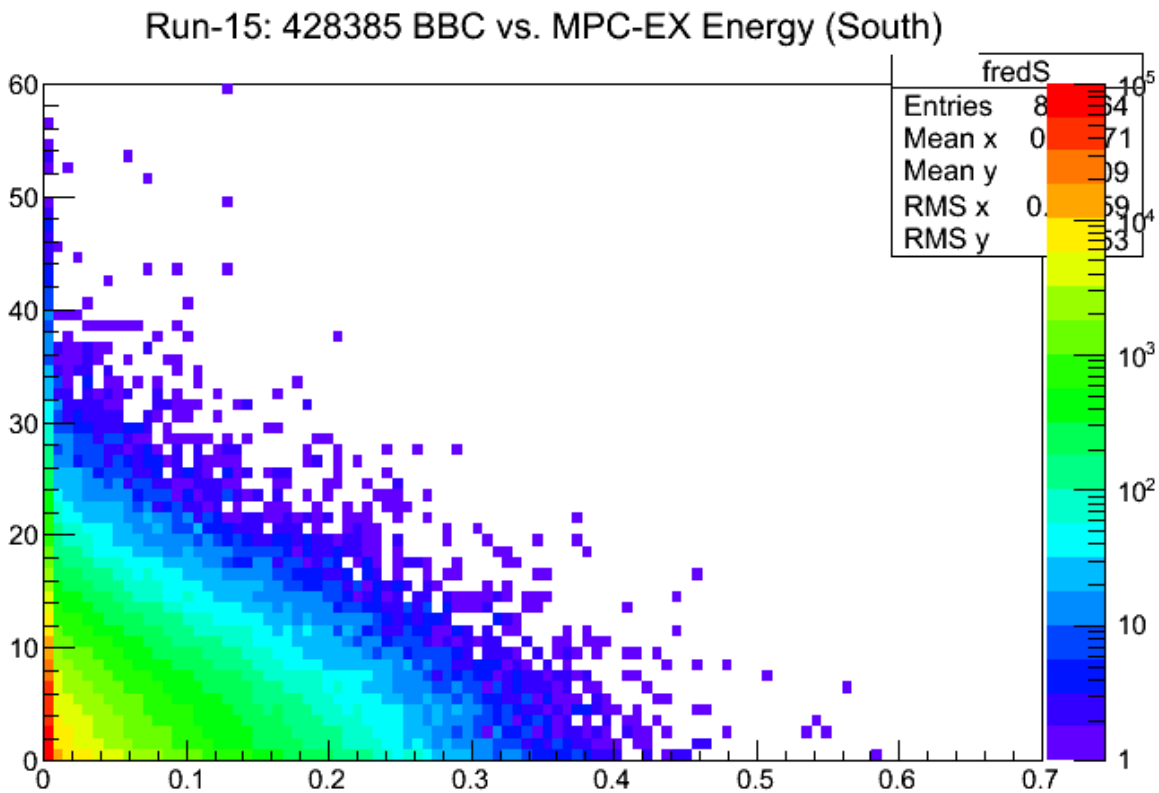
In order to examine the correlation with the BBC the fully calibrated MPC-EX energy sum is compared with the BBC charge for the south arm of the PHENIX detector (Figure 4). The MPC-EX calibrations include the elimination of hot channels and hits from SVX4 chips with CellID problems. This correlation, based on calibrated data, shows that the BBC and MPC-EX are not correlated – they are not looking at the same beam crossing. Note, however, the extent of the correlation in p+p, as compared to Au+Au (see Figure 6).

FIGURE 4: THIS FIGURE SHOWS THE CORRELATION BETWEEN THE BBC CHARGE (VERTICAL AXIS) VERSUS THE MPC-EX SUMMED MINIPAD ENERGY (HORIZONTAL AXIS) FOR THE SOUTH ARM. THIS PLOT IS A RESULT OF THE NEW OFFLINE FRAMEWORK WITH FULL CALIBRATIONS, AND HOT AND DEAD CHANNELS REMOVED.

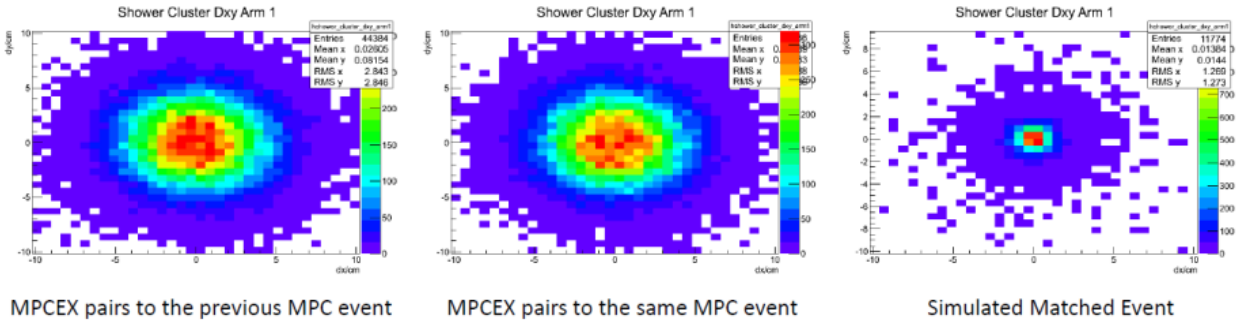
In Figure 5 we show a spatial correlation between MPC-EX showers and MPC clusters in real data and in simulations. As with the BBC correlations, these results support the idea that the MPC-EX is mistimed with respect to the MPC as the correlations are consistent with random association.

FIGURE 5: A COMPARISON OF THE SPATIAL MATCHING IN X (HORIZONTAL) AND Y (VERTICAL) BETWEEN AN MPC-EX SHOWER AND A CLUSTER IN THE MPC. THE CENTER PANEL SHOWS MATCHING IN RUN-15 DATA IN THE SAME EVENT, THE LEFTMOST PANEL SHOWS MATCHING TO THE PREVIOUS EVENT (DELIBERATELY MISTIMED) AND THE RIGHTMOST PANEL SHOWS THE EXPECTATION IN SIMULATIONS, INCLUDING THE MPC-EX DEAD AREAS IN RUN-15. THE CONCLUSION IS THAT IN RUN-15 DATA THE MATCHING IS CONSISTENT WITH RANDOM ASSOCIATION.

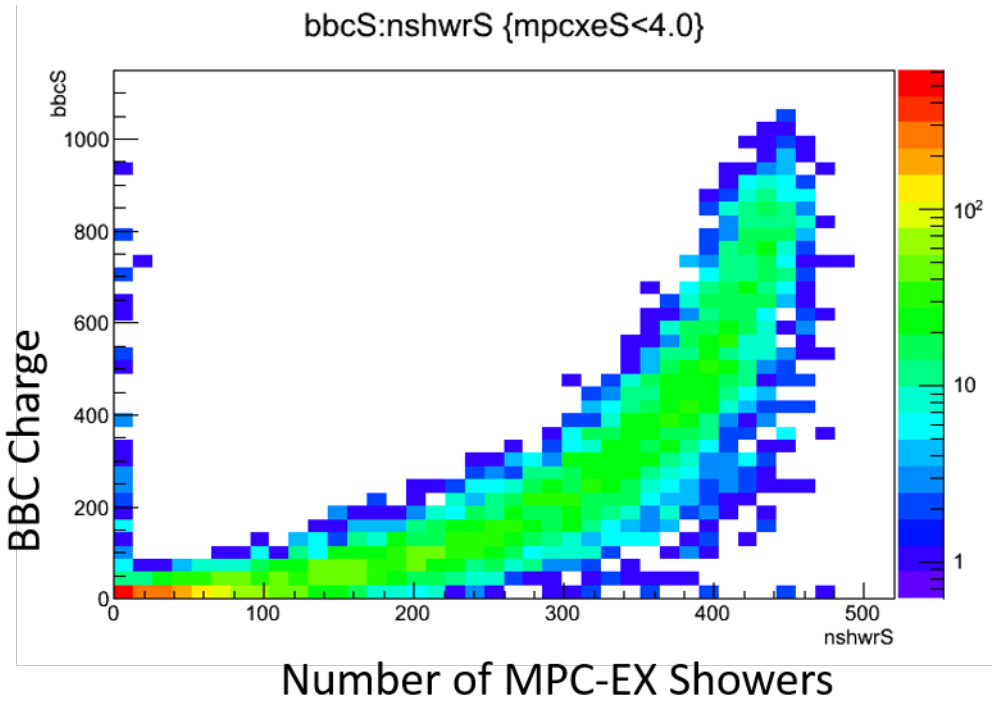
FIGURE 6: CORRELATION OF THE BBC CHARGE WITH THE NUMBER OF SHOWERS FOUND IN THE MPC-EX FOR THE PHENIX SOUTH ARM IN RUN-16. THE LEVEL-1 DELAY FOR THE SOUTH MPC-EX HAS BEEN CORRECTED AND TIMED-IN RELATIVE TO THE BBC, PRODUCING A CLEAR CORRELATION BETWEEN THE NUMBER OF SHOWERS AND THE BBC CHARGE.

In addition to the investigations of the Run-15 data, the detector timing exercise in Run-16 Au+Au collisions was completed for both the north and south MPC-EX. The SVX4 serial download was corrected, and following the original plan from Run-15 a Level-1 delay scan was performed around the nominal value of 40BCLKs, as expected from the VTX strip pixels. Due to the higher multiplicity in Au+Au collisions, and the improved detector performance, it was not necessary to look at MIPs in the MPC-EX but the MPC-EX summed energy (or number of showers) could be compared directly to the BBC charge. The appropriate Level-1 delays for the north and the south were quickly identified.
Figure 6 shows the correlation between the BBC charge and the number of MPC-EX showers in Run-16 Au+Au data. This correlation changes dramatically with a variation of the Level-1 delay of +/-1BCLK, clearly indicating the correct beam crossing, as shown in Figure 7.

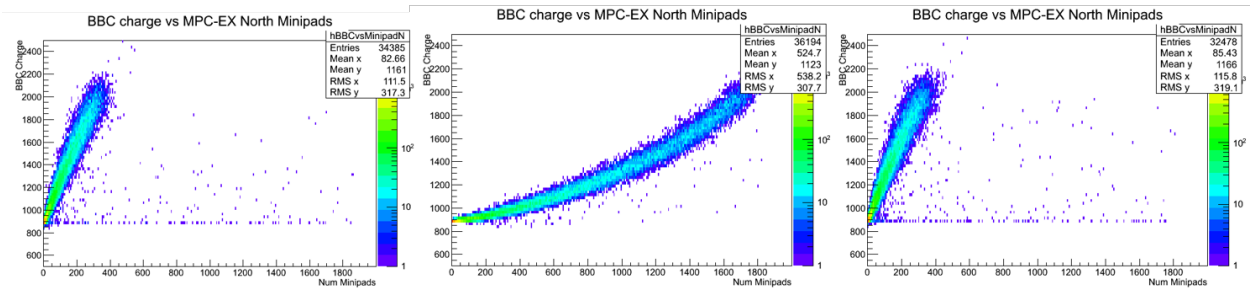
FIGURE 7: CORRELATIONS BETWEEN THE BBC CHARGE AND NUMBER OF HIT MINIPADS IN RUN-16 AU+AU DATA. THE CENTRAL PANEL SHOWS THE CORRELATIONS WITH THE LEVEL-1 DELAY ADJUSTED SO THE BBC AND MPC-EX ARE ON THE SAME BEAM CLOCK, WHILE THE LEFT AND RIGHT PANELS SHOW THE EFFECT OF SHIFTING THE LEVEL-1 DELAY AWAY FROM THE CORRECT VALUE.

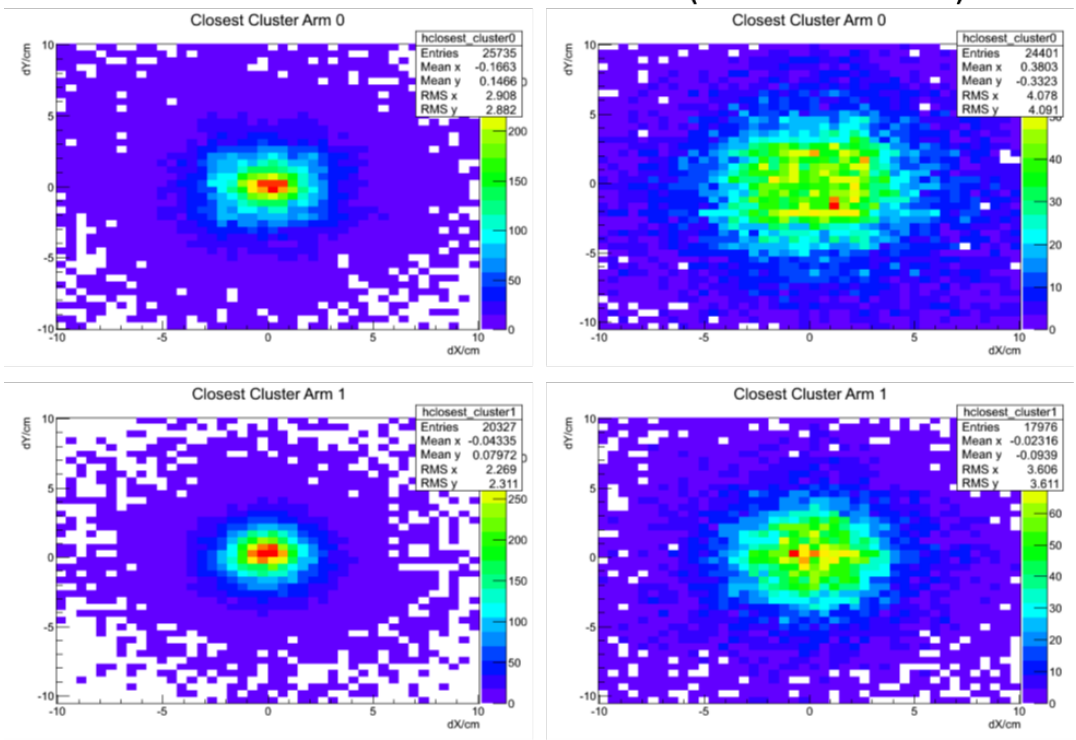
FIGURE 8: A COMPARISON OF THE SPATIAL MATCHING IN X (HORIZONTAL) AND Y (VERTICAL) BETWEEN AN MPC-EX SHOWER AND A CLUSTER IN THE MPC IN RUN-16 DATA. THE COMPARISON IS MADE FOR MPC CLUSTERS WITH AN ENERGY > 1.5 GEV, AND FOR MPC-EX SHOWERS WITH ENERGY IN SEVEN OR MORE LAYERS OF THE MPC-EX. THE LEFT HAND COLUMN SHOWS THE MATCHING IN LOW-MULTIPLICITY AU+AU EVENTS (BBC CHARGE < 200) IN THE NORTH ARM (TOP) AND SOUTH ARM (BOTTOM). THE SAME COMPARISON IS SHOWN FOR MIXED EVENTS WHERE THE MPC-EX SHOWER AND MPC CLUSTER ARE DRAWN FROM DIFFERENT EVENTS. THE SAME-EVENT COMPARISON IS SIMILAR TO THAT EXPECTED FROM SIMULATIONS AS SHOWN IN FIGURE 5.

Finally, Figure 8 shows the spatial matching between the MPC-EX shower axis in Run-16 low-multiplicity Au+Au data for both same-event and mixed event correlations. The same-event correlations compare very favorably with the correlations in simulation shown in Figure 5, and indicate that the MPC-EX shower and MPC cluster are from the same electromagnetic shower.
