X-ray CT Image = Microscope Image = Conductivity Test ?

# CONSISTENCY CHECK

Feb.12, 2021

Hayashi-REPIC

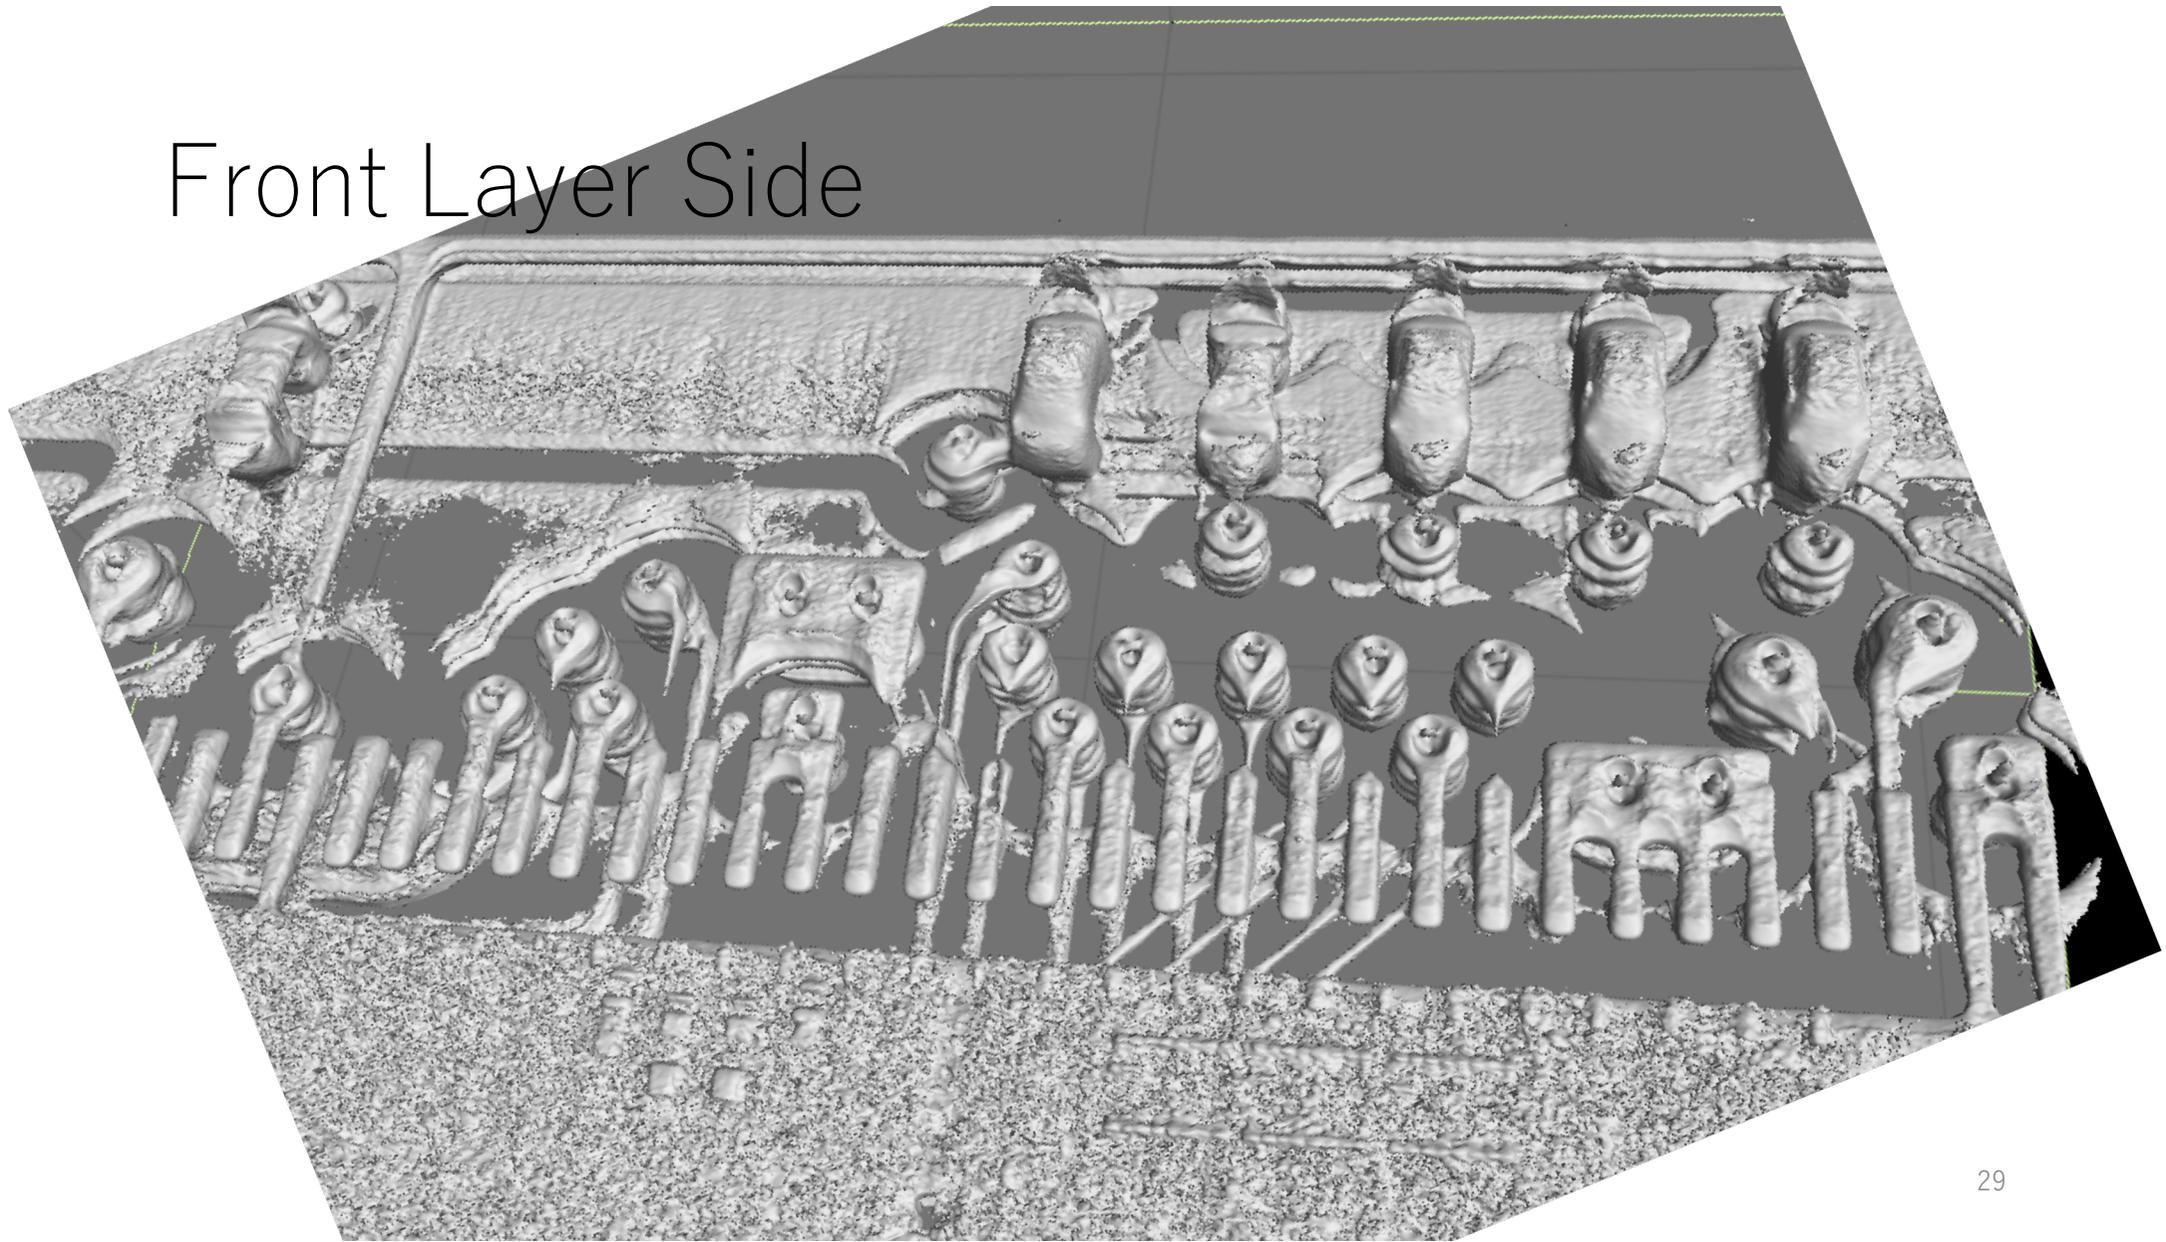
# Front Layer Side

- The X-ray image indicated possible line open in the path between thru hole and bonding pads, and these opens appear almost every other lines.
- This is contradict to what was observed in Taiwan.
- The consistency check was made between different observation methods of the line open.
  1. X-ray CT scan image
  2. Microscope observation of the HDI surface layer
  3. Conductivity check with a multimeter

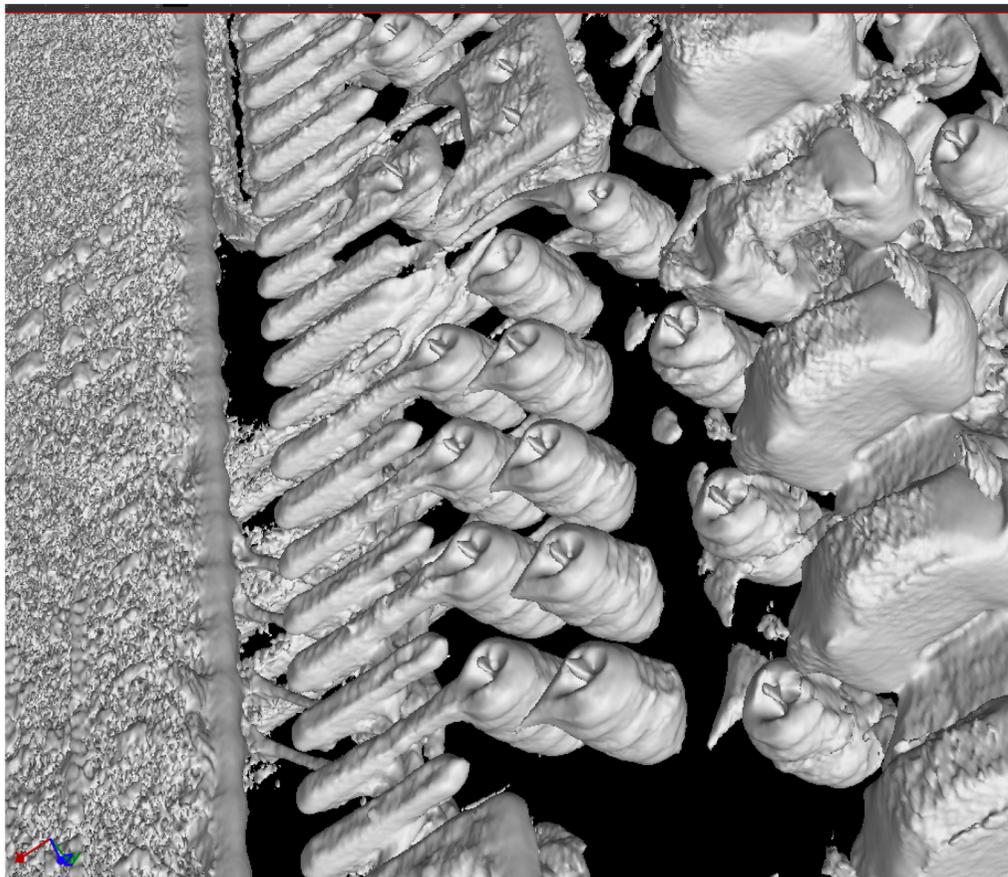
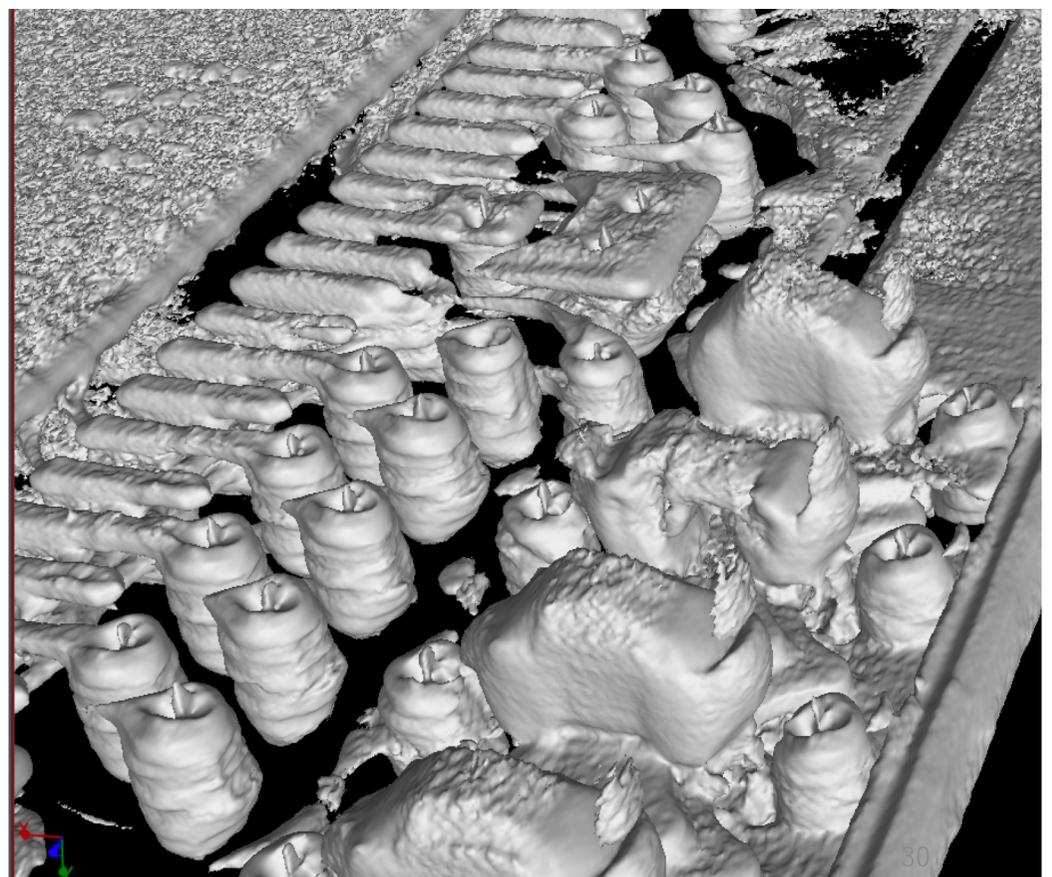
# Front Layer Side

There are traces towards the bonding pad as if the path is torn off.

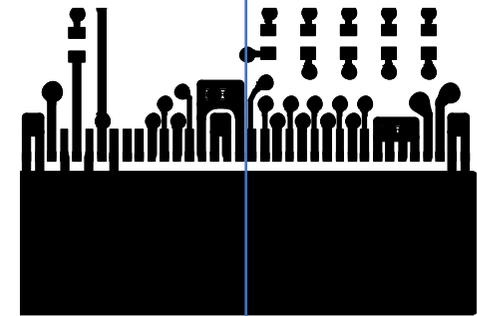
The reconstructed image can be different if we let the chip spin this orientation.

This is the orientation of the rotation
