EIC Roman Pots / AC-LGADIJCLab Progress Report

BNL-IJCLab-OMEGA Meeting - May 6th, 2021

- Progress report on activities related to an AC-LGAD (strips) sensor wire-bonded by BNL onto an ALTIROC1_V2 (PCB #30)
- **➢** Outlook

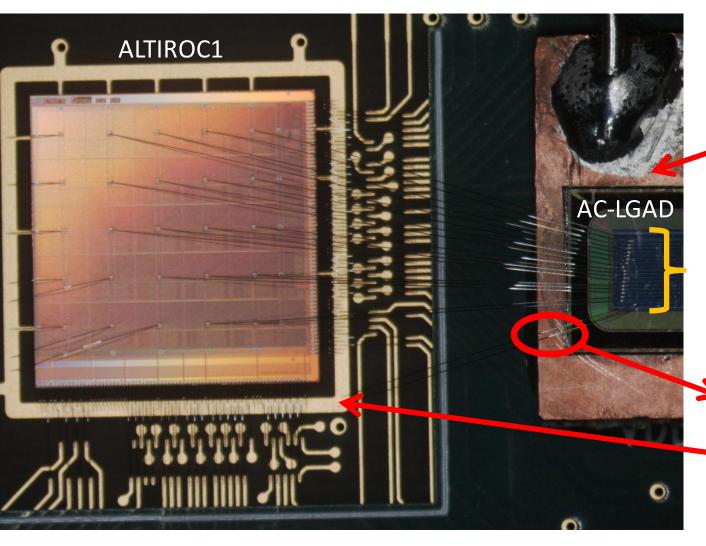
Layout of OMEGA ALTIROC1 wire-bonded by BNL to an AC-LGAD (strips) on ASIC PCB #30

-HV probe touches here

Whatever we do, these wires (Ac-pads and inputs of the ALTIROC) should stay ~ GND, as only 100nm of dielectric separates them from the n-pad at GND

Guard Ring & n-pad go to GND So you can touch here:

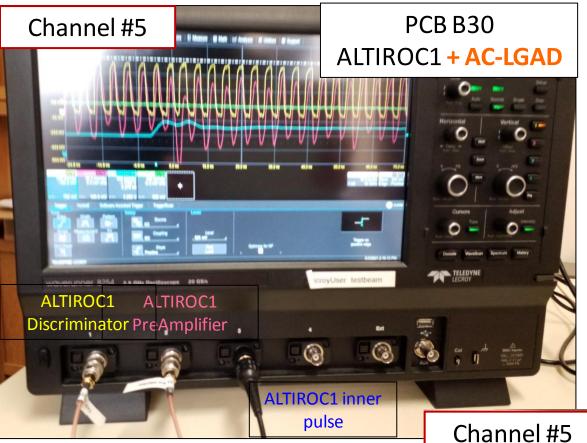
(ALTIROC1_V2 + AC-LGAD) typical observed output signals on scope: B30 and B12 PCBs

AC-LGAD sensor unpolarized (No HV applied)

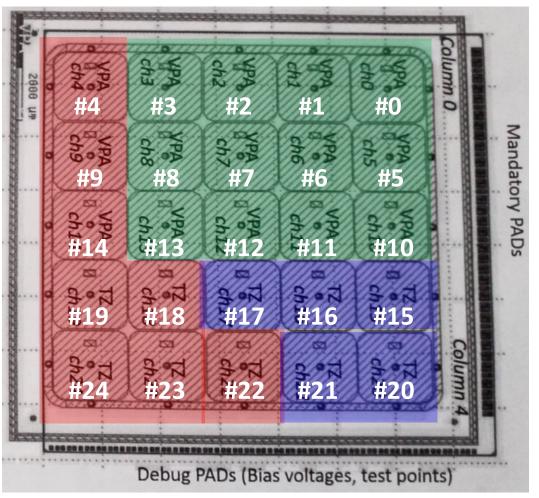
ALTIROC1_V2 mapping / identification of AC-LGAD wire-bonded channels

- Observation on scope of the 25 individual ALTIROC1 PreAmplifier channels triggered by the ALTIROC1 command pulse => identification of the 17 channels wire-bonded / 8 channels connected to the ground.

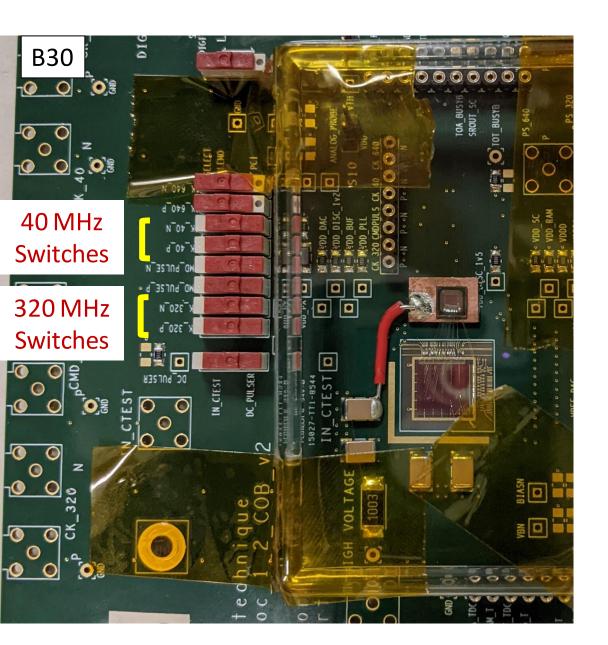
(ALTIROC1_V2 + AC-LGAD) observed output signals on scope : impact of 40MHz/320MHz clocks

AC-LGAD sensor unpolarized (No HV applied)

With 40MHz and 320 MHz clocks

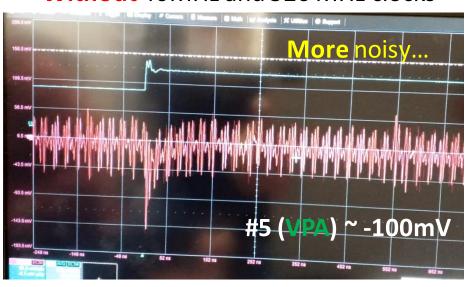
Without 40MHz and 320 MHz clocks

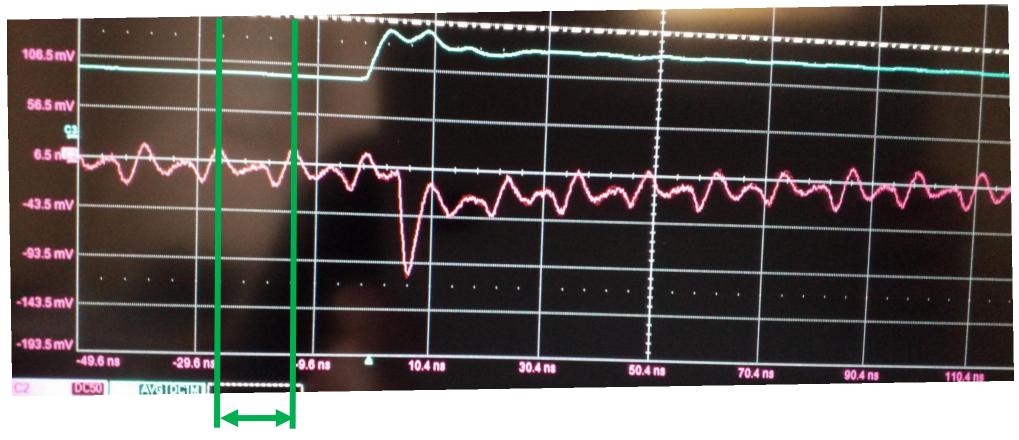
Channel #0 (ALTIROC1)

Amplitude of PreAmplifier output signal \cong - 100 mV

\sim 16 ns (\cong 62.5 MHz)

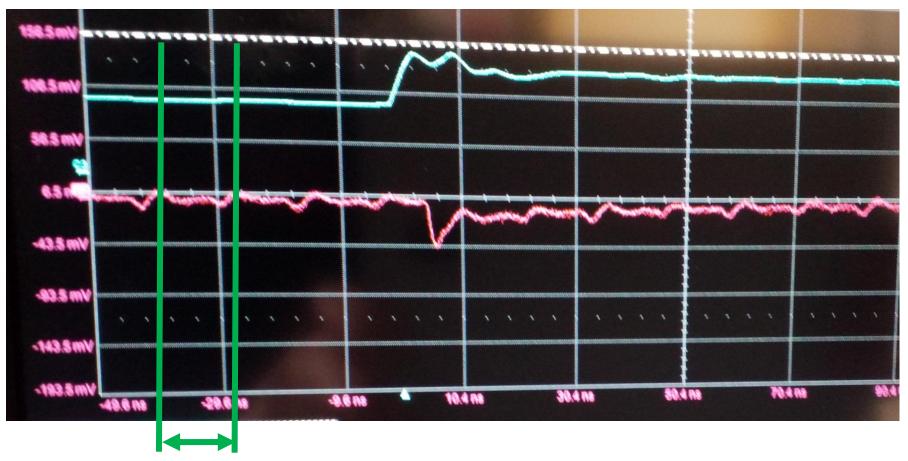
Channel #1 (ALTIROC1)

Amplitude of PreAmplifier output signal ≅ - 50 mV

~ 16 ns (≅ 62.5 MHz)
