HDI Thruhole Discussion with Yamashita co.

RIKEN/RBRC
Itaru Nakagawa

Hideto Enyo, Yasyuki Akiba, IN visited Yamashita co. on May 13th

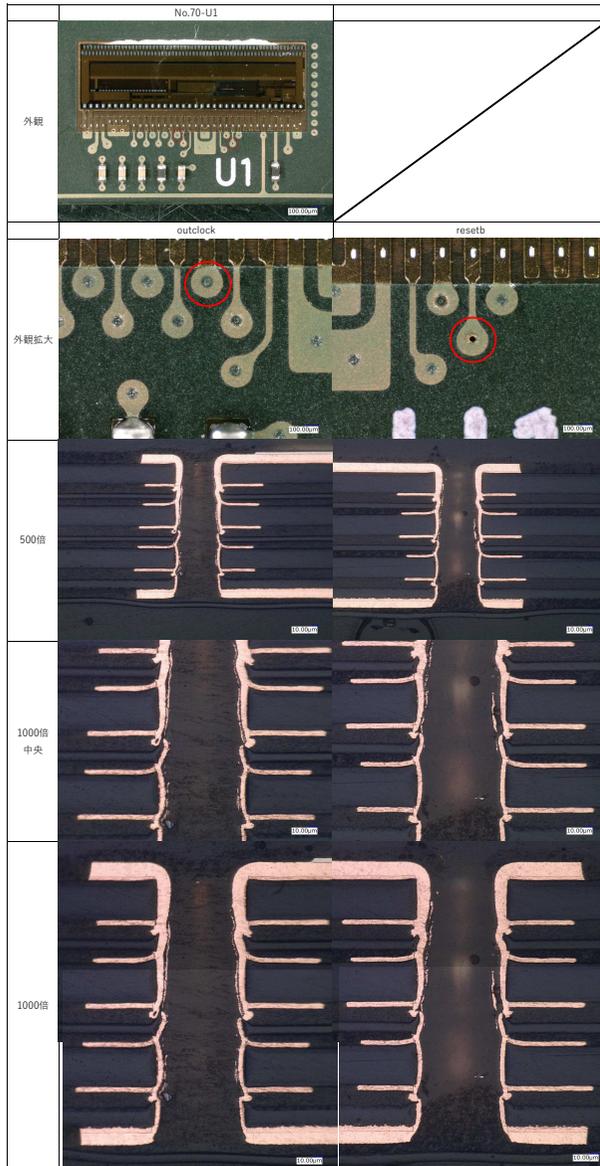
Module-70 Thruhole

- The first HDI inspected thruhole XS
- Cracks in the middle
- Disabled this and next LOT.

- Low quality drilling process.
- Residual etching liquid in multiple soft etching process made the copper plating thinner.
- Left over bubble in the thruhole prevented the copper plating on the upper part of the thruhole.
- Often the case the trouble is caused by the tight aspect ratio (100 μm diameter vs. 450 μm depth.)

- Low quality drilling process.
 - Review drilling parameters and optimize again.
- Residual etching liquid in multiple soft etching process made the copper plating thinner.
 - Consider coating surface for easier exhale of etching liquid from a thruhole.
- Left over bubble in the thruhole prevented the copper plating on the upper part of the thruhole.
 - Likely some bubble is generated by swirl of etching liquid in the plating tank. Try to use alternative production line which is considered to be relatively rather swirl free.
- Often the case the trouble is caused by the tight aspect ratio (100 μ m diameter vs. 450 μ m depth.)
 - There is no way to improve this rather than changing the design. This is not the intrinsic solution though, try to apply 30~60% thicker copper plating in increase the survival rate.
