LArFCS Cryogenic System Progress

9/14/21

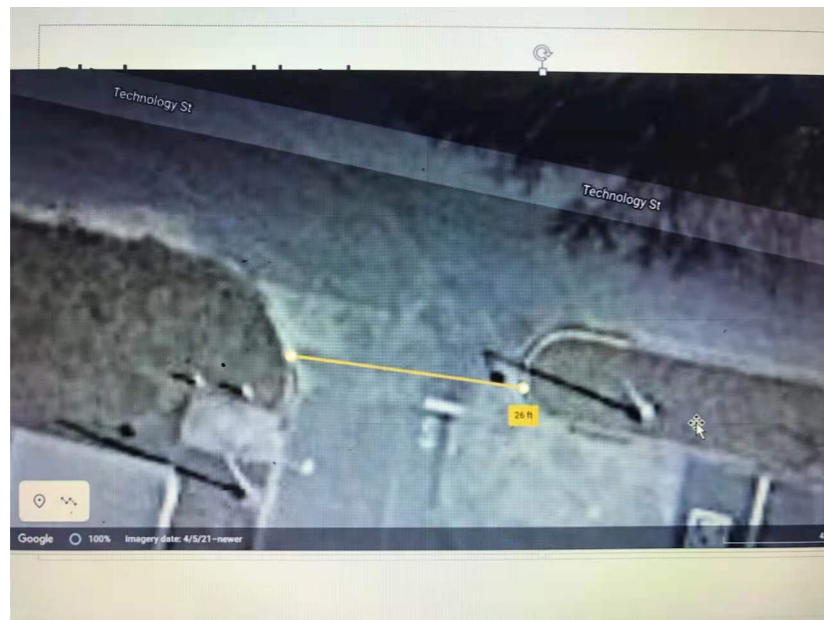
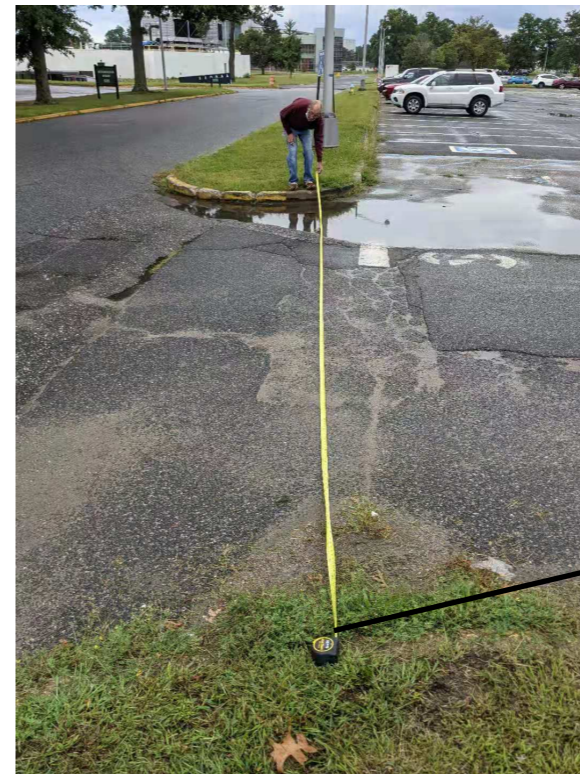
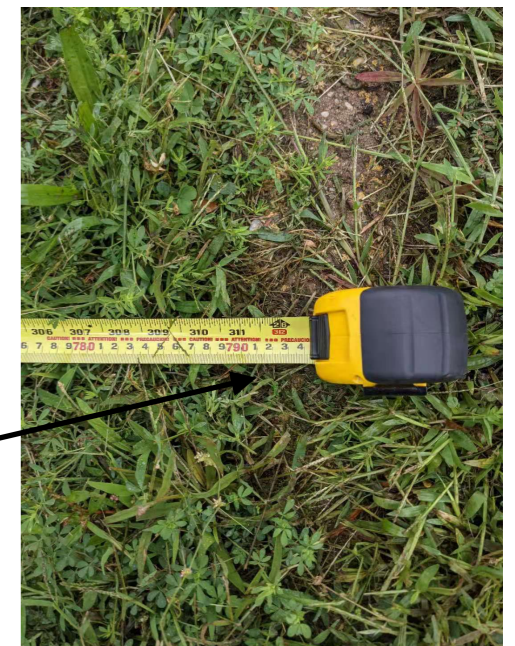
- Current hold up is their logistics department is determine a viable route to access to the tank
- Entrance intersection width may limit the access of the full size 18-wheeler truck
- I was required to conduct a field measurement to confirm the actual width of 26 ft.
- Once their logistics department cleared on the delivery route, the final site survey report will be approved by Airgas and provided to us

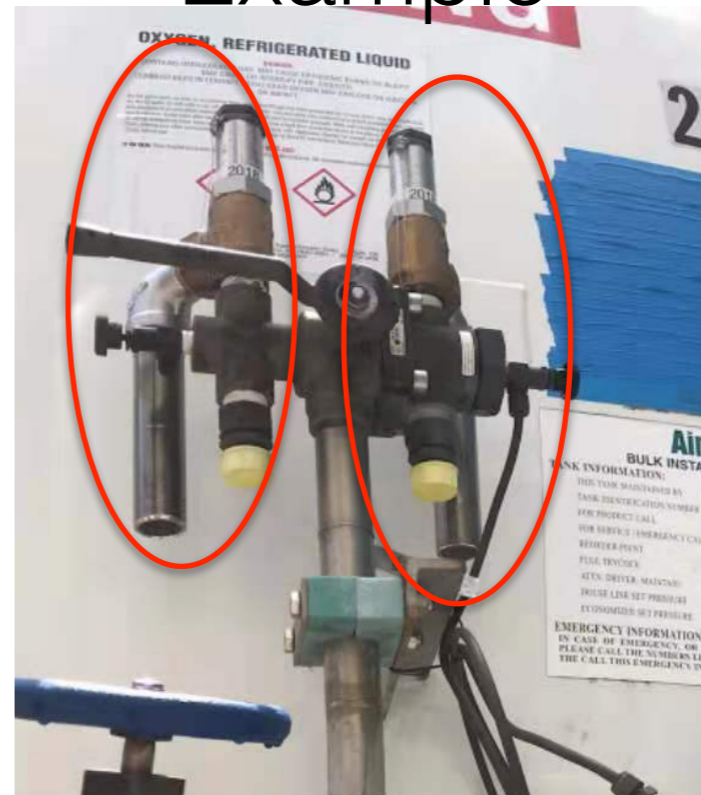
Example

- Recommendation: implement identical safety tree (burst disk+relief valve) on a three-way valve
- Worn label on the relief valve and burst disks

- They can do the installation for us
- Recommend to get the parts from Airgas with suggested specs
- CAD has facility to re-certificate the relief valve

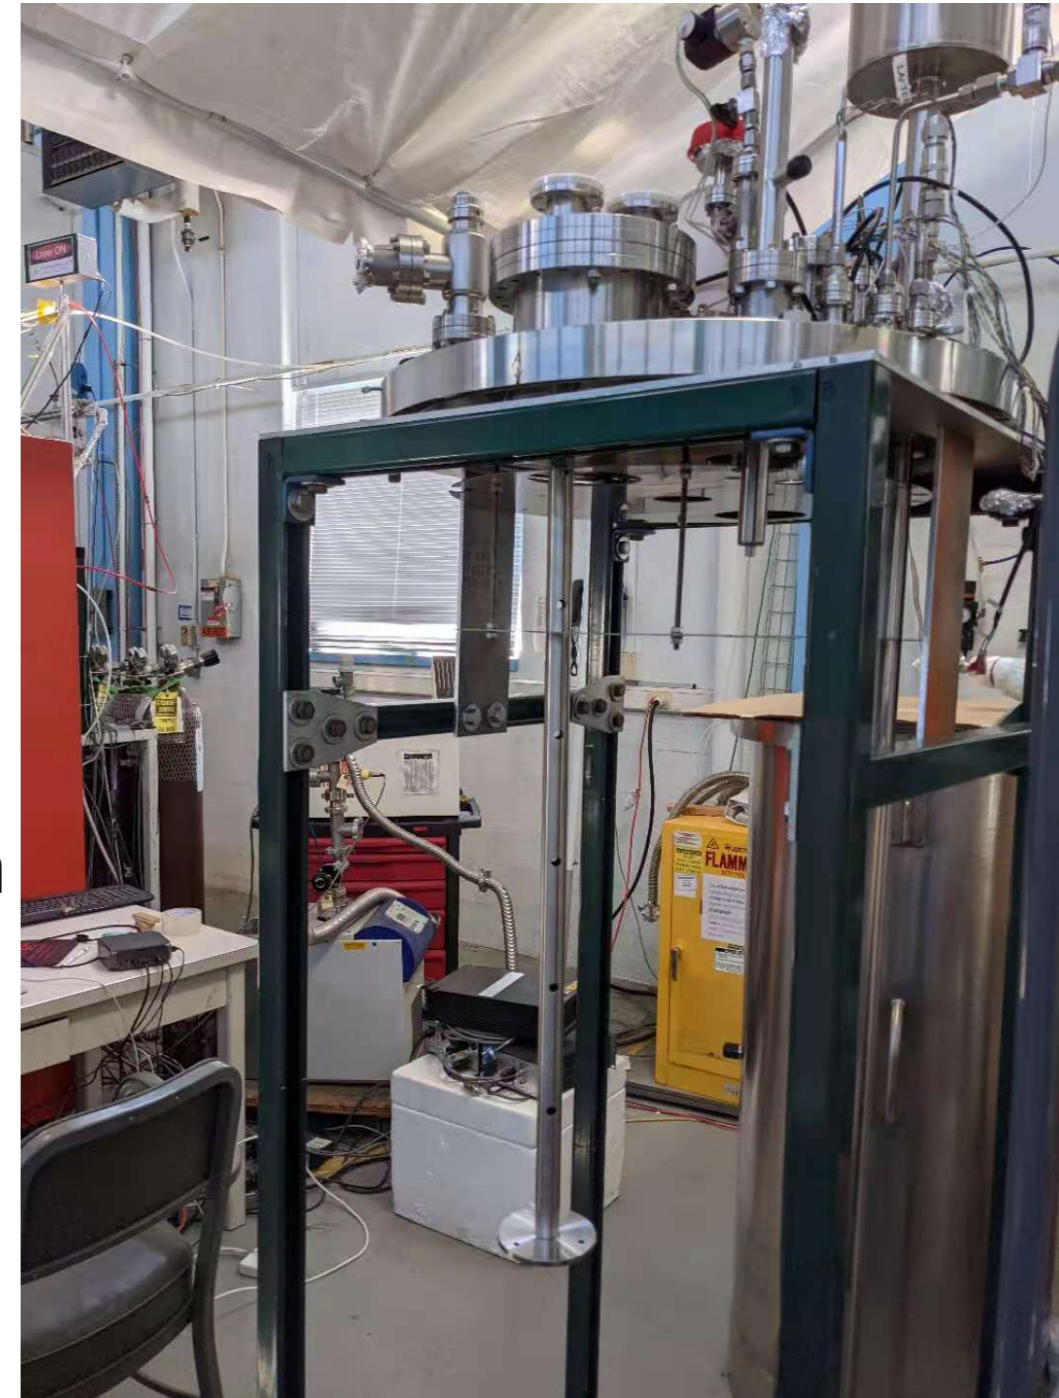
- The Top Flange and mount done by KHV
 - Complete with some after production modification with problems found on site visit
 - Picked up at the factory after completion
 - Mocking up installation on the the main flange
 - The actual measured dimensions agrees with the design
