Taiwan Ladders

Calibration tests and inspection with a microscope.

G. Nukazuka (RBRC)

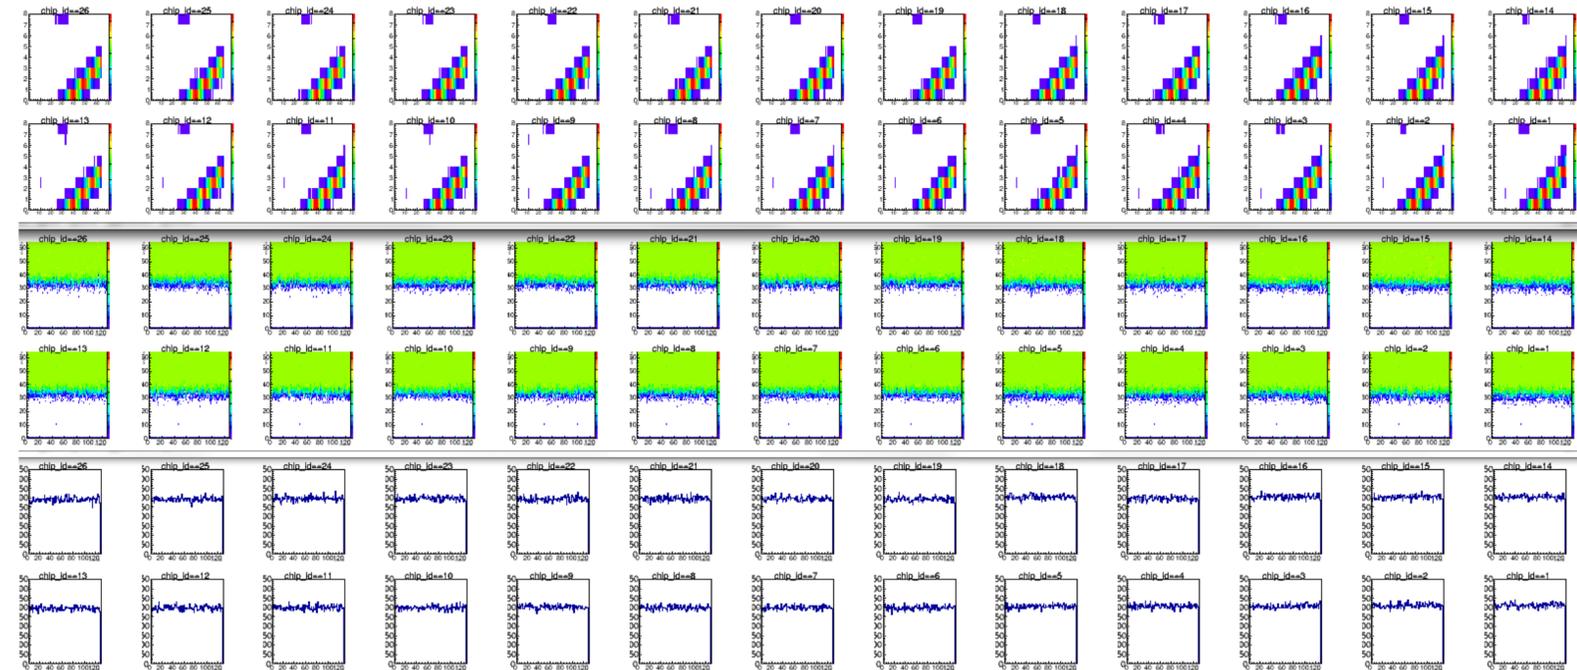
North (HDI #024), Bias: 120V, A = 177 nA, B = 134 nA

Good👍

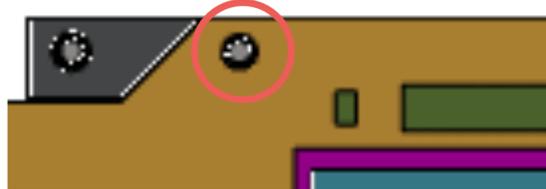
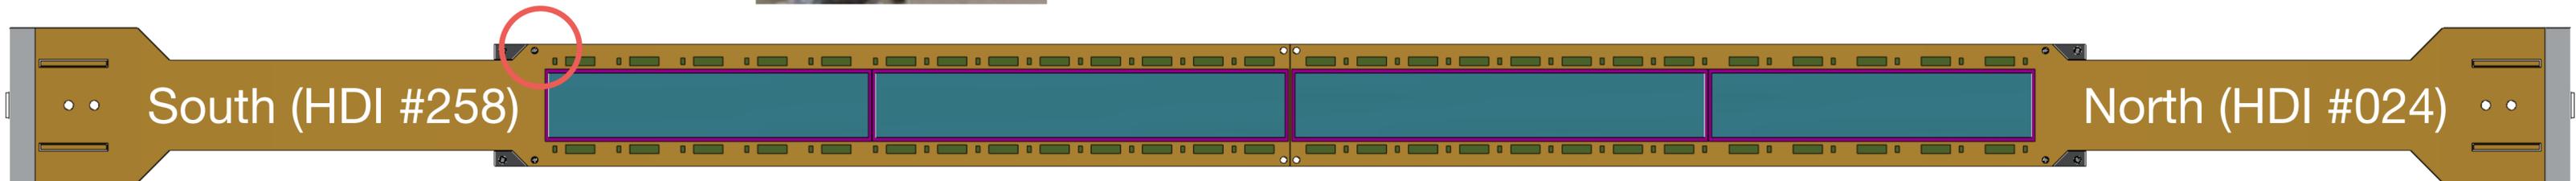
The hole is blocked by ???
A pin cannot go through the hole.
It means the screw for the barrel assembly may also not go through the hole.

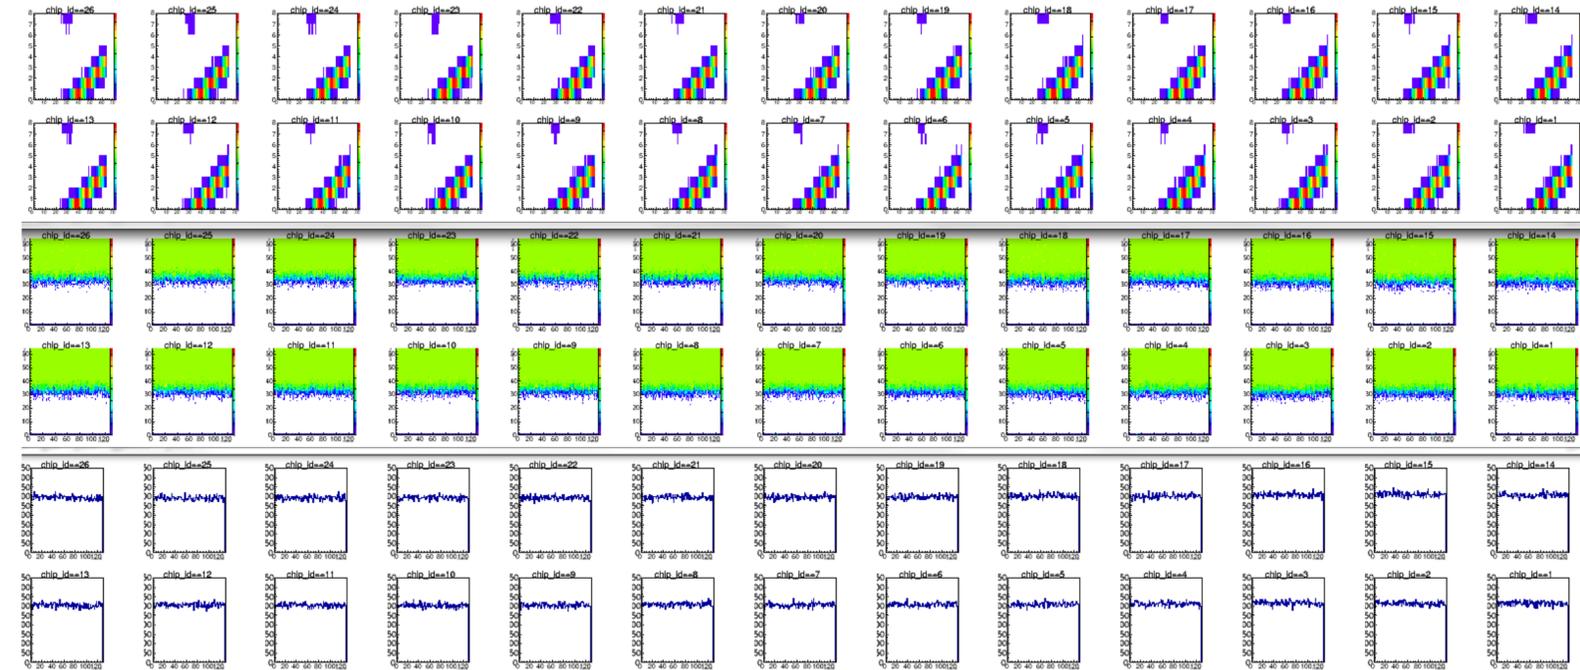
South (HDI #349), Bias: 120V, A = 171 nA, B = 121 nA

Good 🍌

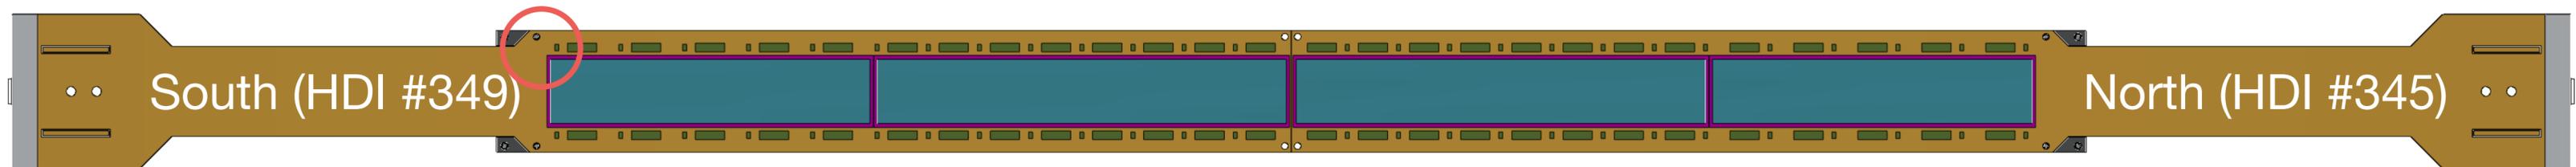
All wires (chip—HDI, chip—sensor) look good.
The hole next to U1 on the south side was blocked by ???
A pin cannot go through the hole.

No additional un-bonded ch found.

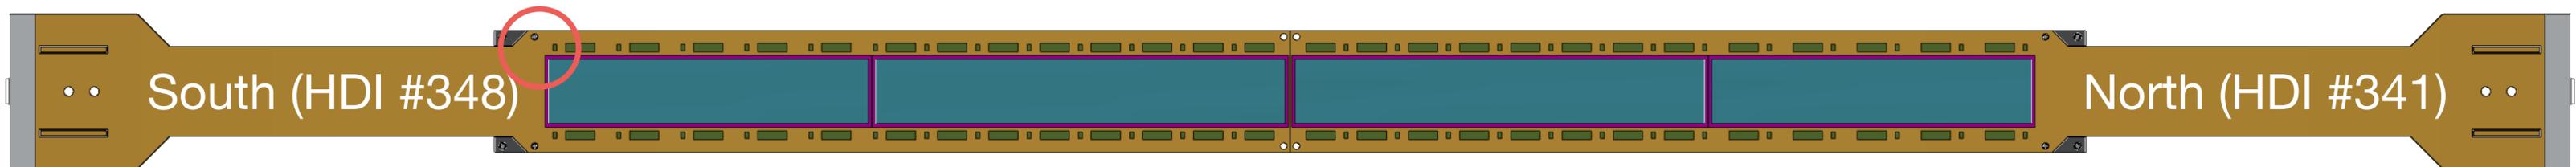
All wires (chip—HDI, chip—sensor) look good.
The hole next to U1 on the south side was blocked by ???
A pin cannot go through the hole. The screw may also not go.

No additional un-bonded ch found.

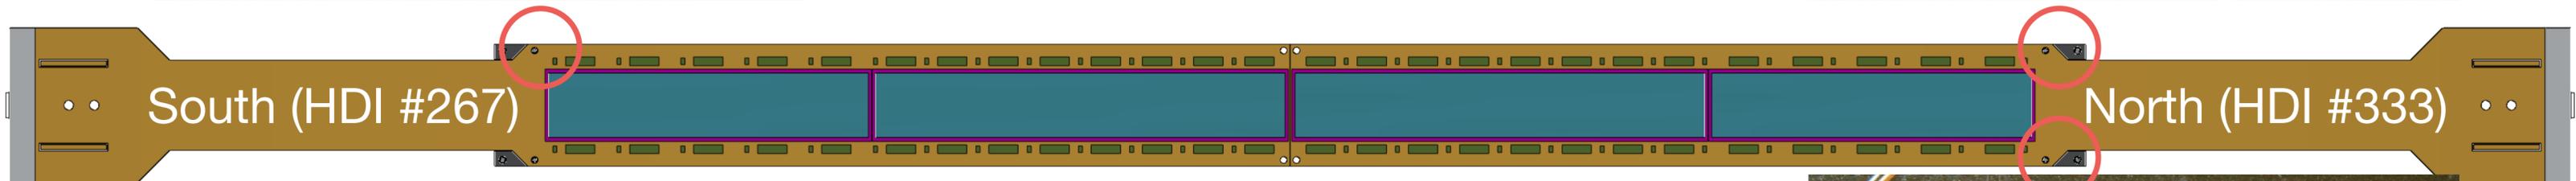
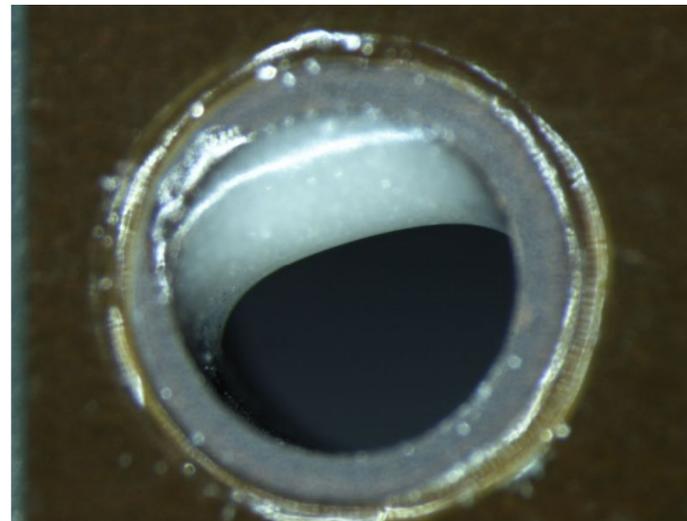
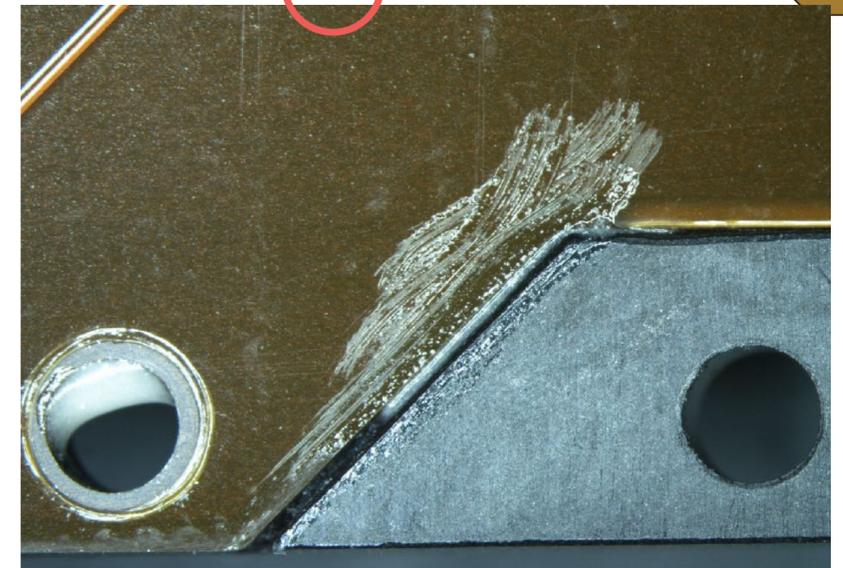
Those 3 holes have something inside.
A pin cannot go through them. It means the screw
for barrel assembly may also not go through them...
