NE5 Fiber Latch Problem

Itaru Nakagawa

RIKEN/RBRC

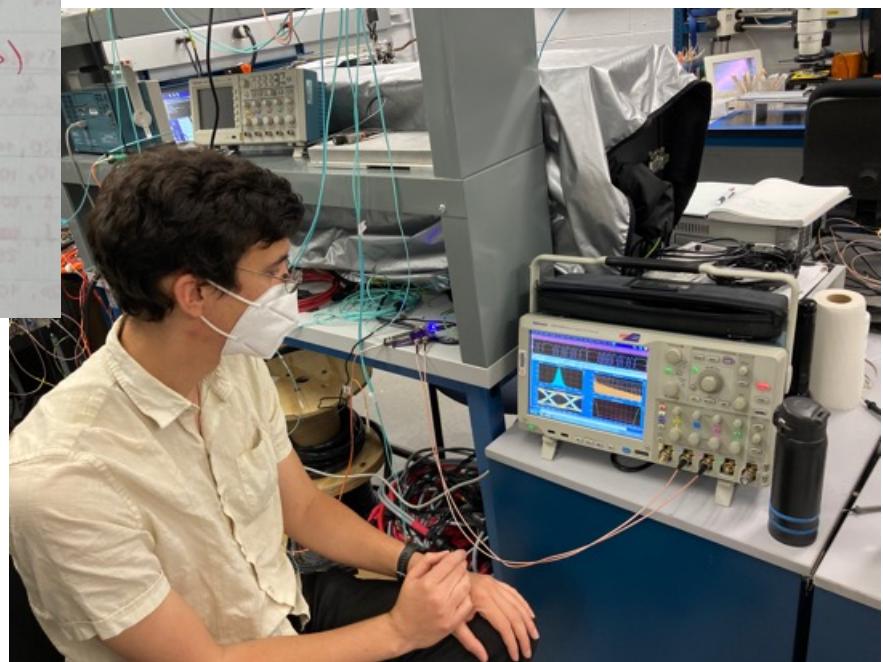
Fiber Sync Error Debugging with John K.

Bad port

$\times FFFF \times CSBC \times CSBC \times E3E3 \times SESE \times 7676$ } Reference (1)
 $\times FFFF \times CSBC \times CSBC \times E3E3 \times SESE \times 7676$

good port

$\times FFFF \times CSBC \times CSBC \times E3E3 \times SESE \times 7676$ } 3x(0000)

After GTH Reset followed by latch

$\times DEFF \times 40BC \times CSBC \times C3E3 \times SESE \times 5676$ } 3x(0000)
 $\times FFFF \times CSBC \times CSBC \times E3E3 \times SESE \times 7676$ } 3x(0000)

- We did observed collapsed comma words which is the smoking gun of the fiber sync error.
- However, the cause has not been identified. Signal shapes, reference clock jitters etc all look normal. This problem remain no solution yet.

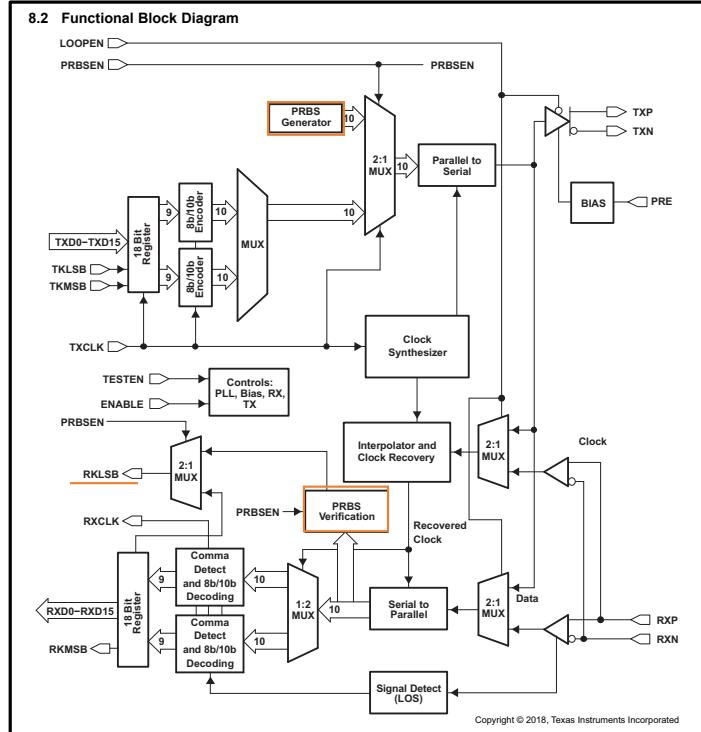
Pseudo-Random Bit Stream (PRBS)

8.3.5 Pseudo-Random Bit Stream (PRBS) Generator

The TLK2711-SP has a built-in $2^7 - 1$ PRBS function. When the PRBSEN pin is forced high, the PRBS test is enabled. A PRBS is generated and fed into the 10-bit parallel-to-serial converter input register. Data from the normal input source is ignored during the PRBS mode. The PRBS pattern is then fed through the transmit circuitry as if it were normal data and sent out to the transmitter. The output can be sent to a bit error rate tester (BERT), the receiver of another TLK2711-SP, or looped back to the receive input. Because the PRBS is not really random, but a predetermined sequence of 1s and 0s, the data can be captured and checked for errors by a BERT.

8.3.14 PRBS Verification

The TLK2711-SP also has a built-in BERT function in the receiver side that is enabled by the PRBSEN. It can check for errors and report the errors by forcing the RKLSB pin low.

- Honestly, we ran out of idea how to debug this problem further.
- We decided to replace TLK2711 without observing any direct evidence of the cause.
- TLK2711 is discontinued product and not available in the US market. We salvage “the old ROC”, a prototype version and take TLK2711 from it. There are 33 (8/column+SC) TLK2711 are implemented per ROC.
- Replacing TLK2711 is a certain risk since it is the ball soldering and non-negligible possibility of damaging soldering pads of both TLK2711 and ROC.
- The attempt is done in the instrumentation division.
