# Slow Control TLK Replacement

RIKEN/RBRC

Itaru Nakagawa

# TLK Replacement at BNL

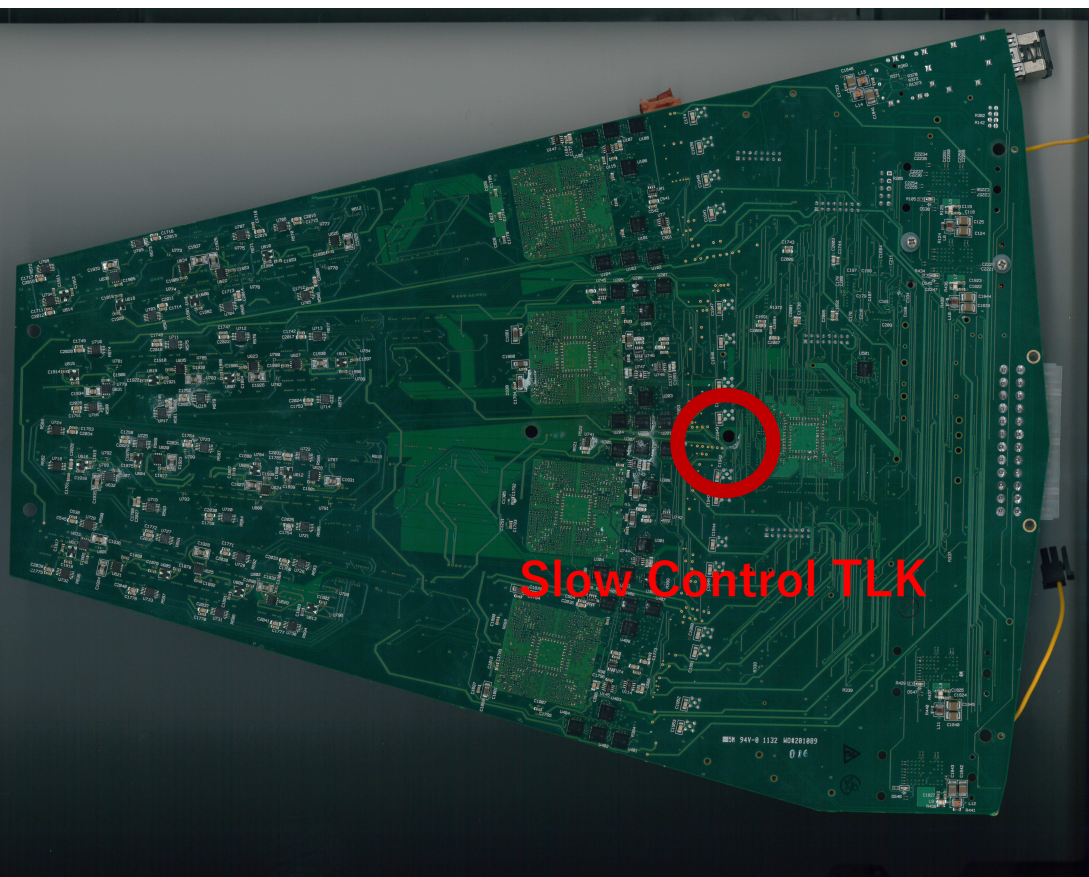
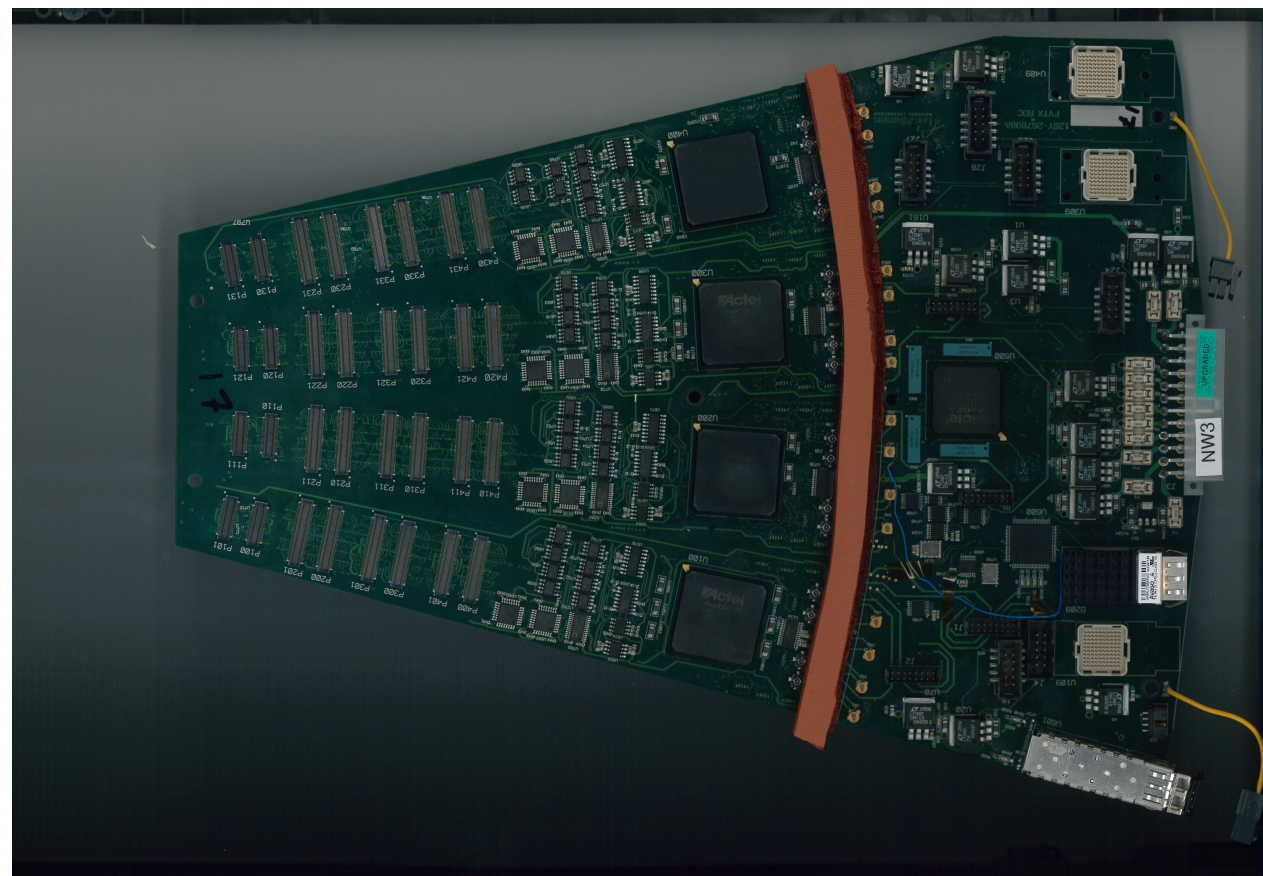
# ROC NW3 Slow Control Replacement

Jan. 13, 2023 Replaced B1 port TLK.  
B1 port didn't fixed after TLK replacement.  
Soon later, we lost the slow control.

Disconnected  
Jumper cable.  
-> Most likely this is  
the cause of the slow  
control problem.

Jan 26, 2023 Replaced Slow Control TLK

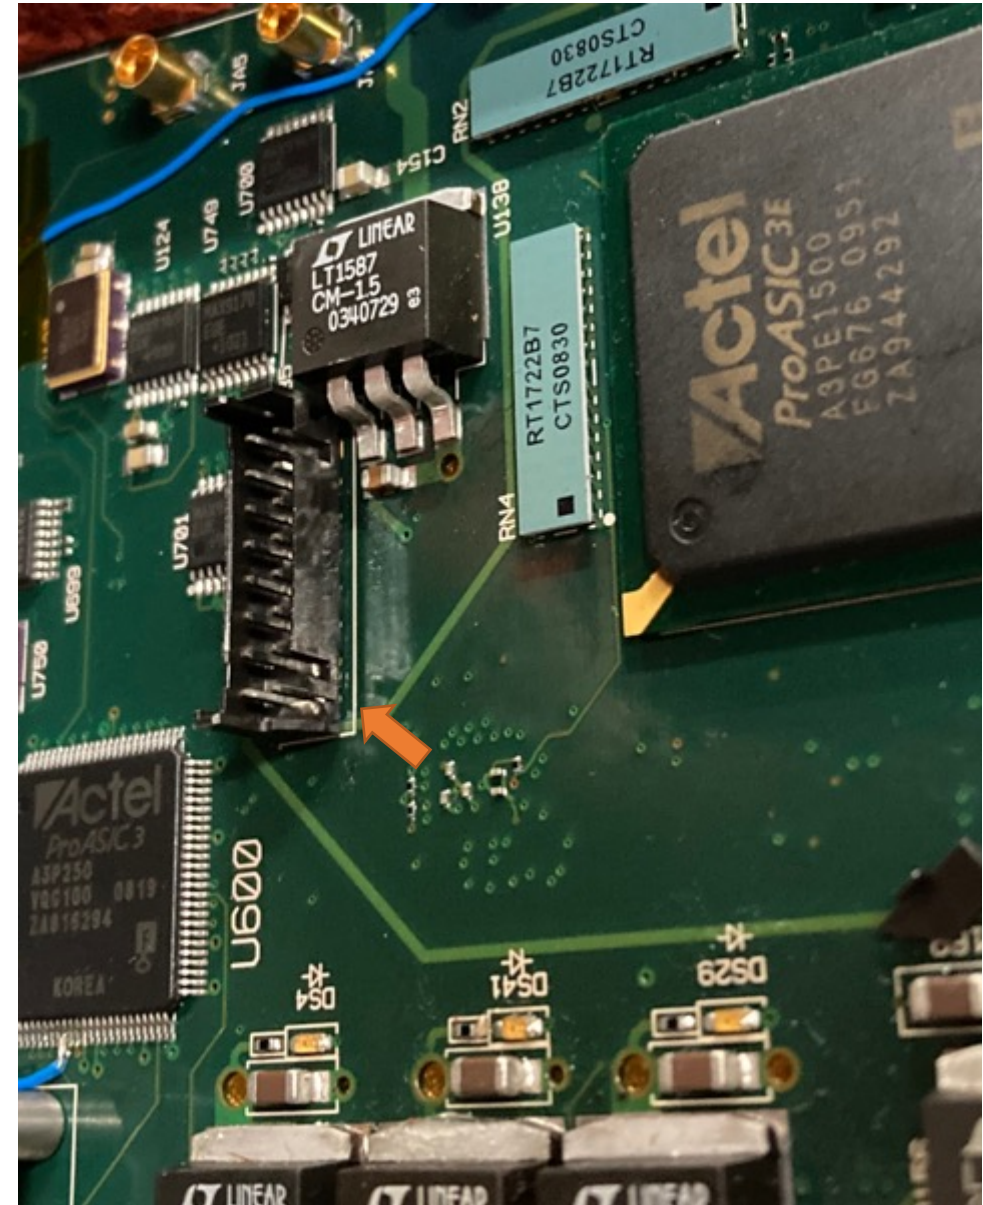
# Damaged J1A port

I happened to damaged J1A connector. It still holds the cable, but may be better to be replaced before use.
