Status of machining of tiles at UCR

Miguel Arratia,
University of California, Riverside

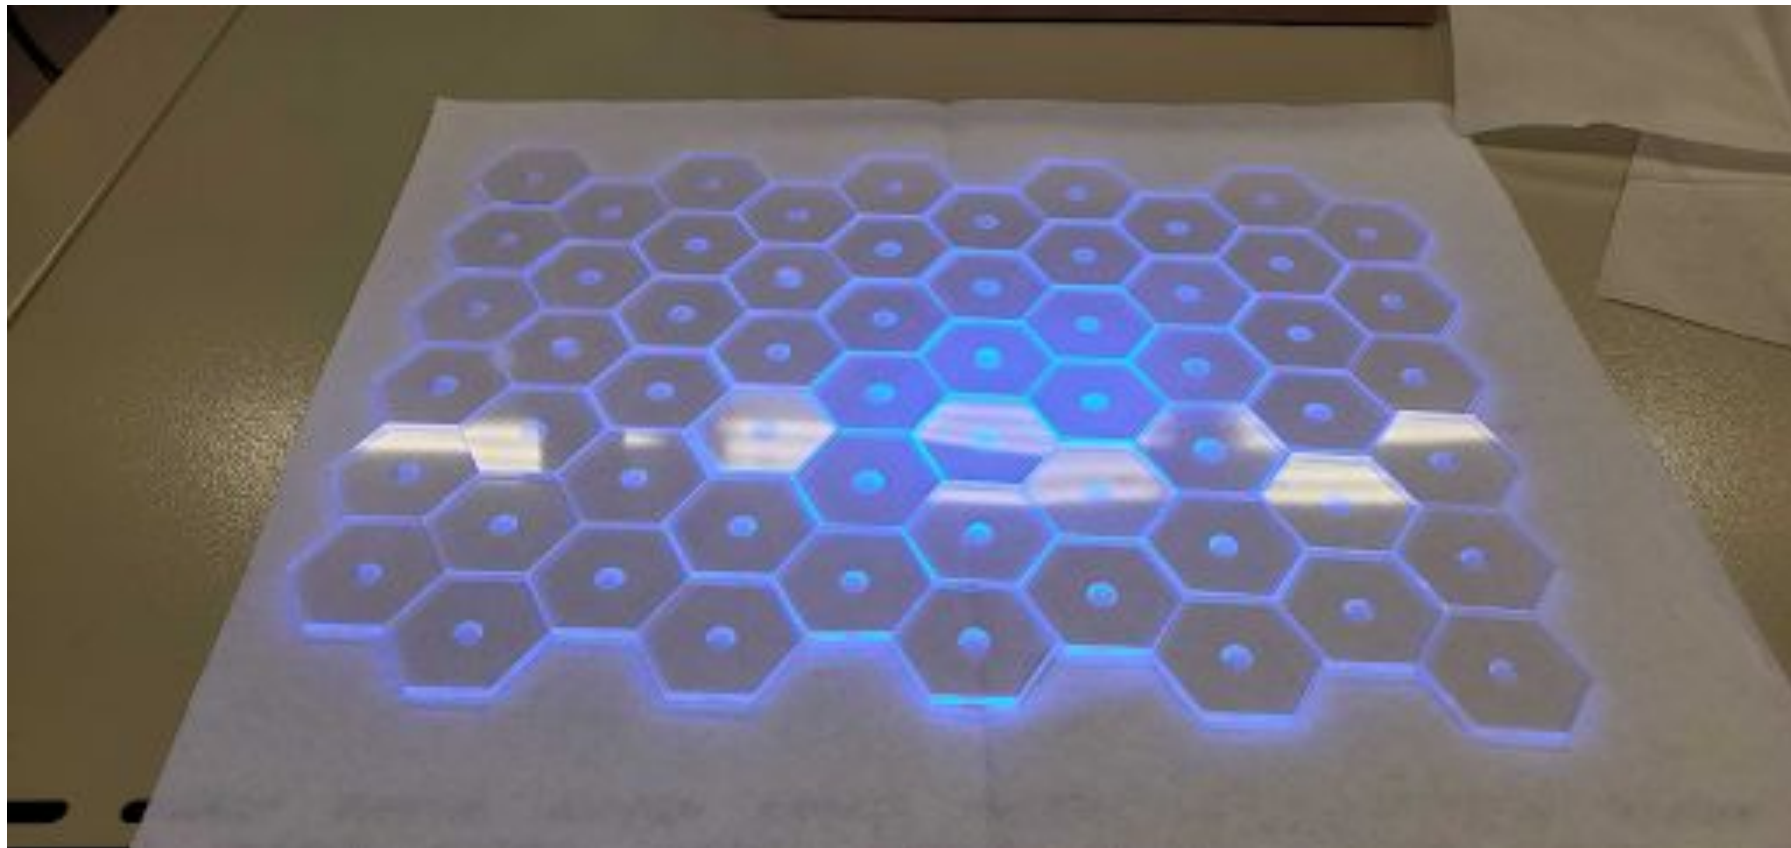
Machined tiles looked beautiful at first

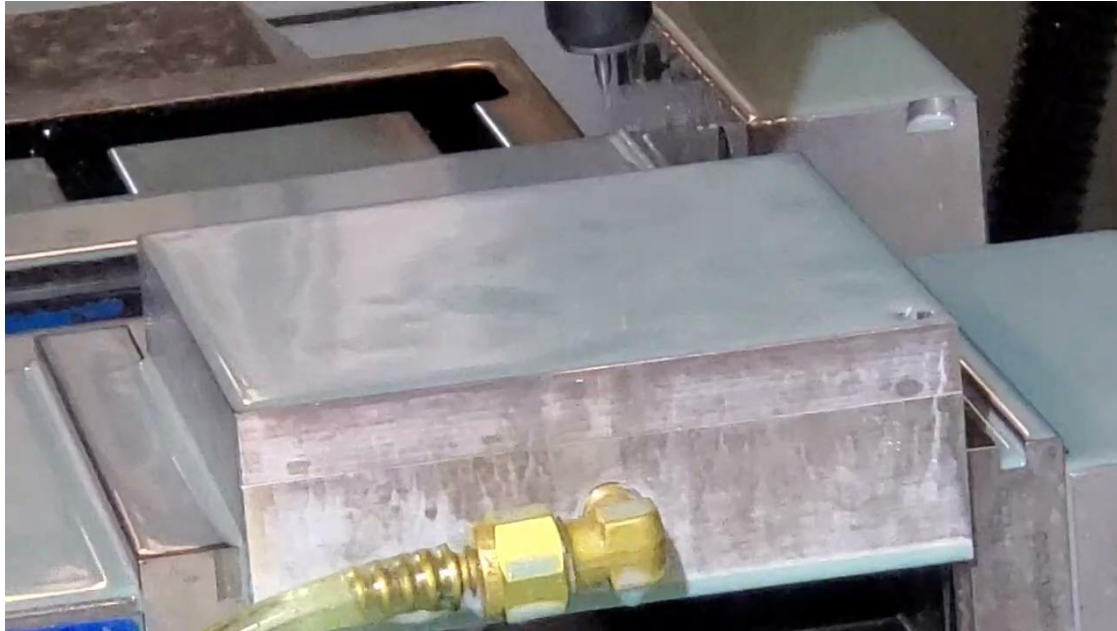
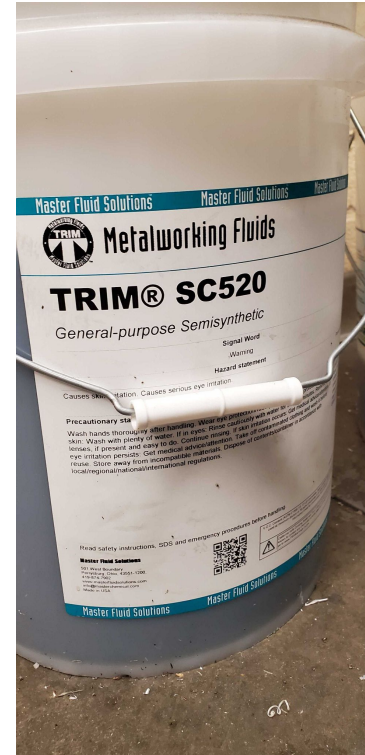
Likely culprit: Traced that our machine shop was using standard coolants , and “scraping” piece afterwards by hand.

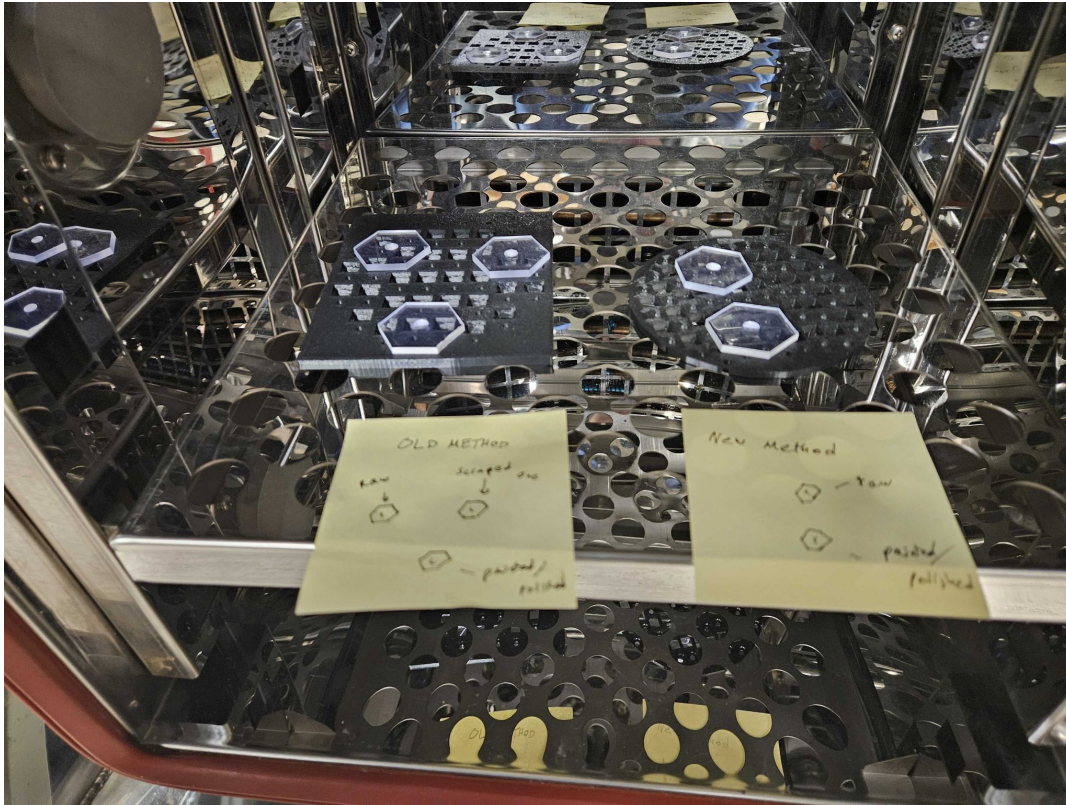
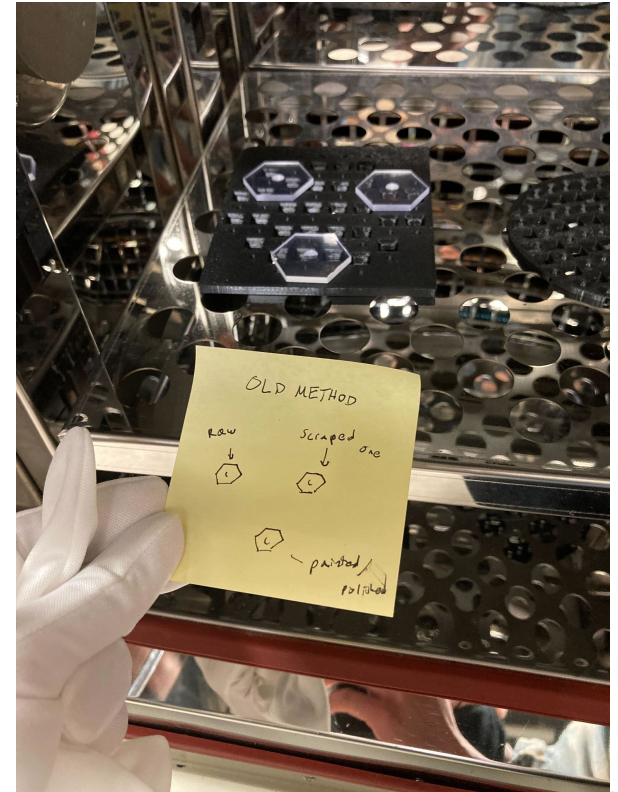
We suspect that annealing of the scintillator might help with the crazing

We used our climate chamber to test approaches
