Status of 1004B Valve Box / Ring Repair

3 Oct 2023

1004B "Valve Box" Failure Timeline

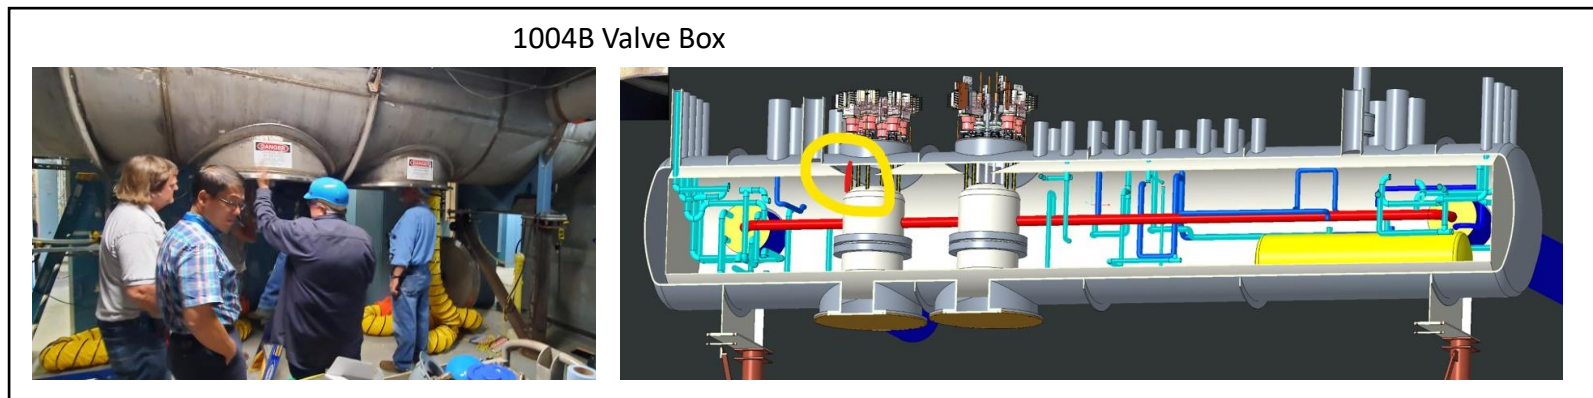
- At 12:31 on 1 Aug 2023 a spurious trip of the Quench Interlock System commanded the RHIC power supplies to turn off and for the energy extraction system to begin dissipating the stored energy in the Blue Ring. At 12:39 the Cryo control room informed the MCR that the Blue Valve Box in 1004 B was venting Helium to the exterior of the building.
- Decision to end RHIC Run-23 made on 4 Aug 2023. RHIC Valve Box/Short status (30 Aug 2023) at RHIC Retreat.
- Following numerous safety reviews (hazards: electrical, confined-space, oxygen deficiency) and work planning, the valve box was opened on 1 Sep 2023; Helium breach found on warm cable interface at top (of the inside) of the valve box

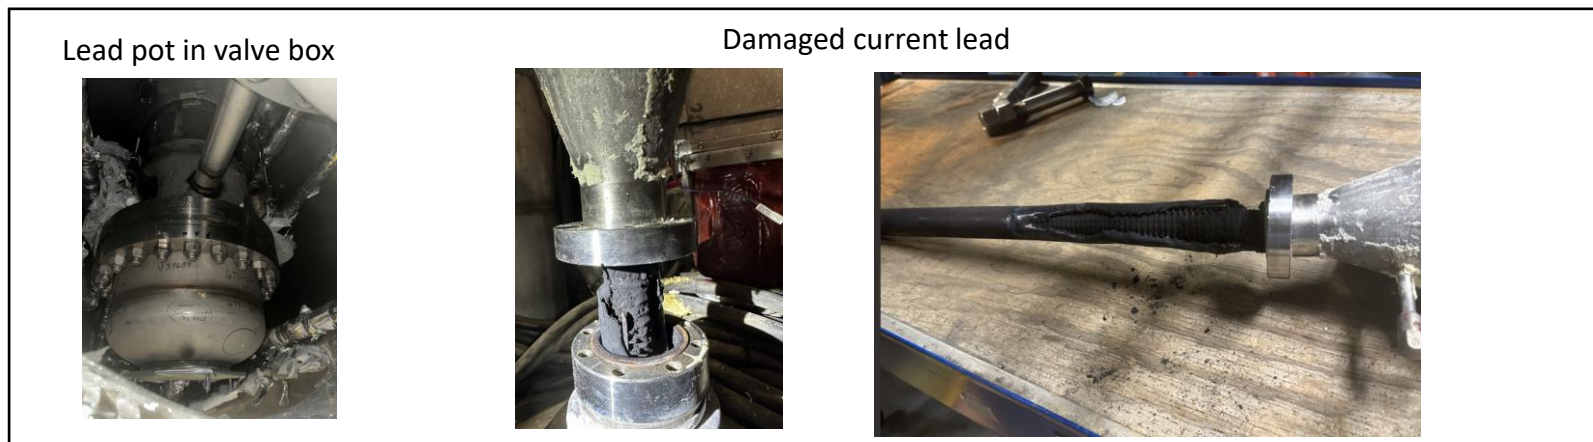
- Valve box lead pots (LP) accessed on 7 Sep 2023 (VB #1) and 8 Sep 2023 (VB#2). Damage to 12-conductor cold-to-warm, gas-cooled current lead found in LP #1, no trouble found in LP #2.

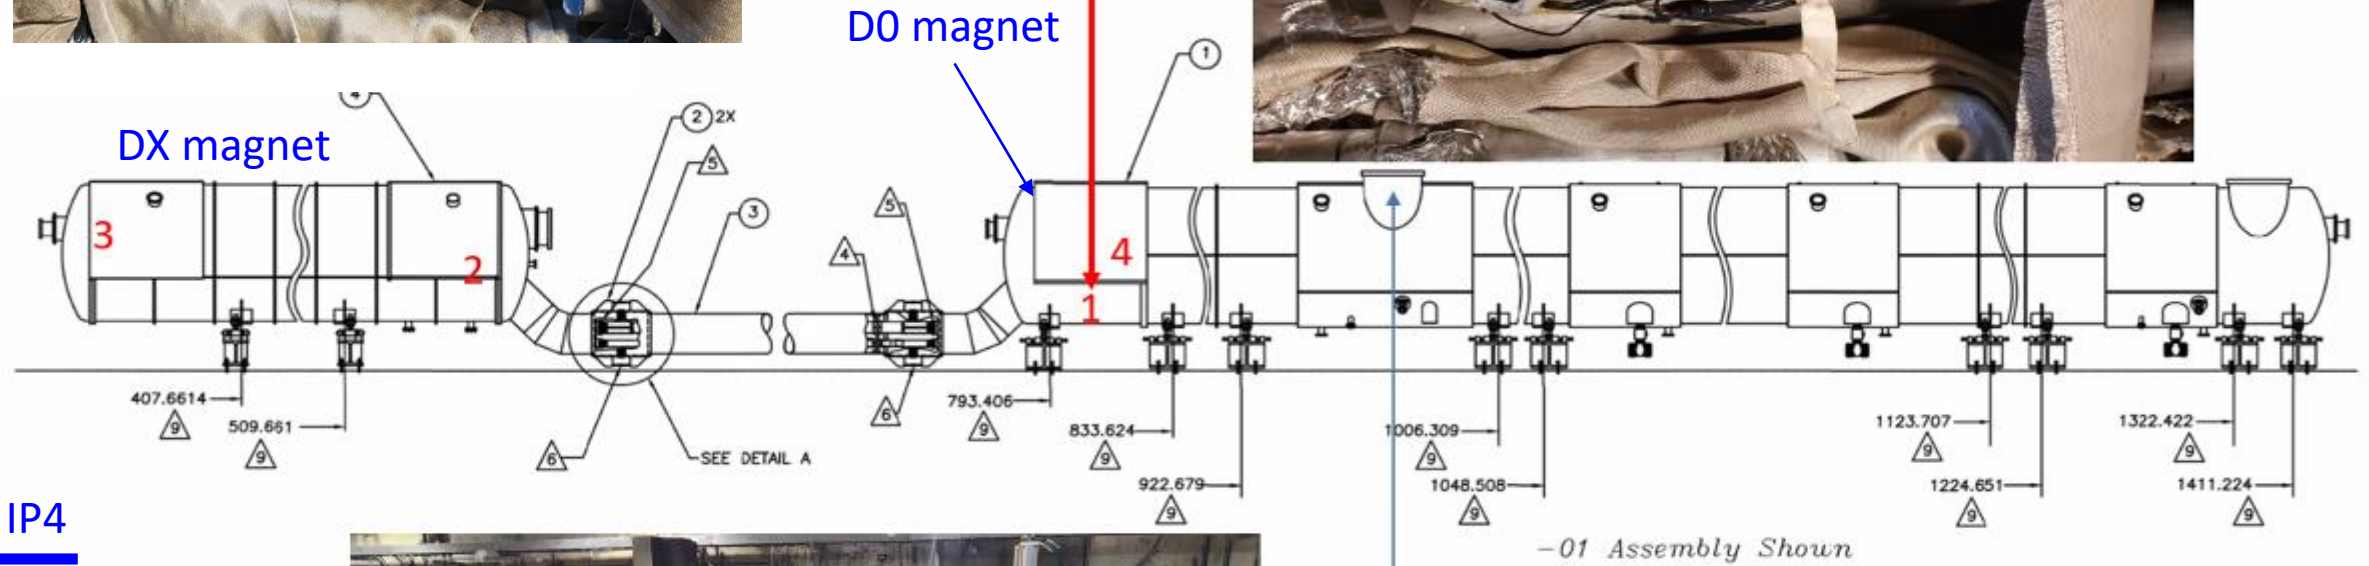
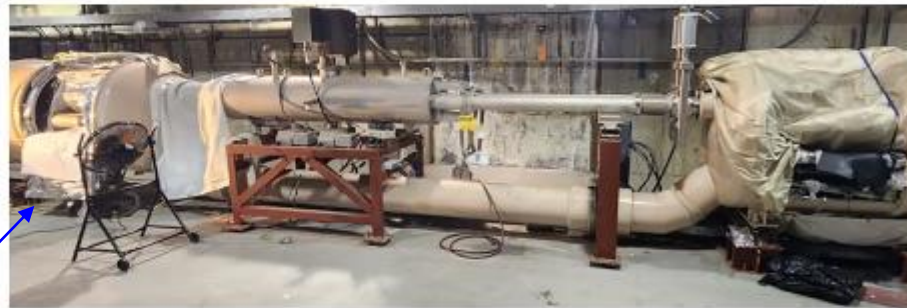
Splice can #1 after opening (no trouble found)

Location of electrical connections to 1004B valve box

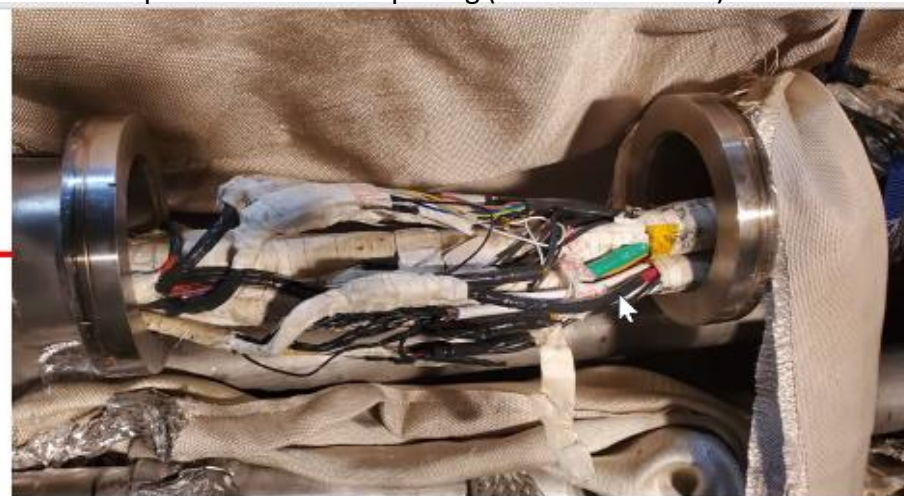
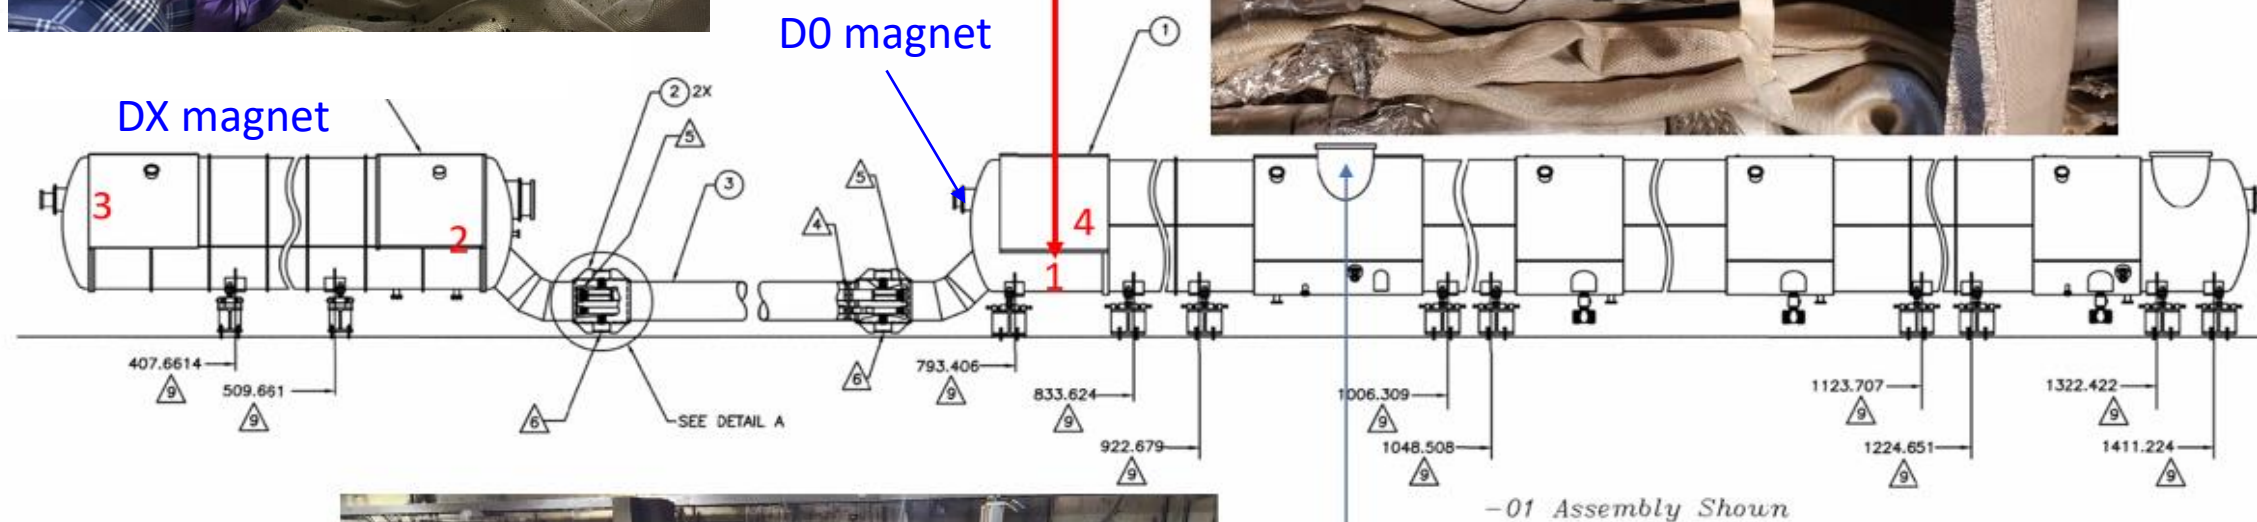
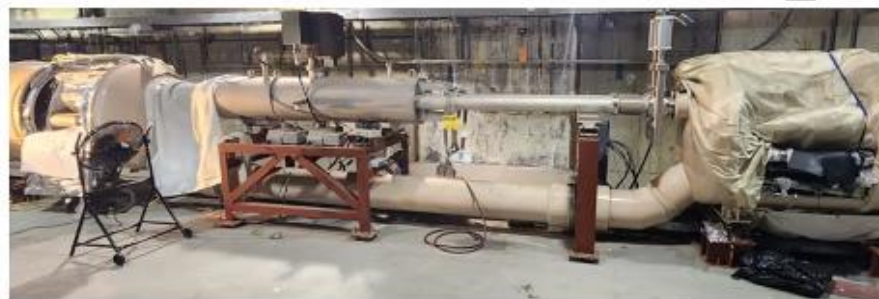
- “splice can #2” at IR4 DX magnet found severely damaged 27 Sep 2023

damage inside splice can

Location of electrical connections to 1004B valve box

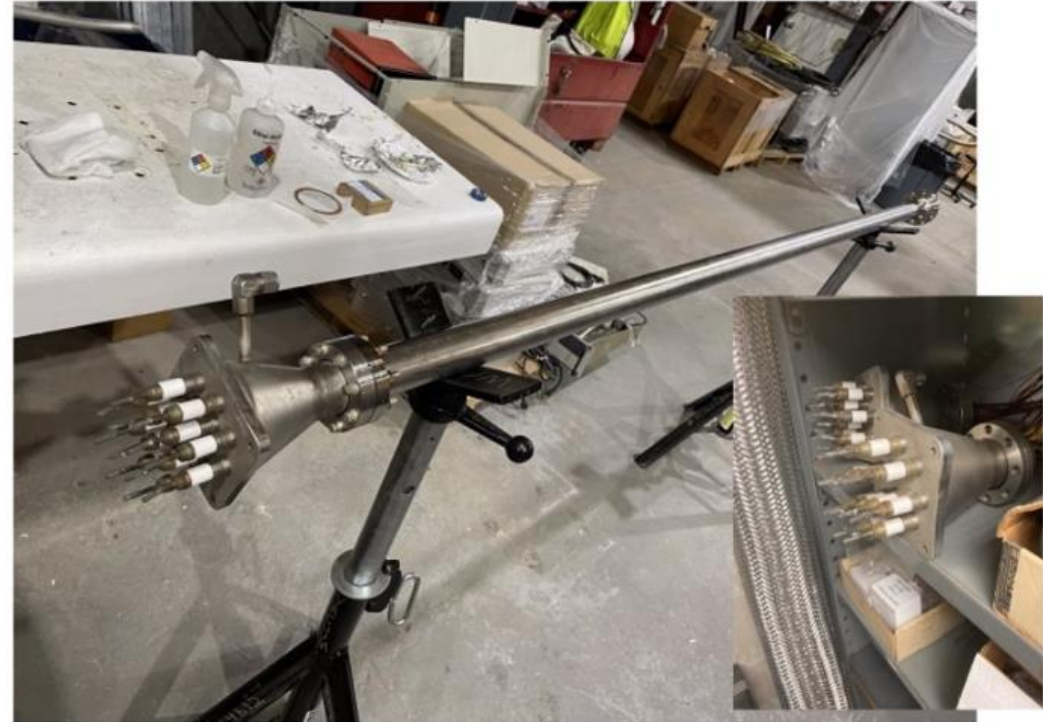
Vacuum test setup (using another, partially-built current lead)

- Spare lead assembly under test
 - passed vacuum leak checks
 - electrical and pressure tests underway

- Plan B (if pressure test fails)
 - build new lead
 - mine existing lead assembly for parts
 - have identified technician support for this as well as for building new spares

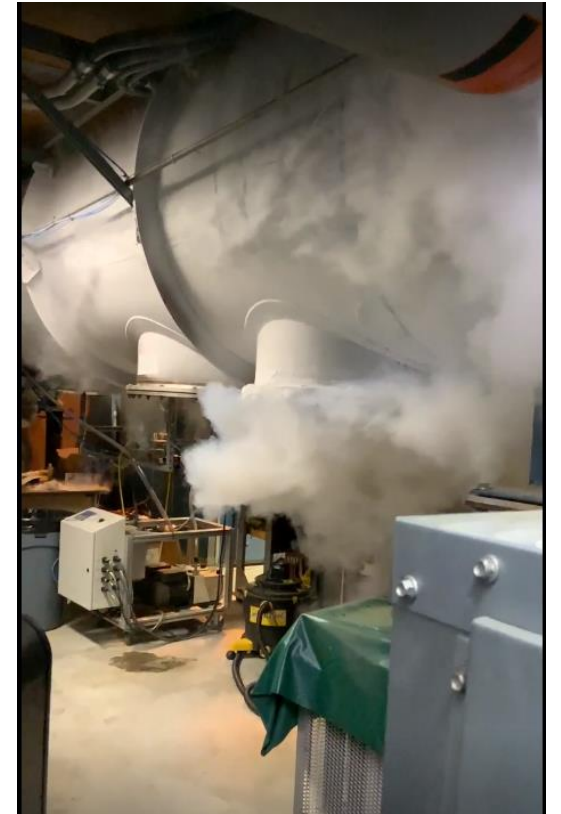
- new issue: Helium release into building - He breach filled 1004B valve box, pressure relief to outside worked as expected but some He released into building unexpectedly (likely that large access port O-rings froze and cracked).
- ODH evaluation underway to determine maximum concentration levels
 - C-AD ES&F engineering evaluating fresh-air makeup rates as input
 - C-AD cryo evaluating leakage rates for components that can fail
- Results will inform if existing ODH monitors (which did not trip, nor did the personal oxygen monitor worn by fire rescue first accessing site) must be made credited controls.
- If that were the case, then the RHIC ASE would need to be modified and approved by BHSO. Scope of that effort, if needed, similar to effort required at sPHENIX last summer.
- Presents potential schedule risk.
- USI development by C-AD ESSHQ (Ray Fliller)
