12 by 150 amp warm to cold feedthrough Failure analysis

John Escallier

11/28/23

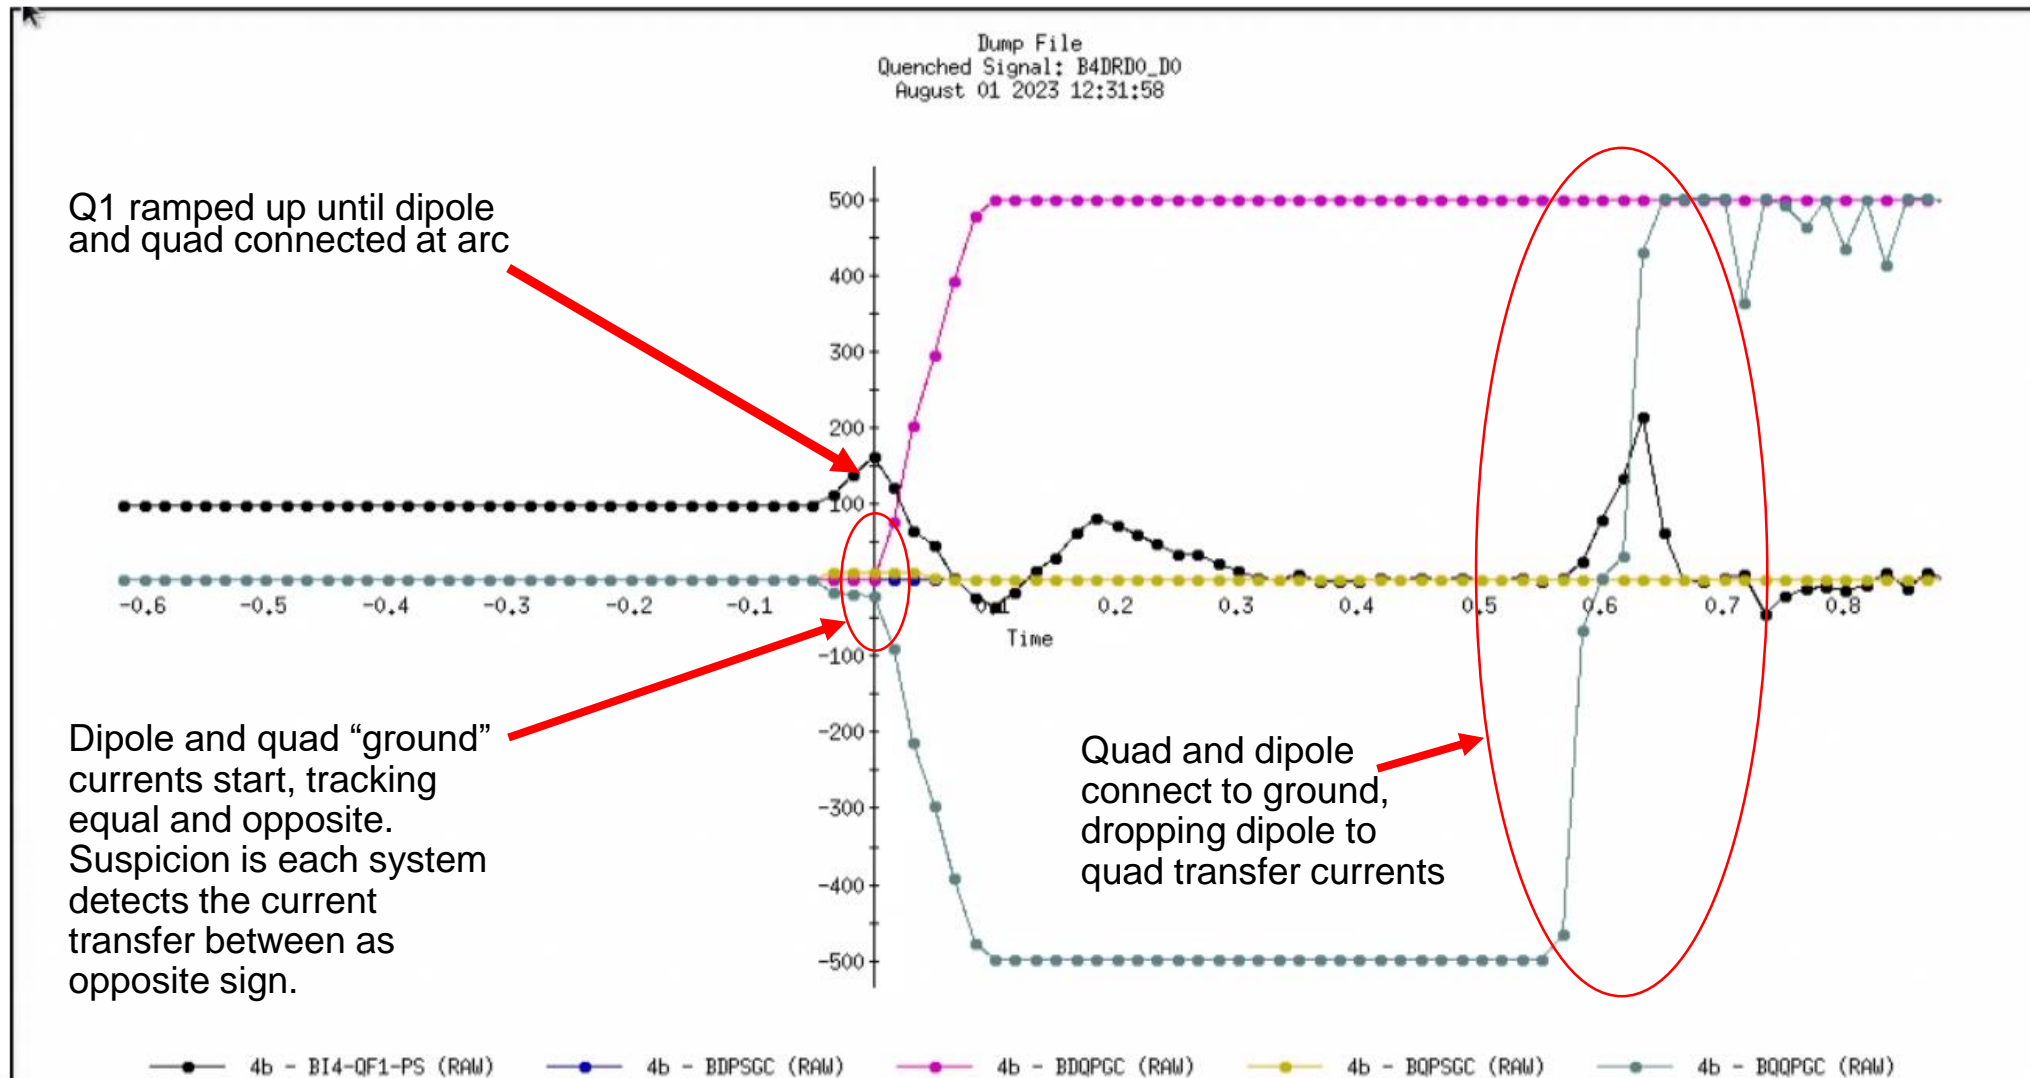
Dipole ground current, quad ground current, and Q1 current sequence

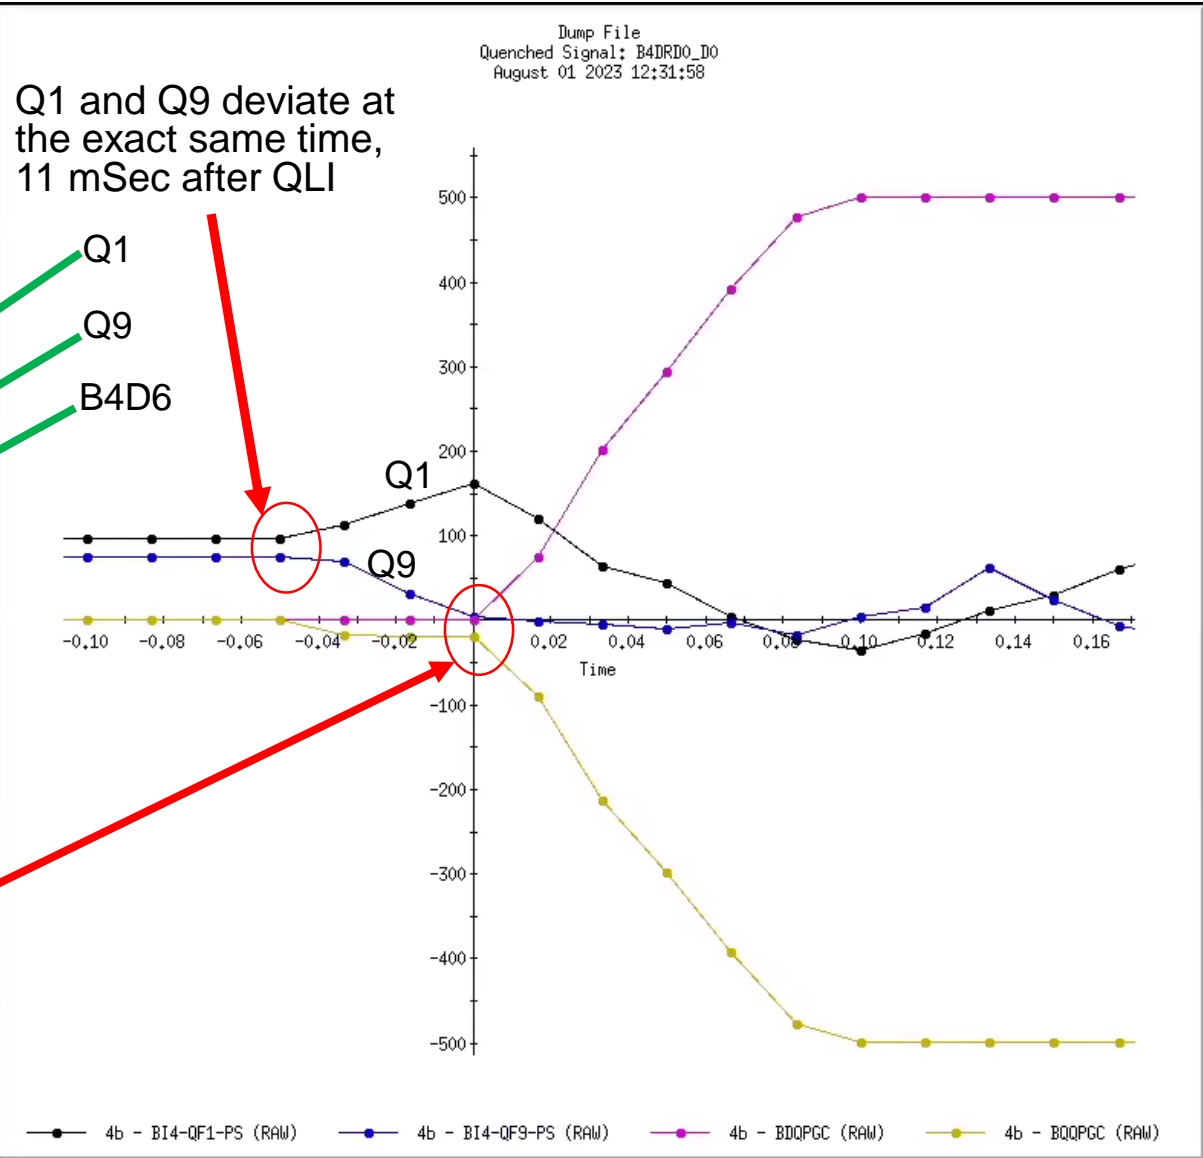
Dipole and quad “ground” currents start, tracking equal and opposite. Suspicion is each system detects the current transfer between as opposite sign.

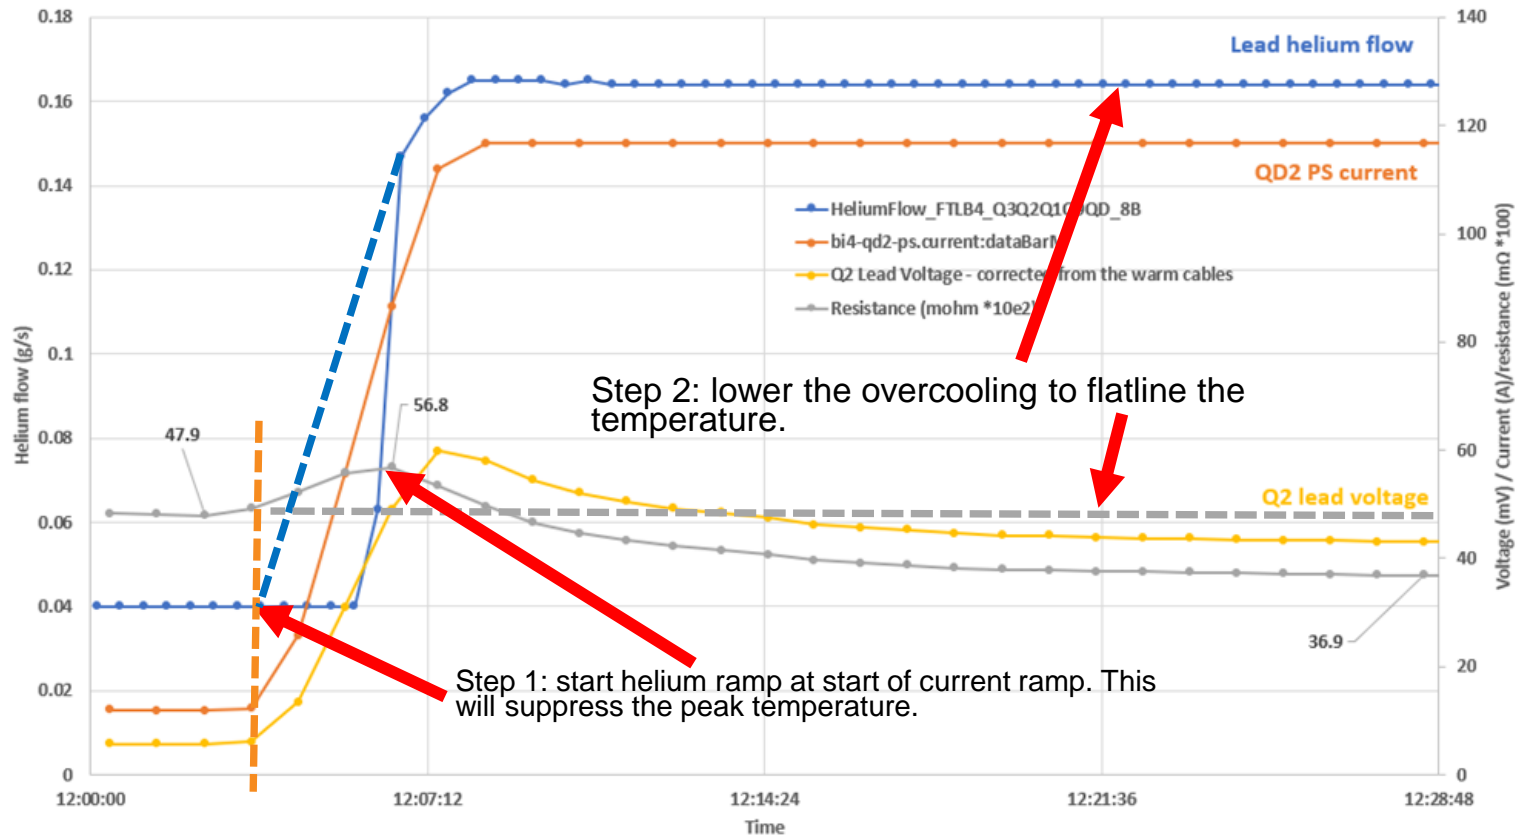
This temperature peak is caused by the delay of helium cooling

Lead Q1Q2Q3QDD6 - 8/1/23 12:02pm current ramp up data measured

- Modification of the control loop of the helium cooling can be used to prevent further temperature cycling degradation, preventing further degradation of the feedthroughs.
