FPC mounting & bonding (spTAB) - update

James Glover

ePIC SVT WP3: Electrical Interfaces Meeting

Thu, 13th March 2025

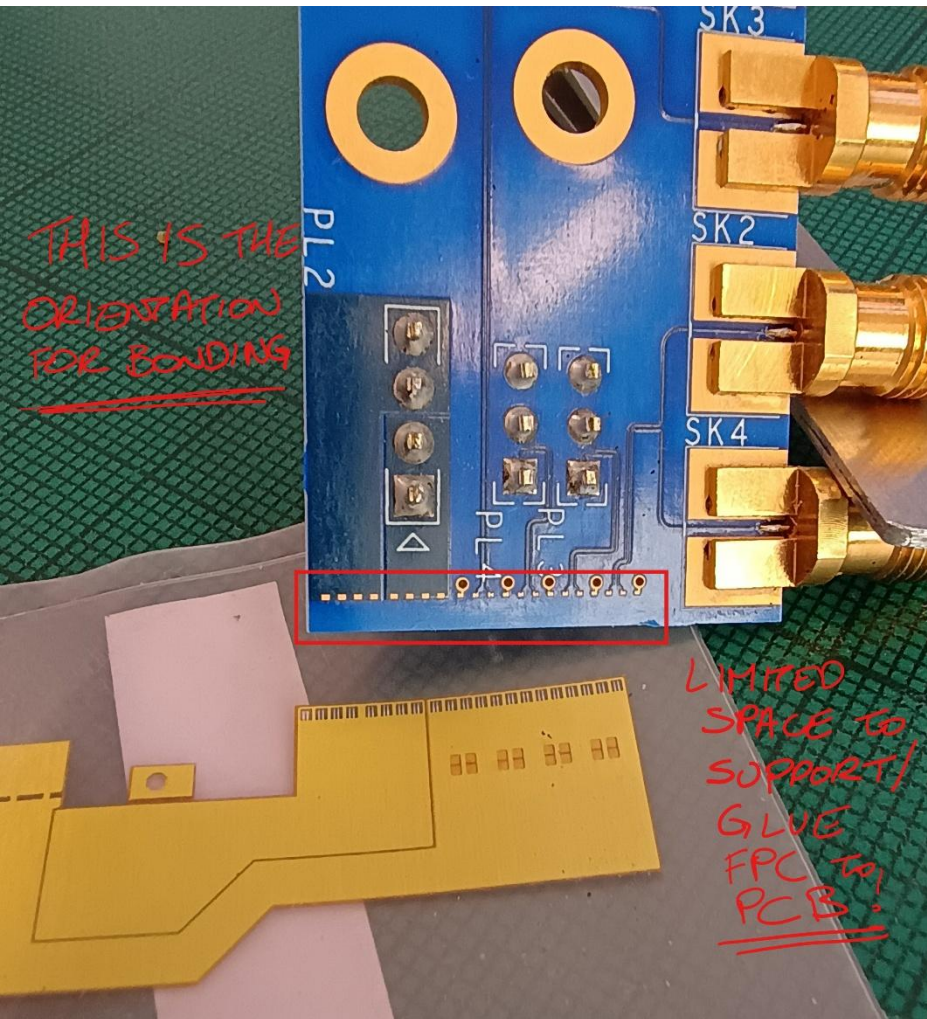
Next spTAB sample

- We now have a B-FPC-B and PCB from DL to retry the spTAB set-up.
- Complications with support jig for PCB (cut-outs needed for header).
- Limited PCB space to support the FPC.
 - We will see how best to support and mount the FPC to the PCB.
