Understanding the Dark Spot on Mirrors

The End of SULI Program Summary

Preet Mann (SBU), Jan Vanek (BNL), Mahmodol Mojumder (SBU), Bishoy Dongwi (SBU), Yongxin Deng (BNL), Kong Tu (BNL/SBU)

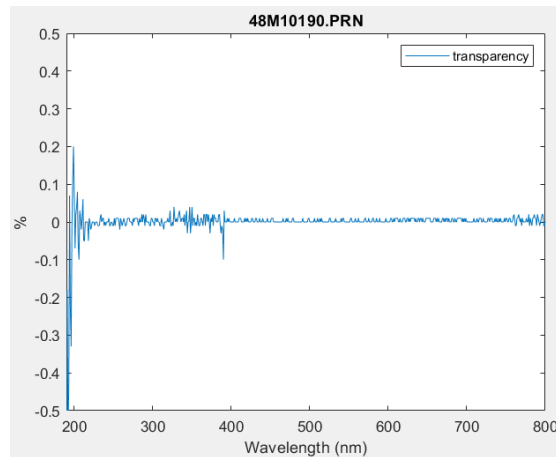
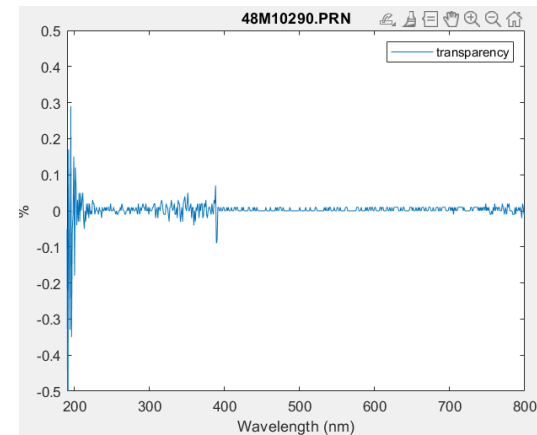
90 degree:

Lexan-only cleaned mirror

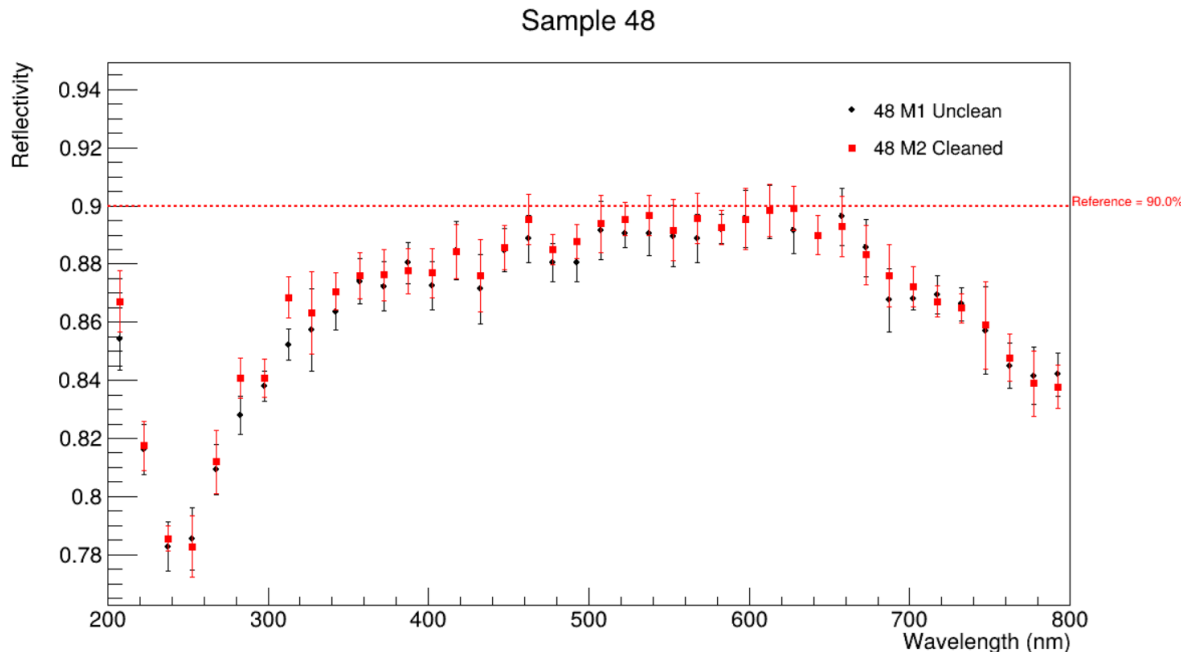
Coating 48(2kA Cr, 8kA Al): Good Lexan-only mirrors as reference

Cleaned(ethanol soaked) and
Uncleaned(ethanol unsoaked)
lexan-only mirror:

- They are highly consistent
- Can't conclude alcohol bath is having any impact
- ~89% maximum reflectivity
- Provide reference for subsequent testing, named M1 & M2

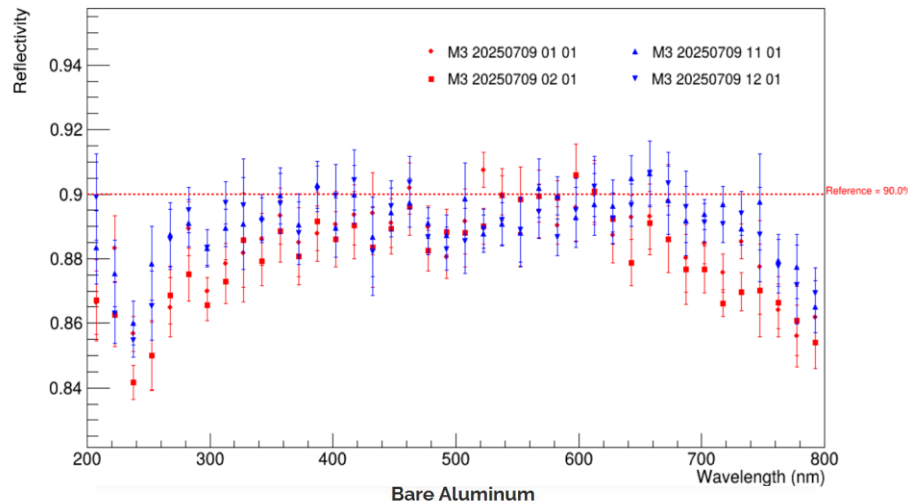
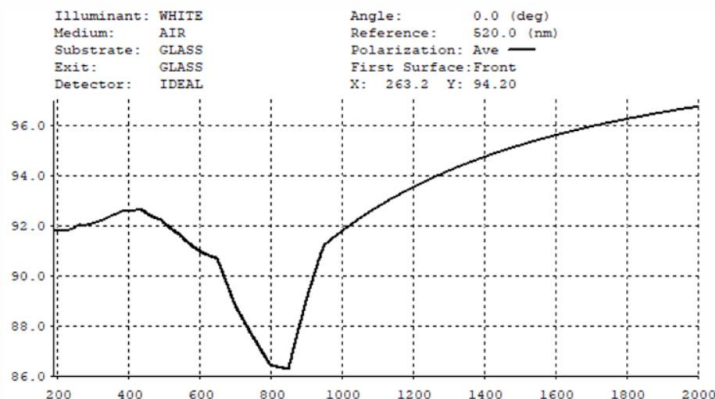
Sample 11 Mirror 3: test point 1 & 2

New references for 800 nm tested with Sample 11 mirror 3

- Two test points; Each test points was measured twice.
- Generally speaking, the reflectivity starts to drop at around 600 nm. The dropping phenomenon is consistent with professionally manufactured mirrors.

Due to interband transitions, where photon energy is being absorbed by electrons to jump to a higher energy level instead of being reflected.

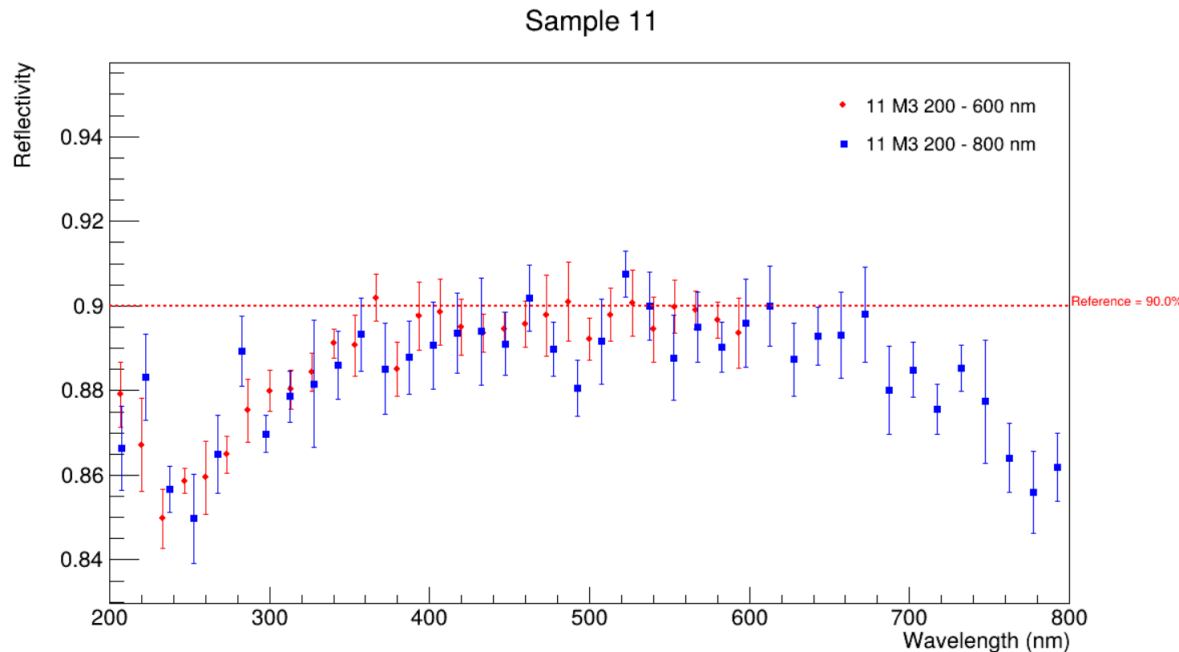
System updated to scan 200 to 800 nm

- New references for 800 nm
- Verified by mirror 3 of coating 11
