# SPHENIX INTT - Weekly Report

Cheng-Wei Shih,  
Chia-Ming Kuo

NCUHEP

2021/6/3

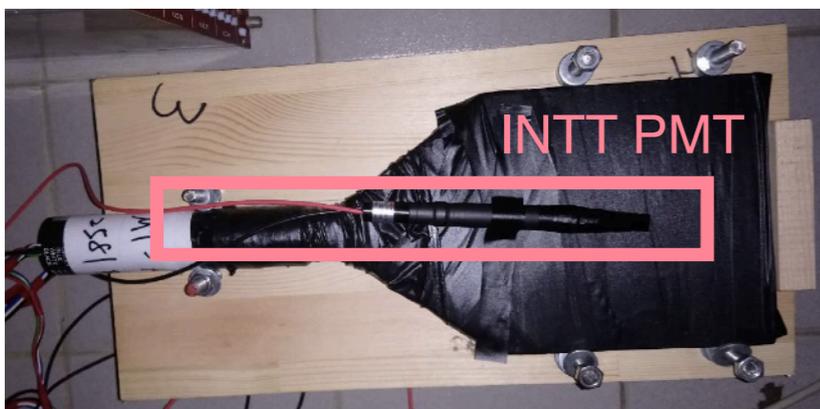
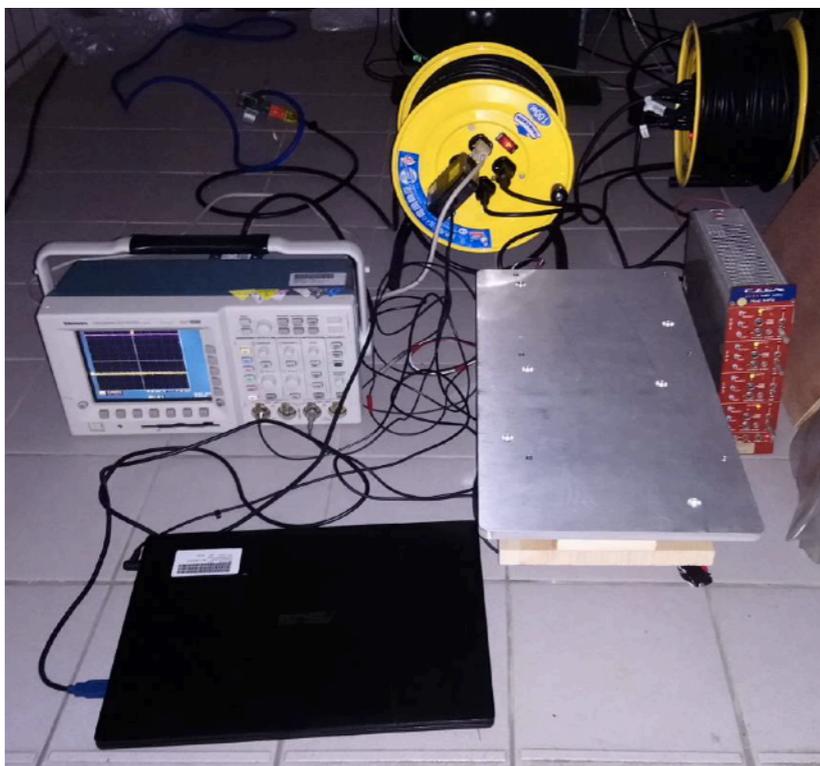
- Cosmic test is performed for supply voltage, threshold cut
  - NWU Supply voltage : -1100V
  - Test voltage : -800 V & -1100V

Voltage -800V, threshold : 10 mV  
Event rate : 0.0038

Signal size

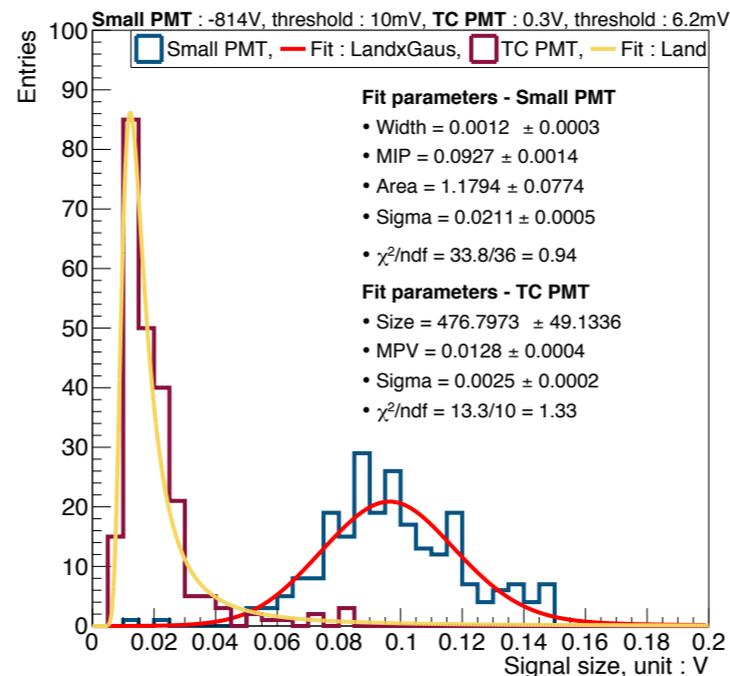
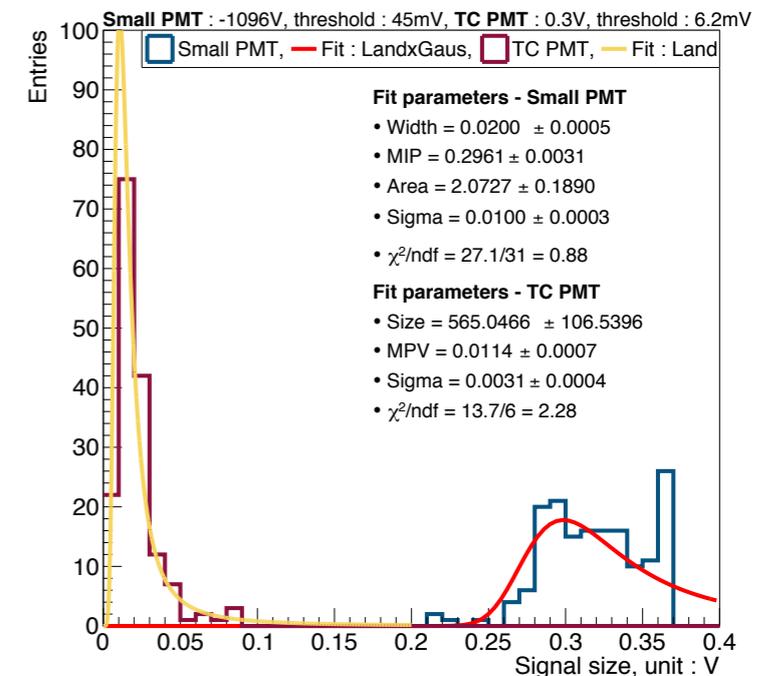
Voltage -1100V, threshold : 45mV  
Event rate : 0.0024

Signal size

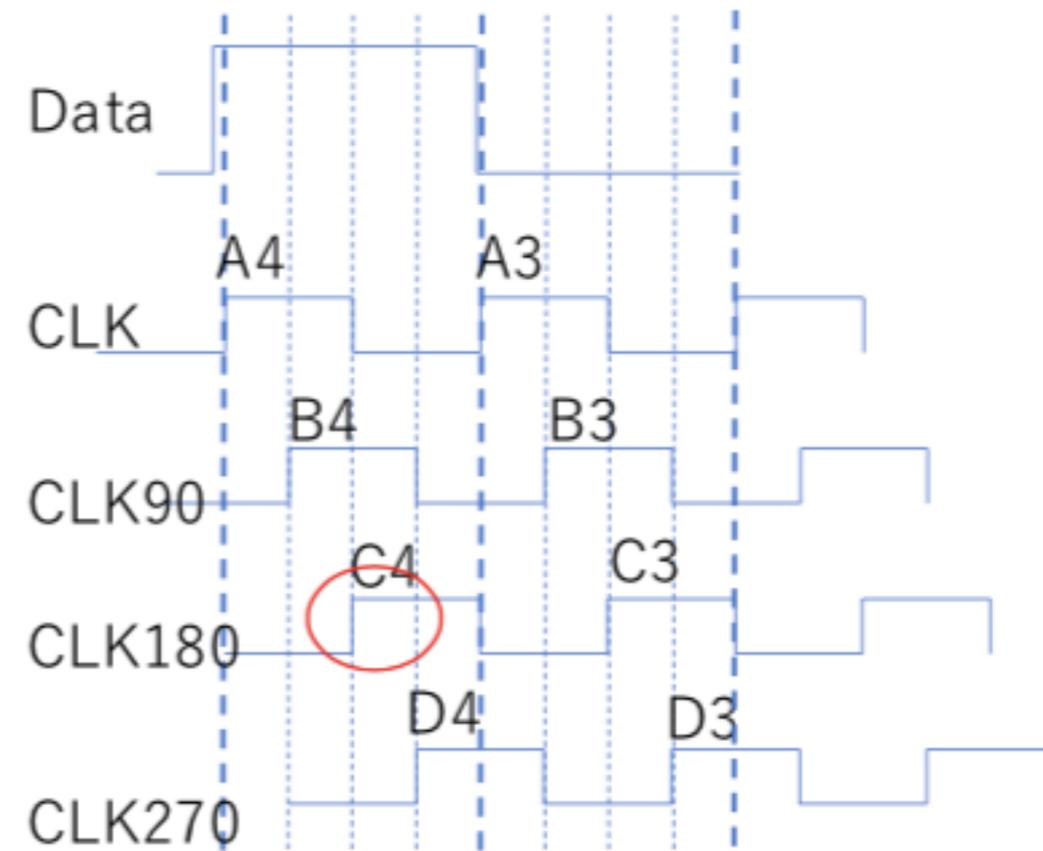
Plot from Takashi's report

- We only see 2 clock, CLK and CLK90 in the code, not 4.

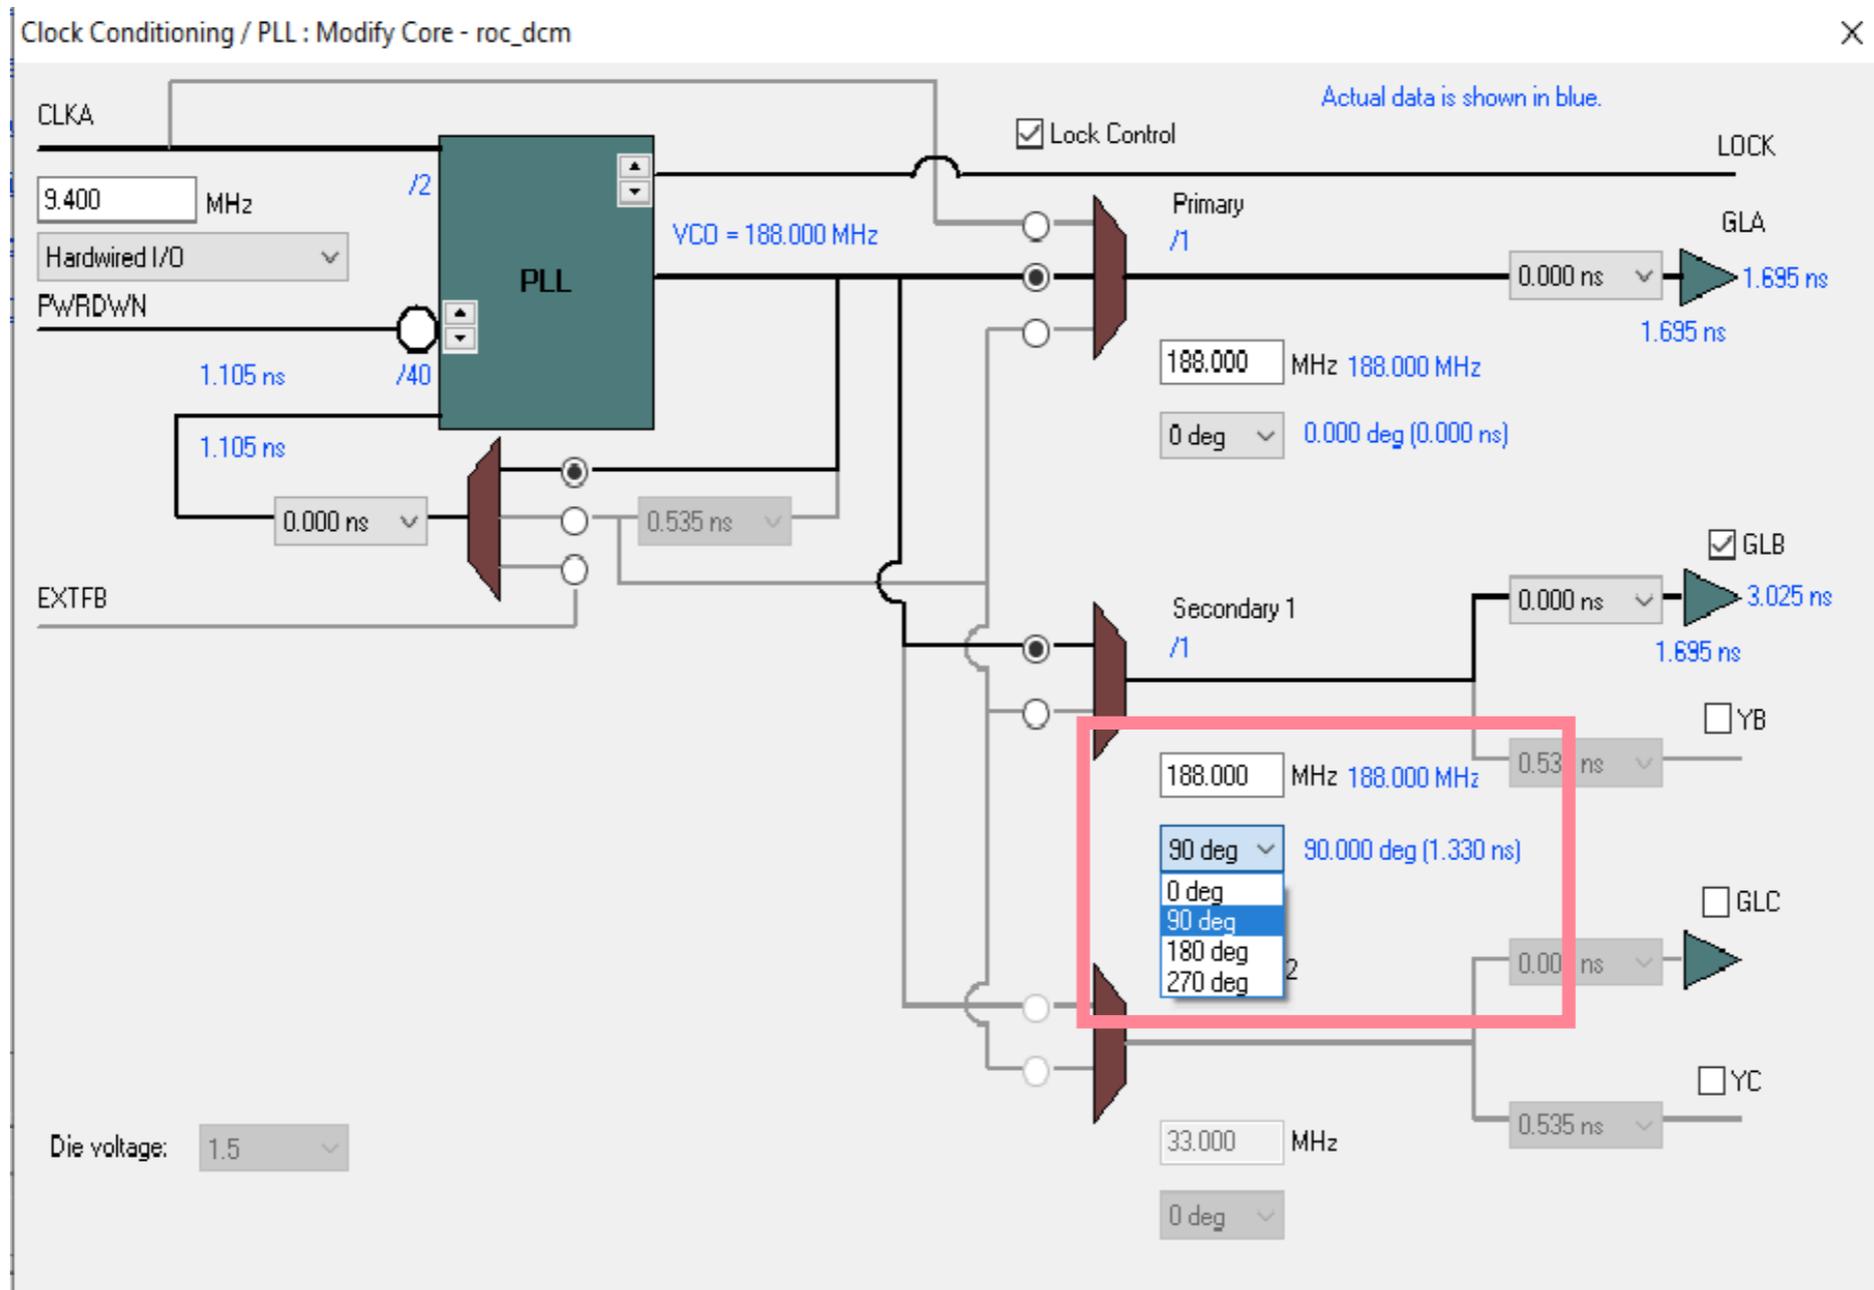
- We can change the clock directly by the GUI below.

- We will try to apply the DP460 in NCU.
- The macro of channel classification is uploaded.
- I will test the PMT with different supply voltage.
- INTT FPGA to do list :
  - We will try to load the original code from (comment out the error 2 lines) to one FPGA, and see whether it can work or not.
    - Concern : if FPGA fails to work, it is dead. We don't have solution to recover it (we don't know the original code version in FPGA ).
  - We will change the clock directly by the GUI, and load the code to FPGA and test it.
  - I will initiate a mail for the discussion
