LArFCS Cryogenic System Progress

LArFCS Construction

► Preparation for the purity run

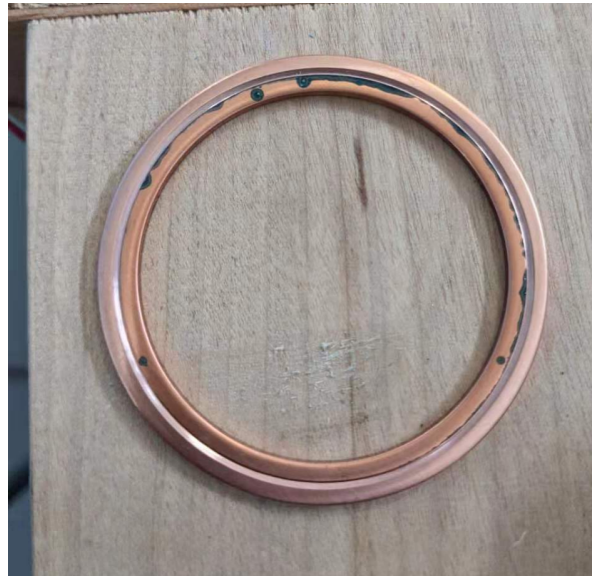
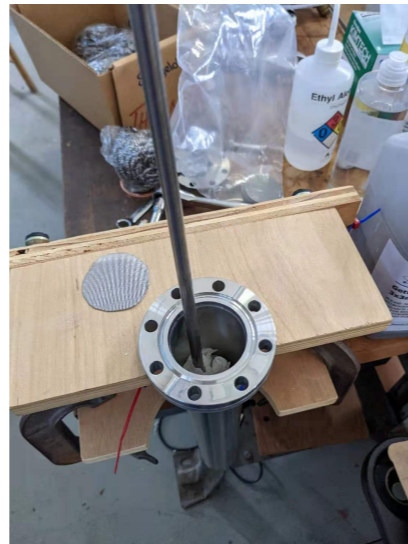
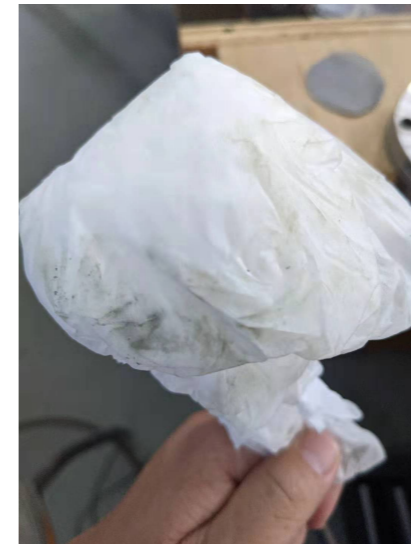
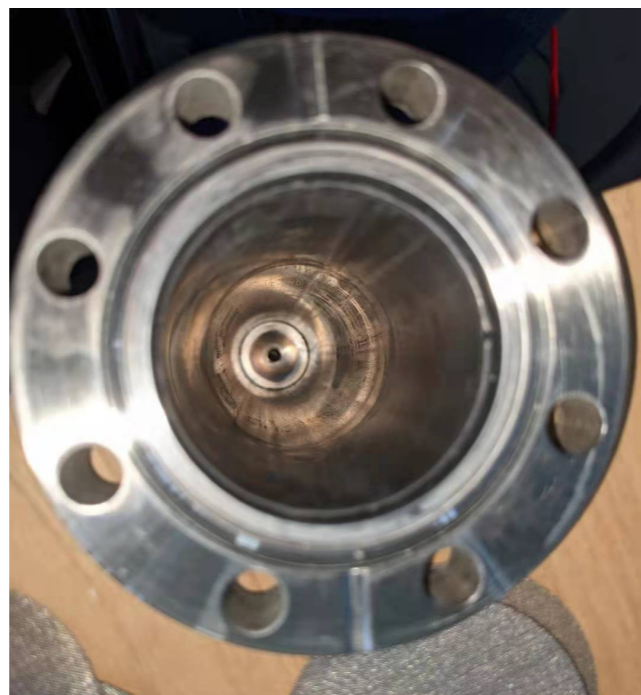
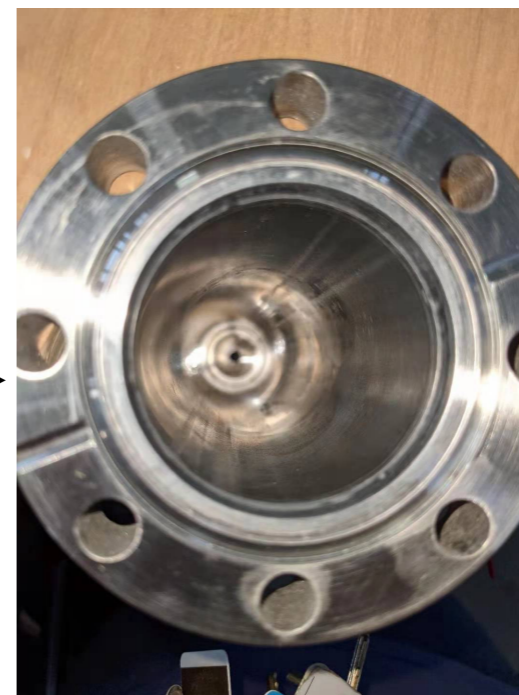
- LArFCS purifier assembly

- Rust found observed on the copper gasket, a signature for water in the system
- The purifier cylinder inner surface found dirty
- Inner surface wiped down

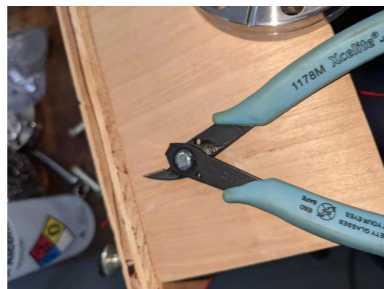
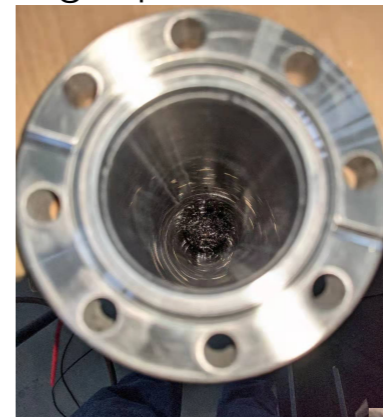
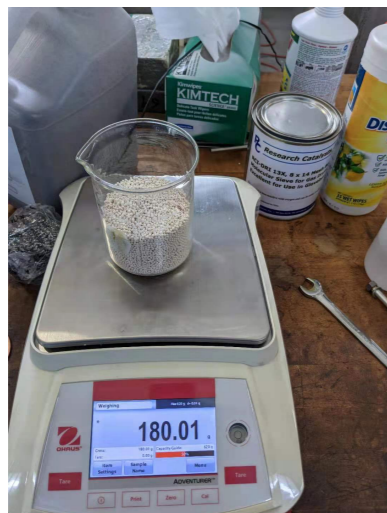
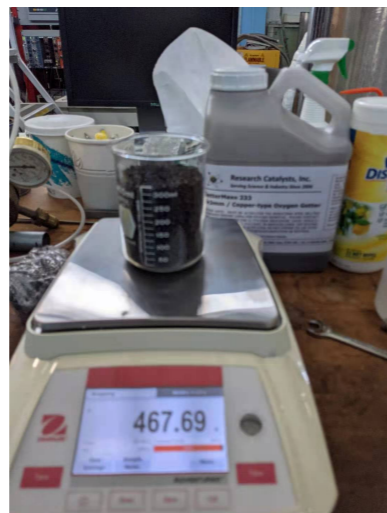
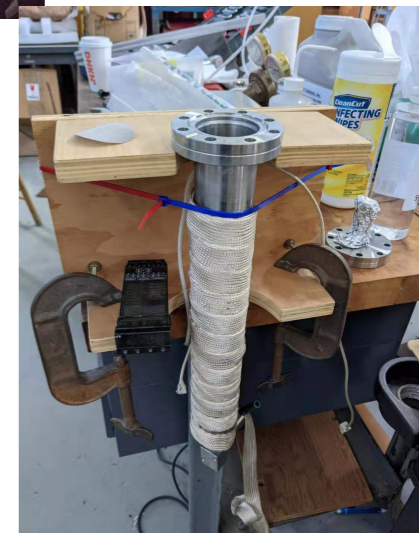
▸ LArFCS purifier assembly (contd.)

- Mesh trimmed down to match in the cylinder ID
- Stainless steel wool filled at the bottom
- Total available filling volume is about 660 ml
 - ~220ml, 180g 13X molecular sieve
 - ~440ml, 673g GetterMax 233 O2 getter
- Oil contamination on the mesh accidentally found
 - Going to do ultrasonic bath wash to the mesh and SS wool
- Heating tape mockup wrapping done, need to order shorter heating tape

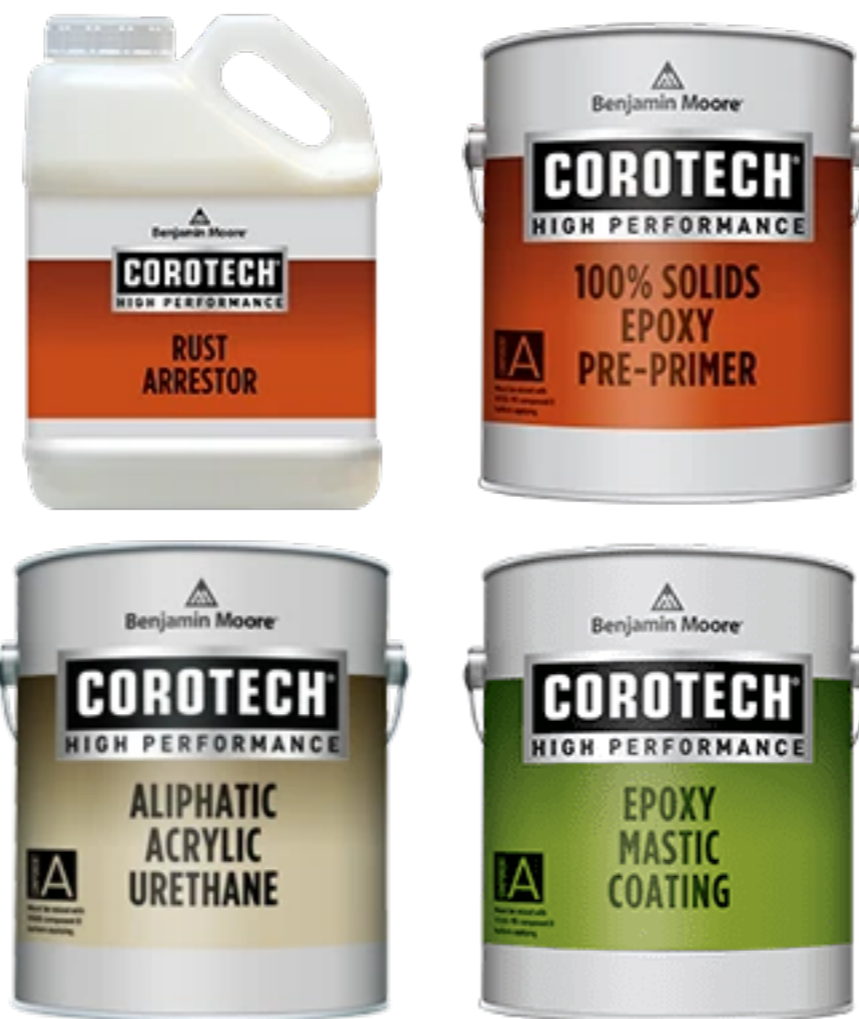
- ▶ **6000 Gallon LN2 tank Preparations Painting the tank to white**
 - Paint just approved by chemical, ordered, painting expected to start soon
 - Airgas site survey
 - Vendor provides quote for the labor cost, est. cost \$1050 for 6hrs
 - Setting up the PO. Please approve the WebReq asap

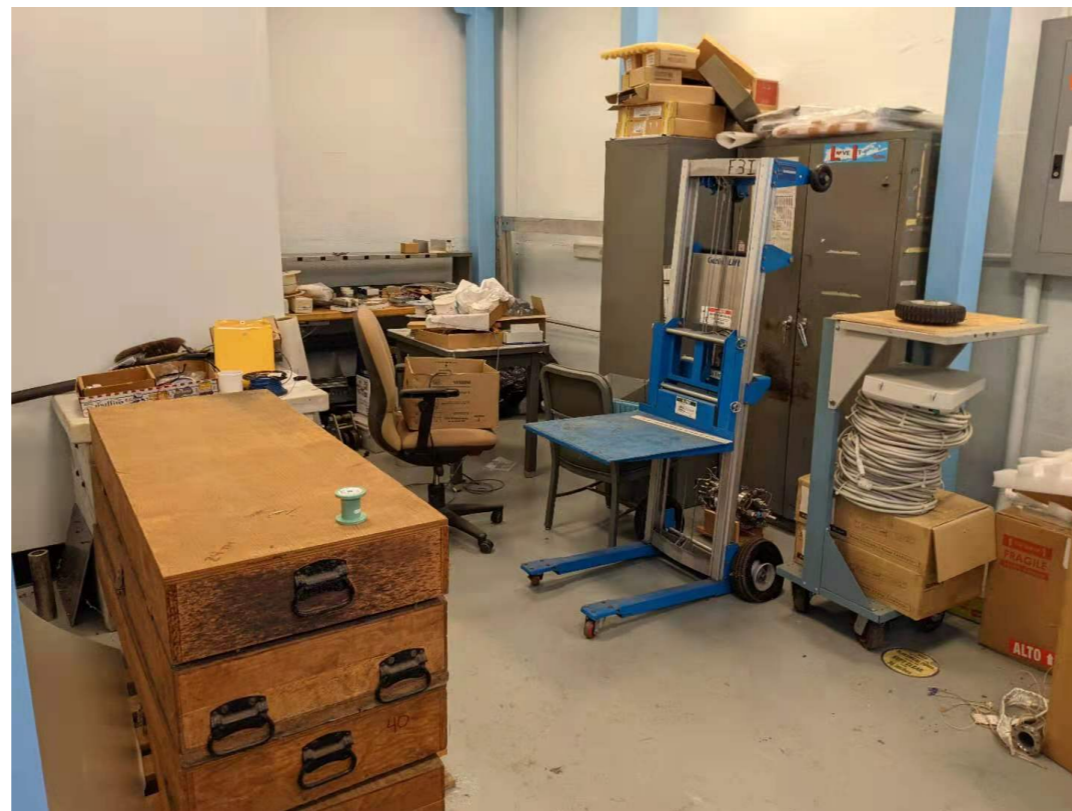
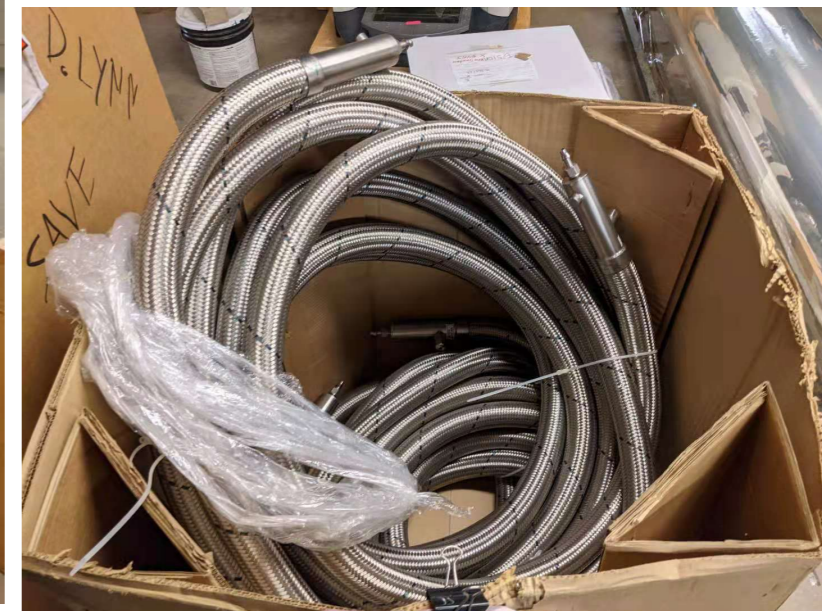
- ▶ **Highbay corner RM1-144 clean up**
 - Fetched most of the useful items from the room
 - Going over with Brandon for the next steps
- ▶ **Flexible cryogenic hose located in the basement**
