# SPHENIX INTT

## - Weekly Report

# Testbench system in radiation lab

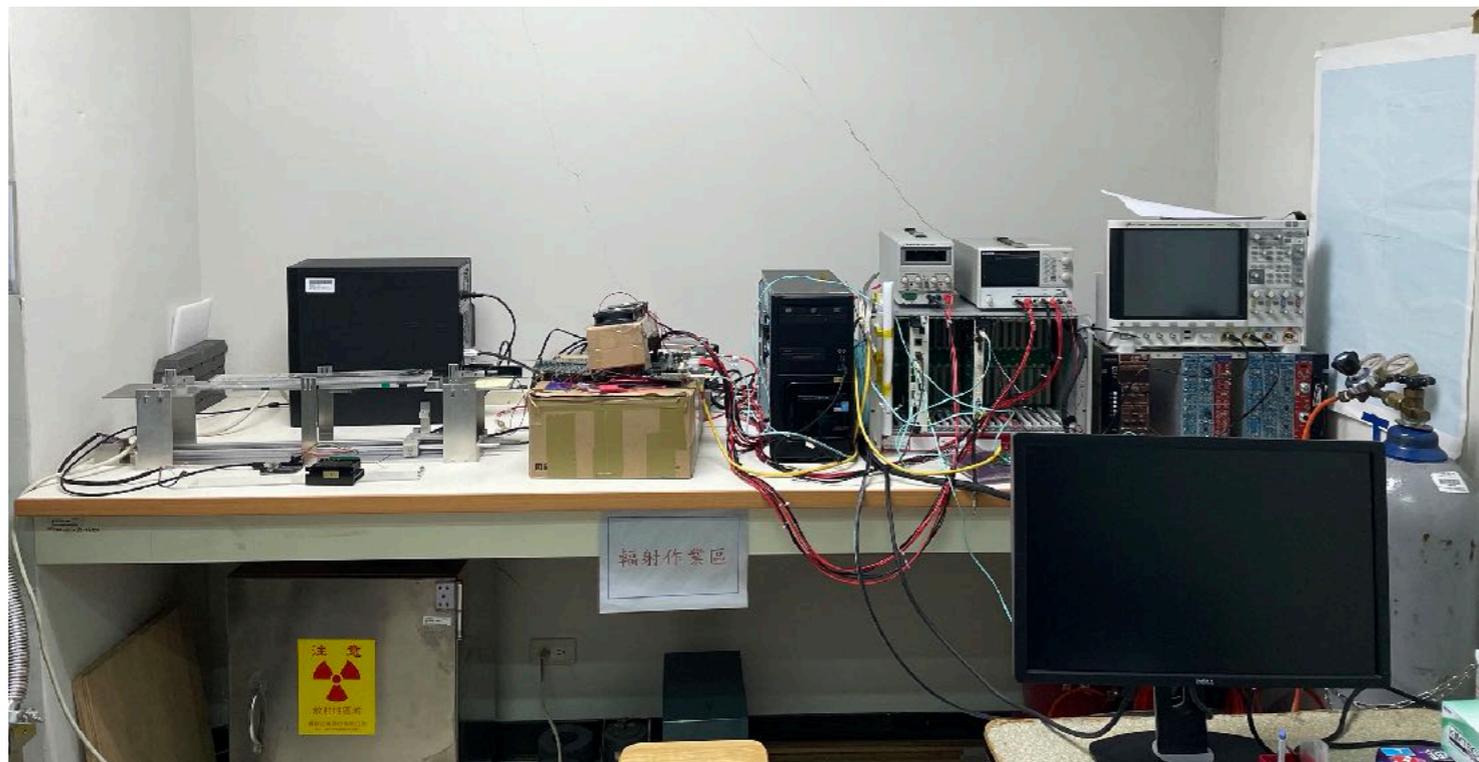
External trigger mode      GND cable on support

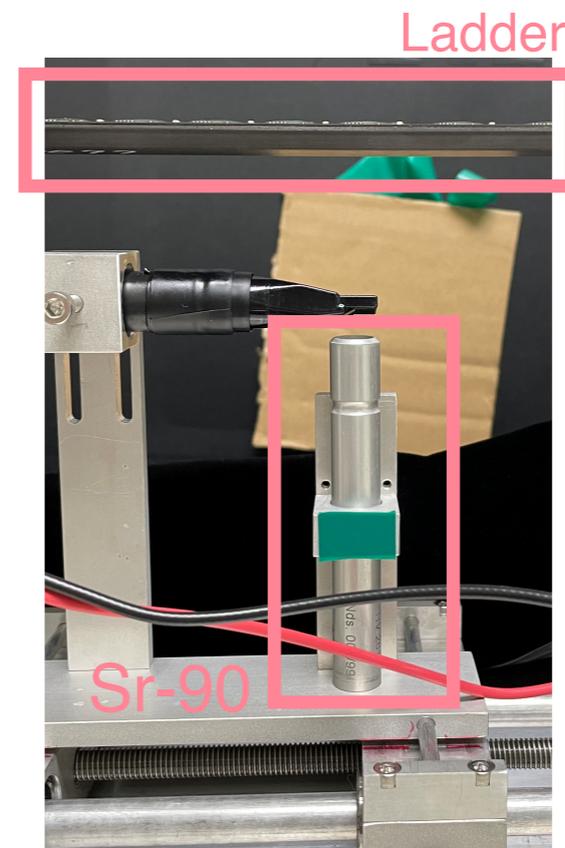
By switching **FEM-IB**, **PCIE cable** and **PC**, we can have 2 Testbench systems, one in 923 (calibration test) & one in radiation lab (source test)

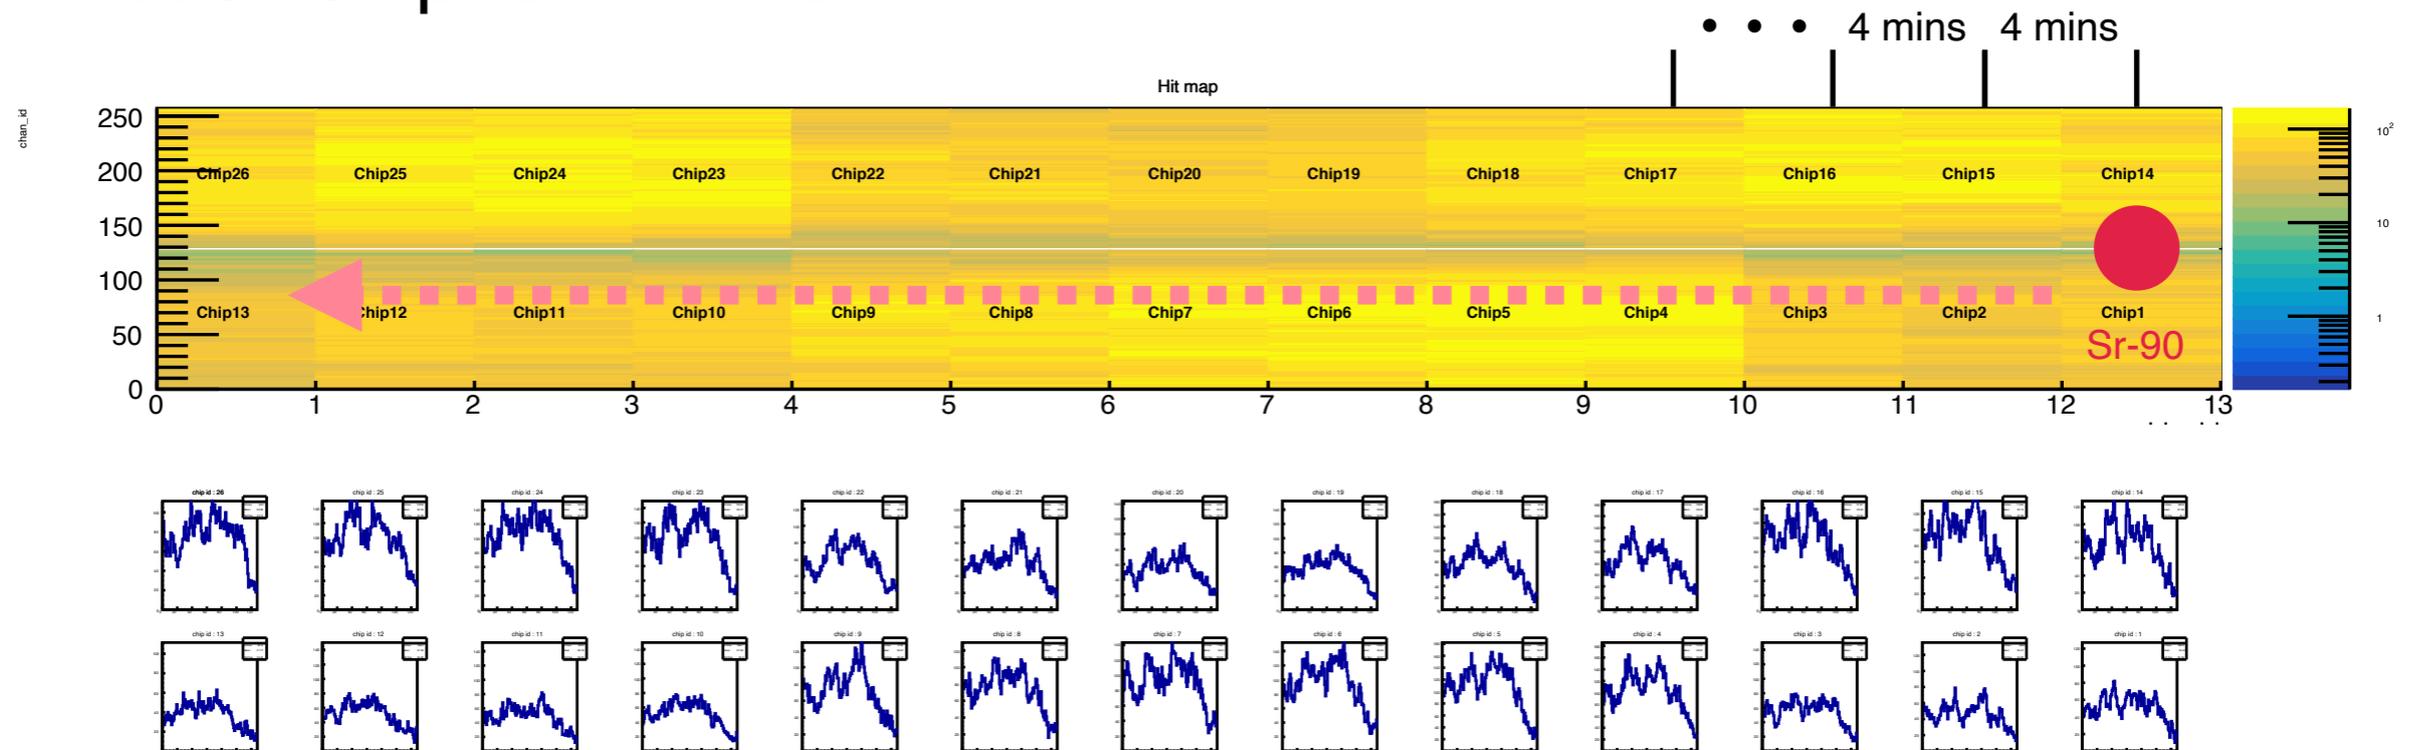
- Plan :
  - External trigger mode.
  - Sr-90 fixs at middle of ladder in transverse axis, and stays at each chip for 4 mins.

At least 1 event for each channel

- Source test :
  - The set up of Testbench system in radiation lab is finished.
  - 4 mins for each chip is enough to make sure at least 1 signal for each channel under current setup.
  - It takes ~ 2 hours to finish the source test for one ladder.
- 15 ladders assembled in Taiwan. C-1 : 11 ladders
- We are moving to next half-ladder assembly session.

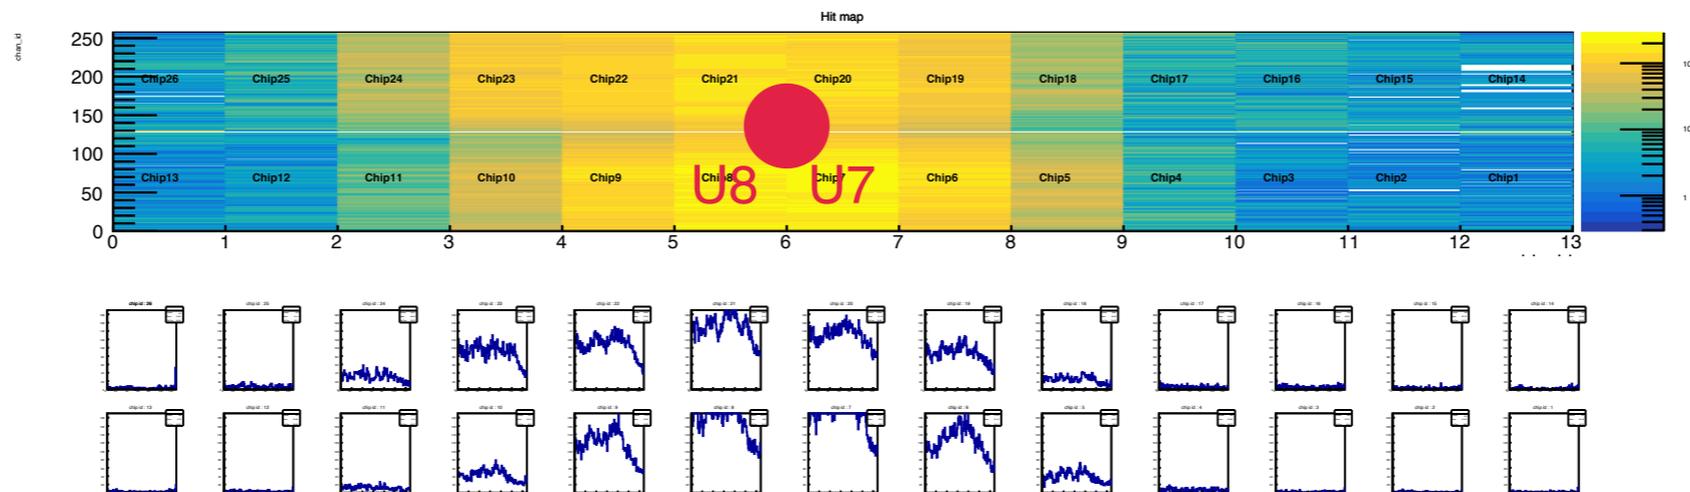
- Self-trigger (silicon signal ==1 → FEM signal =1)

Sr-90, source position fixed at U8 & U7    adc0 is set at 40 to reduce the noise (original adc0 : 15)

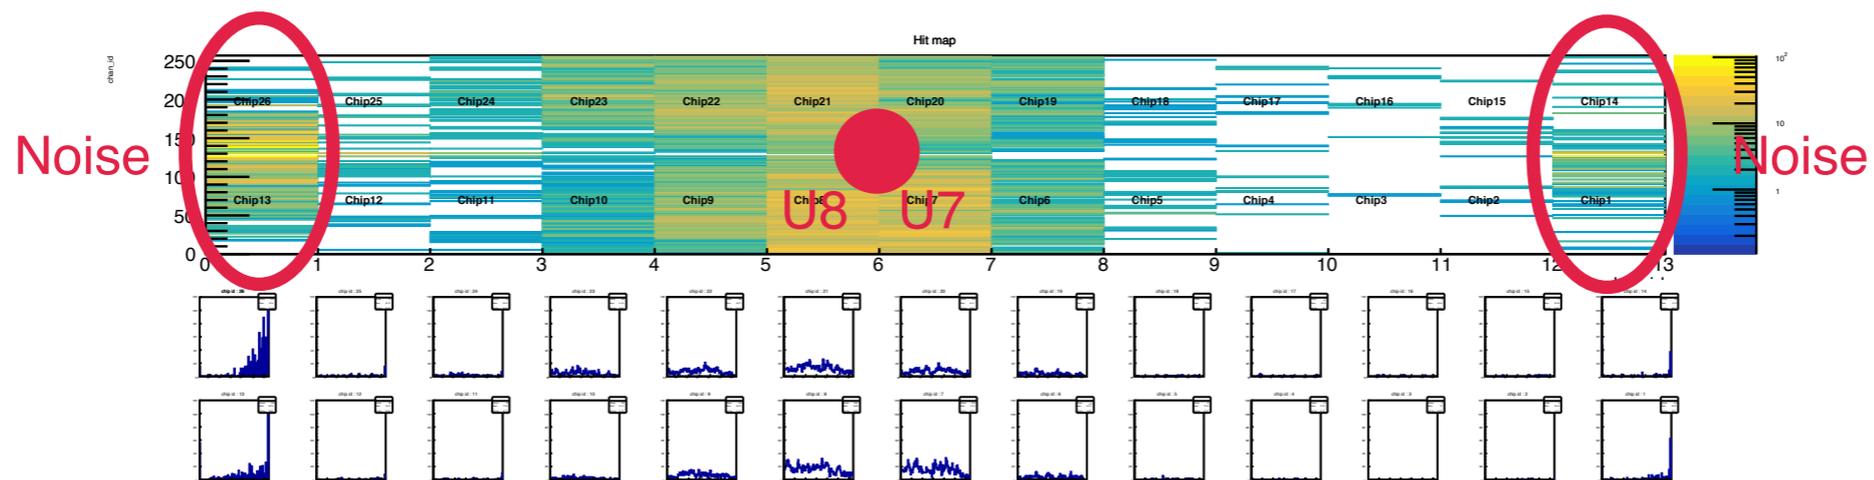
- External trigger (silicon signal ==1 && sci signal ==1 → FEM signal =1)

Source fixed at U8 & U7    adc0 is set at 25 to reduce the noise

Some chips around the edge seems to be noisy

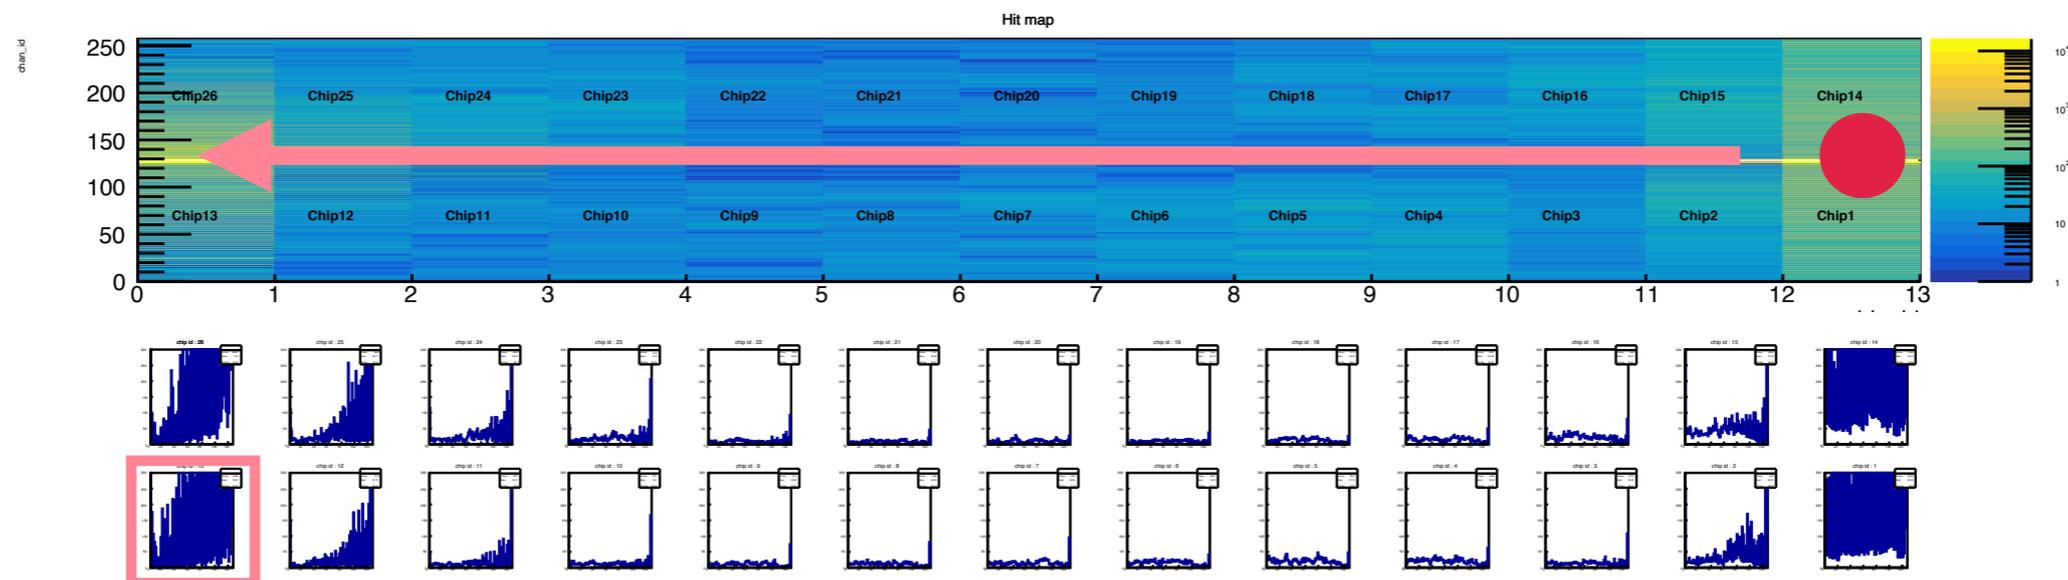
- External trigger (silicon signal ==1 && sci signal ==1 → FEM signal =1)

Source move along the HDI

adc0 is set at 25 to reduce the noise

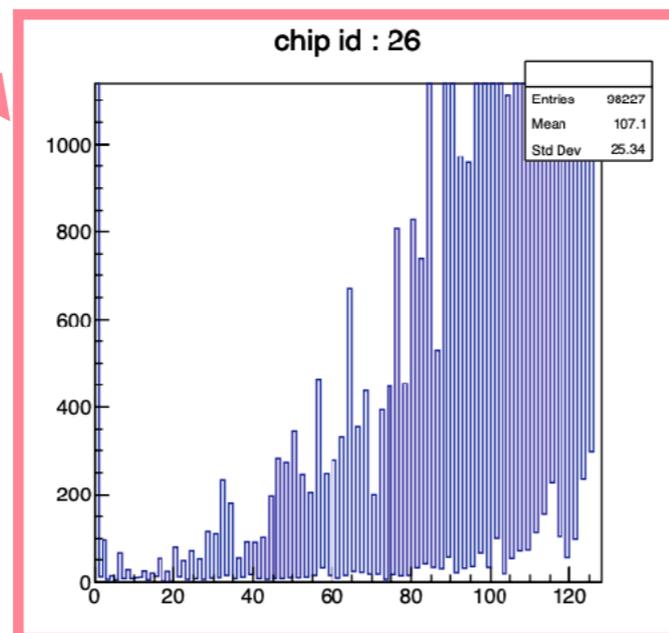
Fishbone behavior

- The fishbone behavior appeared when the motor is in operation.
- JP group also saw this behavior before.
- It seems to be the problem from GND.
- Possible solution : connecting a ground wire to mechanical support
