Production Status

RIKEN/RBRC

Itaru Nakagawa

INTT Production Status

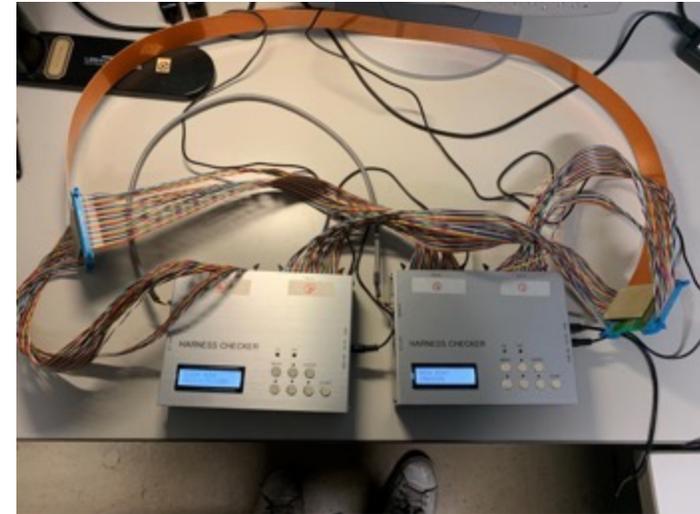
CN-50 Harness Checker

- There are 46 good BEX confirmed before DF18 implementation and the implementations should be completed by today.
- The BEX are then tested at Hayashi-REPIC using CN-50 on Monday ~ Tuesday next week and then delivered to RIKEN in the late afternoon on Tuesday.
- The paper works for the export has pre-processed and arranged pick up date on June 22nd Wednesday. (Expected delivery to BNL by the end of June).

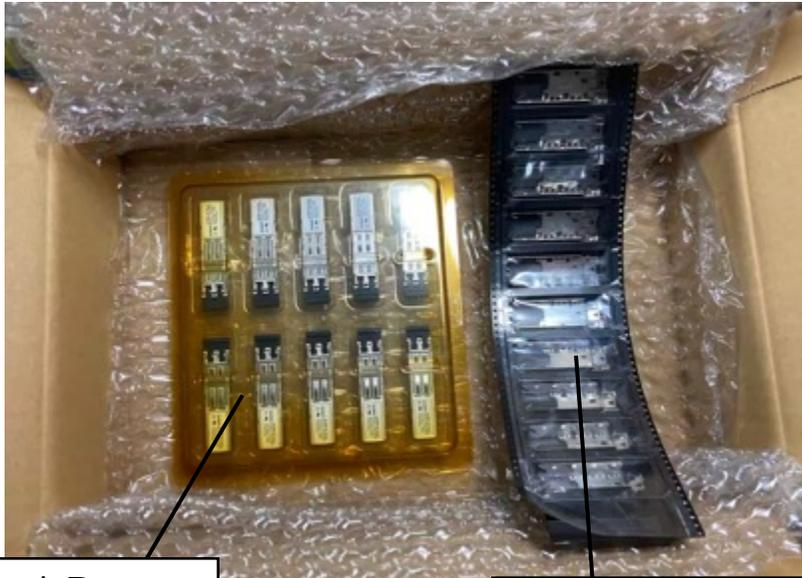
Optical Driver

Available	Shortage
Plug I/O connector	40+	0
Optical Driver	40+	0
Cage Base	10	30
Cage Cover	0	40

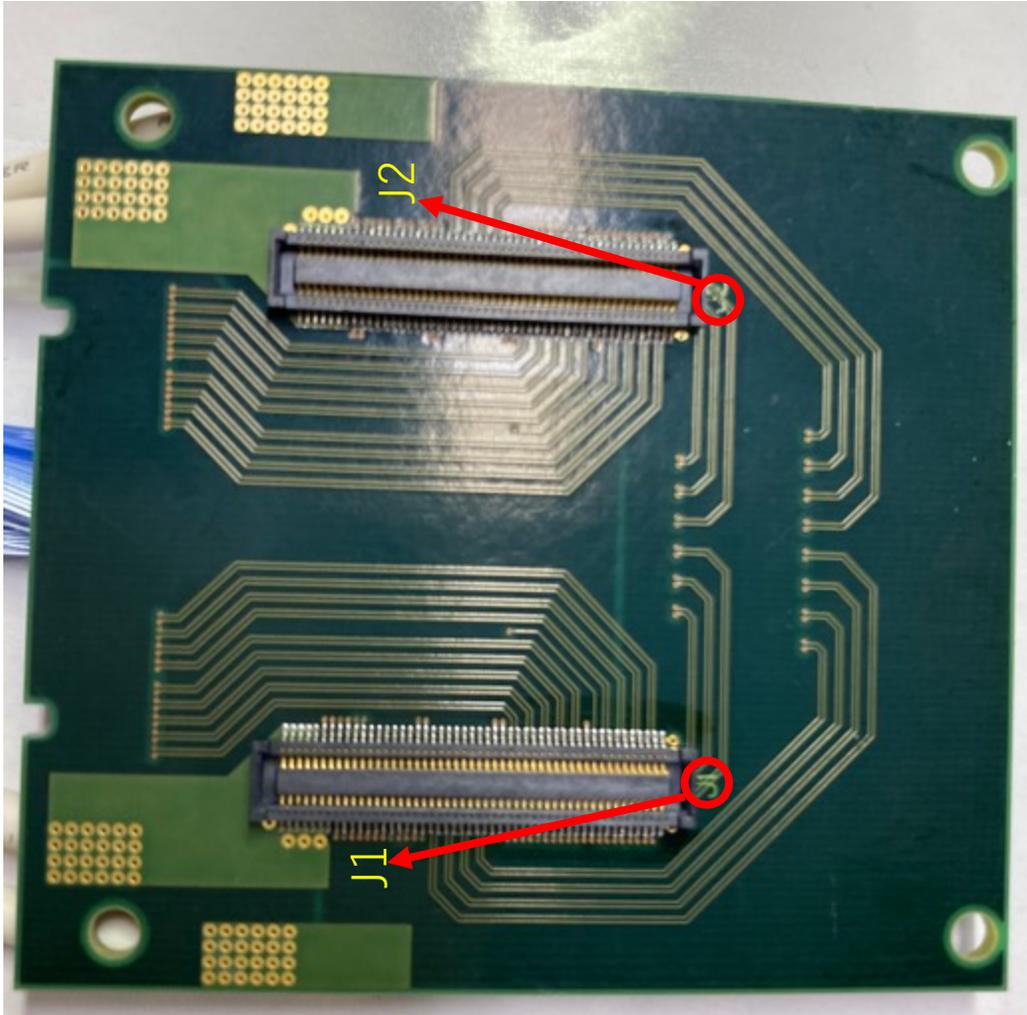
J1/J2 の印がパターンと重なって見にくいのでDF18コネクタ脇に配置してください。

Silk Pattern ROC Side Connector Board Serial No Sticker

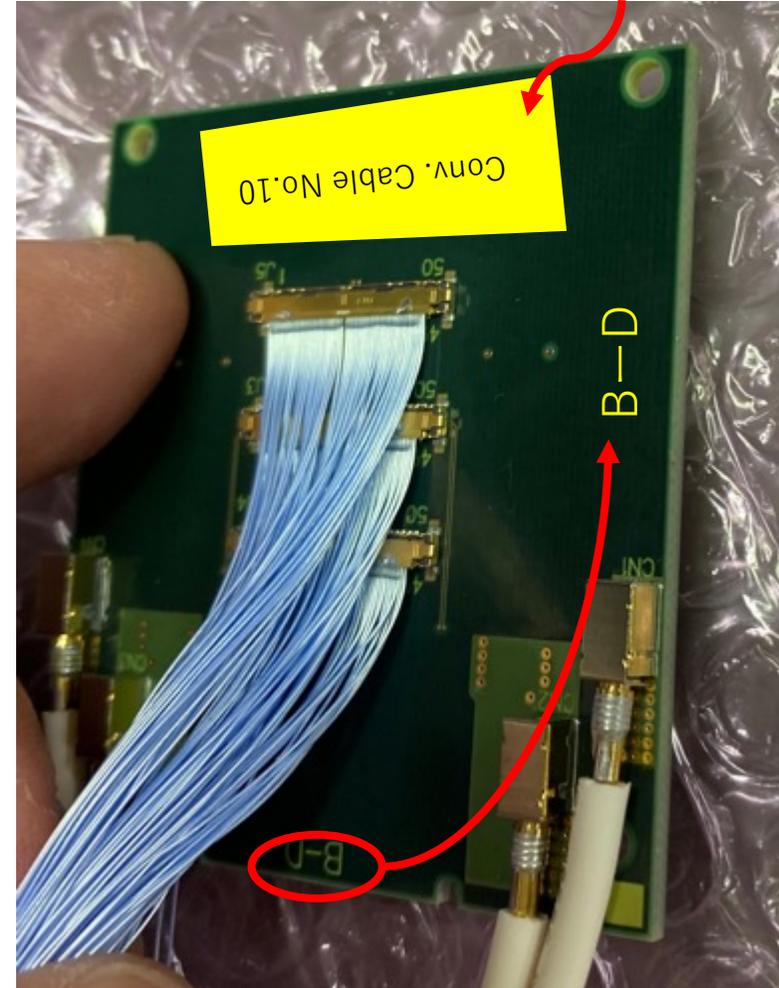
AC/BD の印がハーネスで隠れてしまうので、ボードの反対側に配置してください。

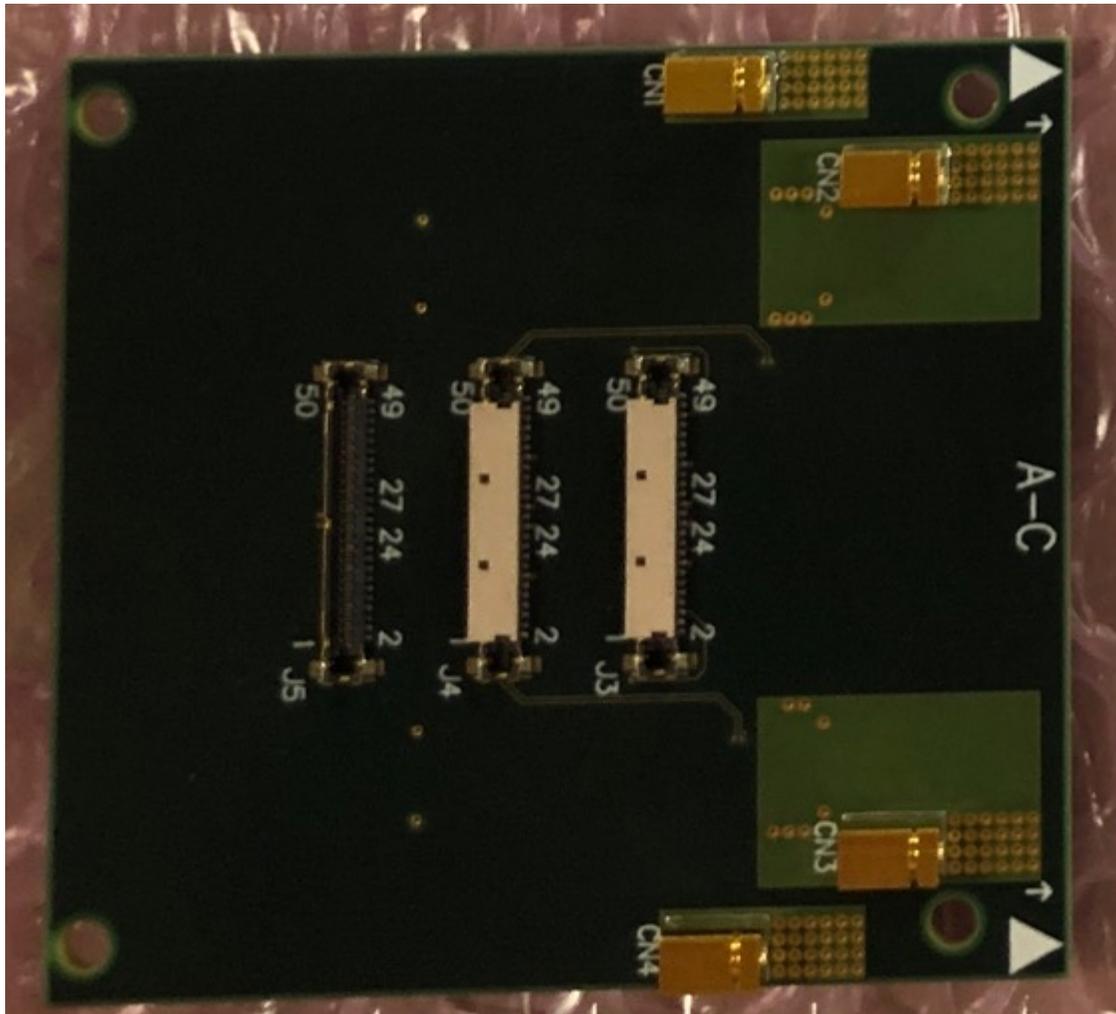
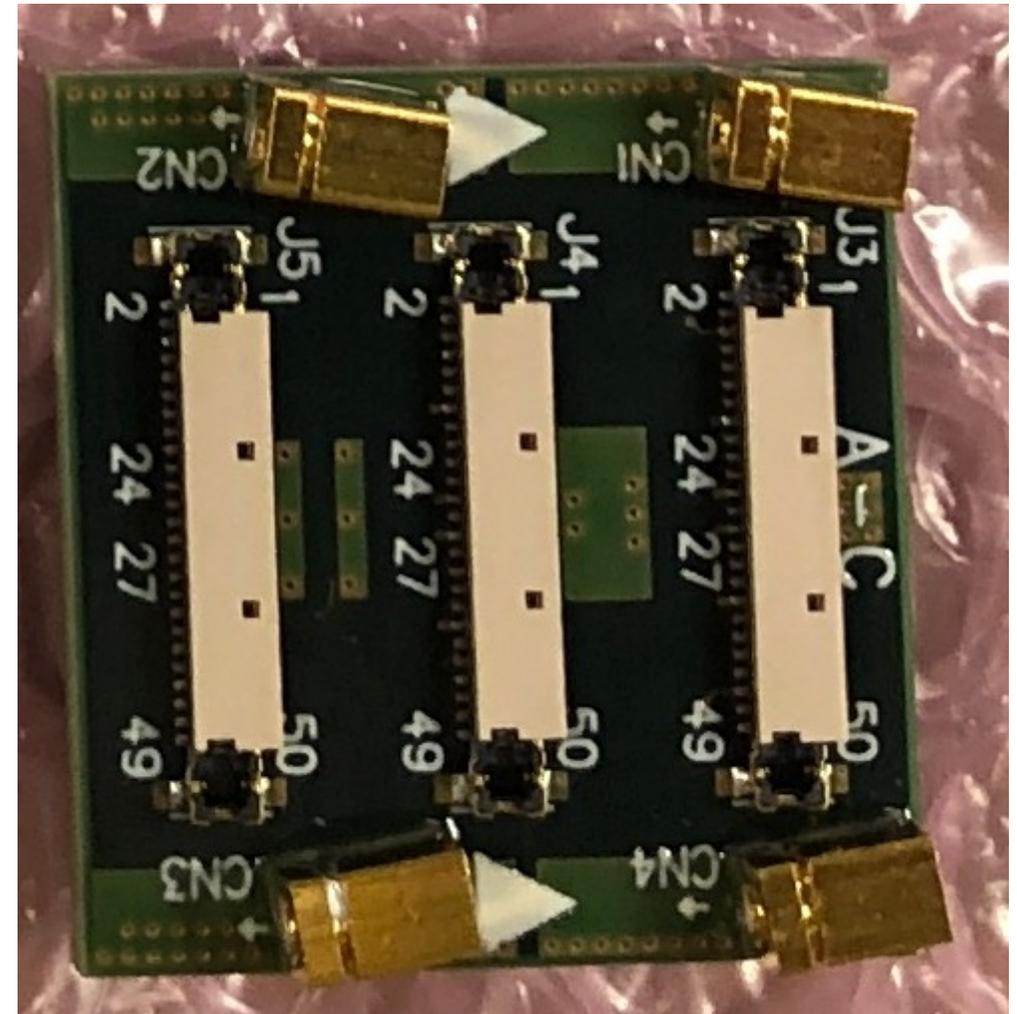
CN1/CN2/CN3/CN4 marks are to be changed to be AGND/DGND/APWR/DPWR

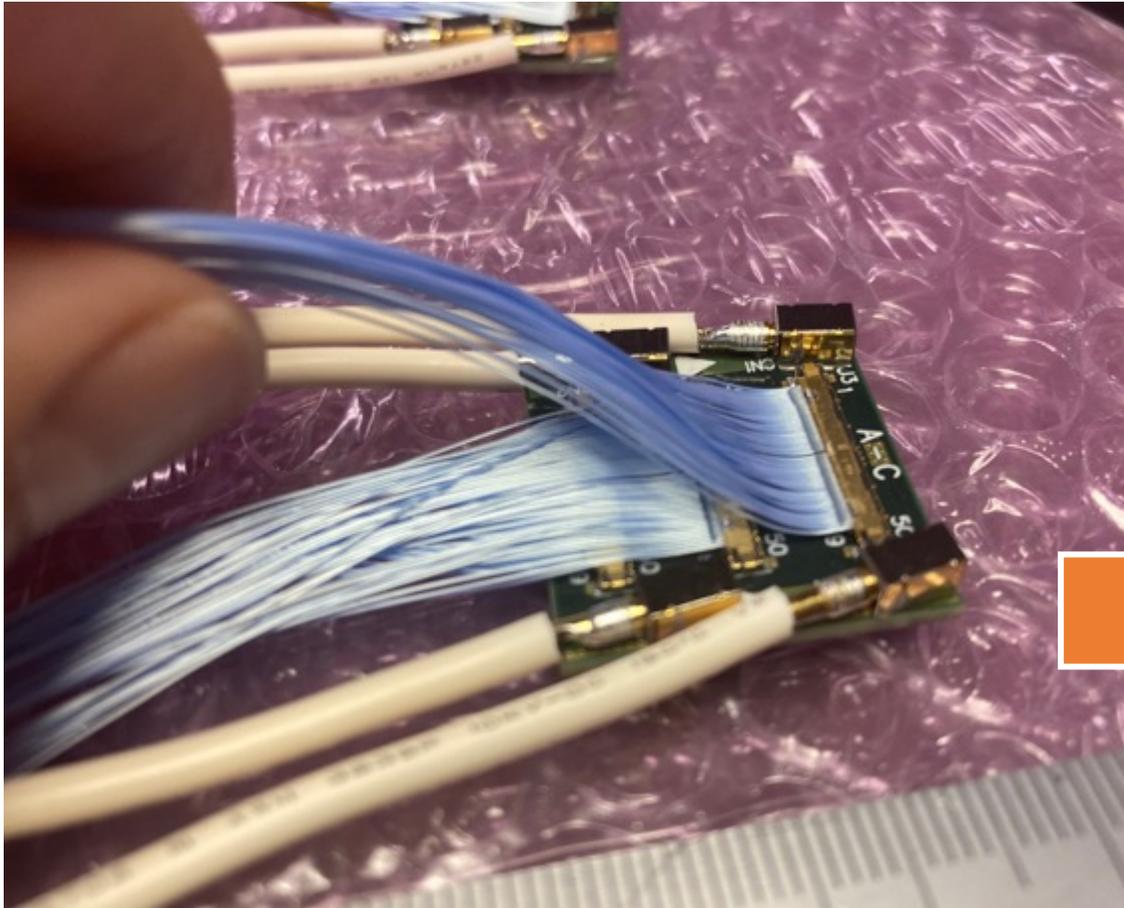
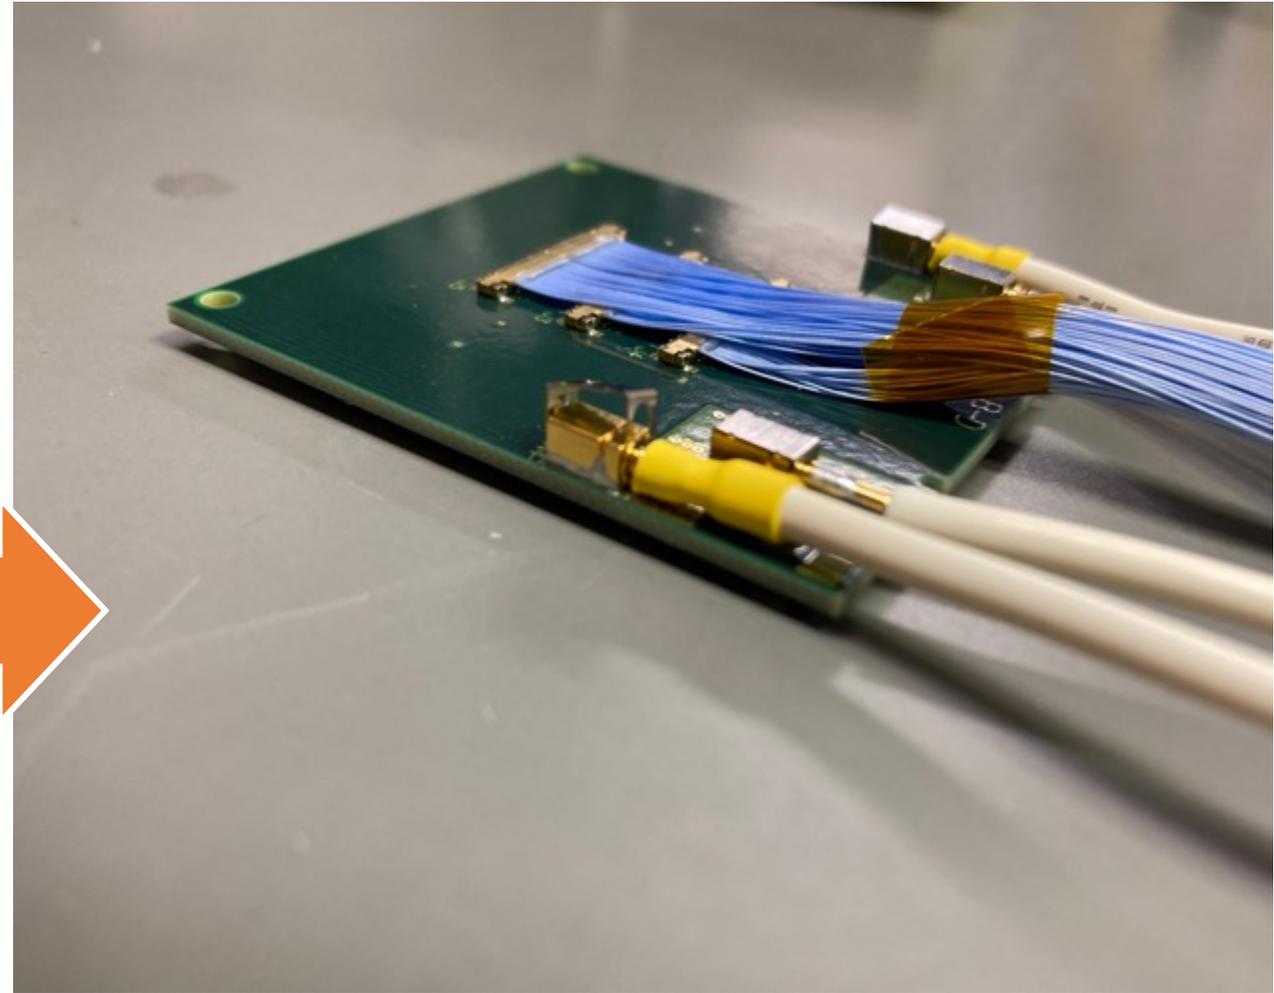
Insulation of GND/Power Cables

The tip of GND/Power cables are to be insulated by heat shrink tubes.

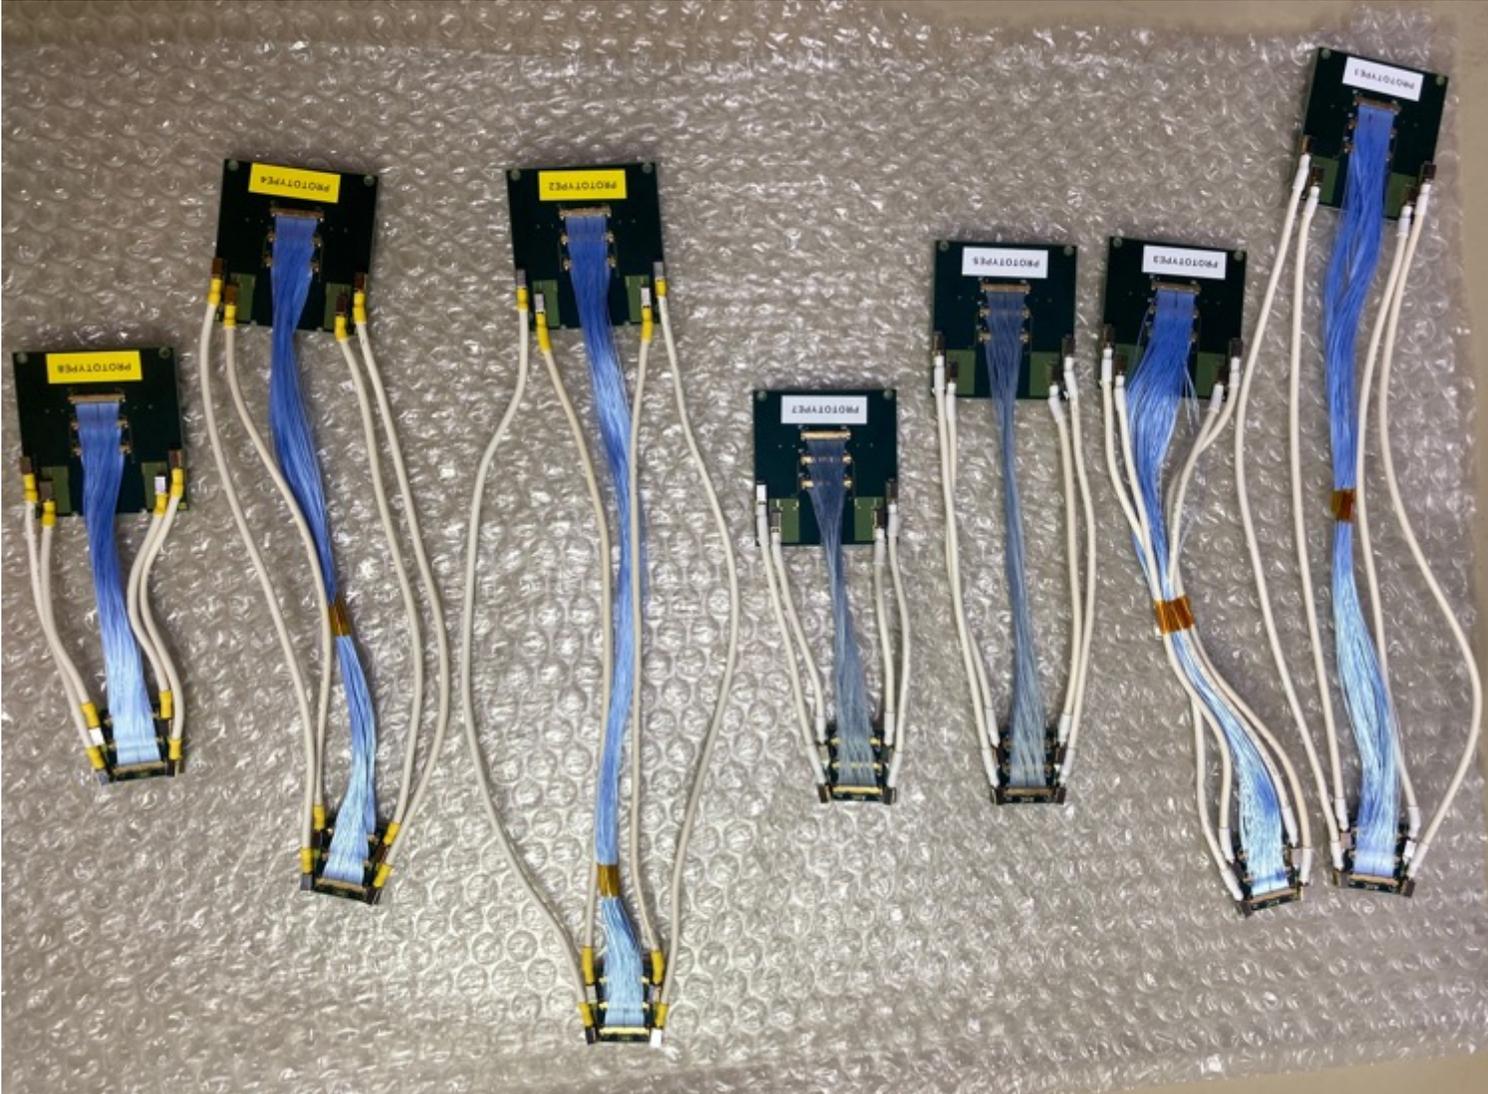
Assembly and Serial Numbers

- Conversion cables are to be delivered in assembled style and tested conductivities of each channel.
- Harness and GND/Power cables are to be bundled by a tapes.
- Serial numbers are assigned odd for AC while even for BD types.
- Serial number stickers are white for AC and yellow for BD types.

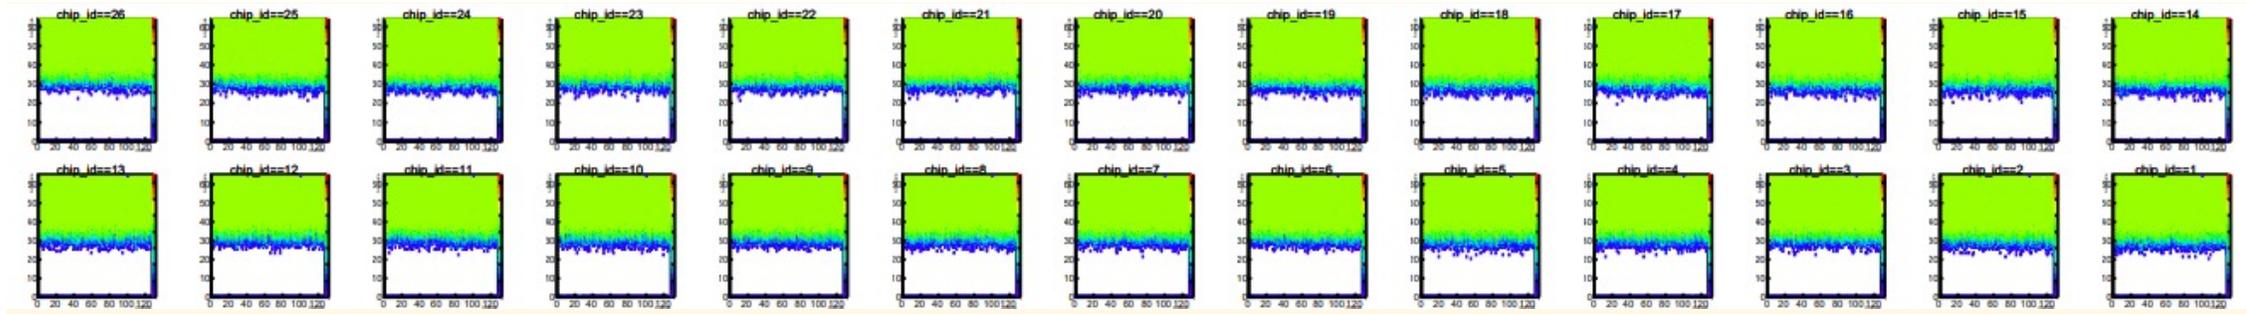
Occurs particularly in D-port of ROC.
Worst in D3 port.

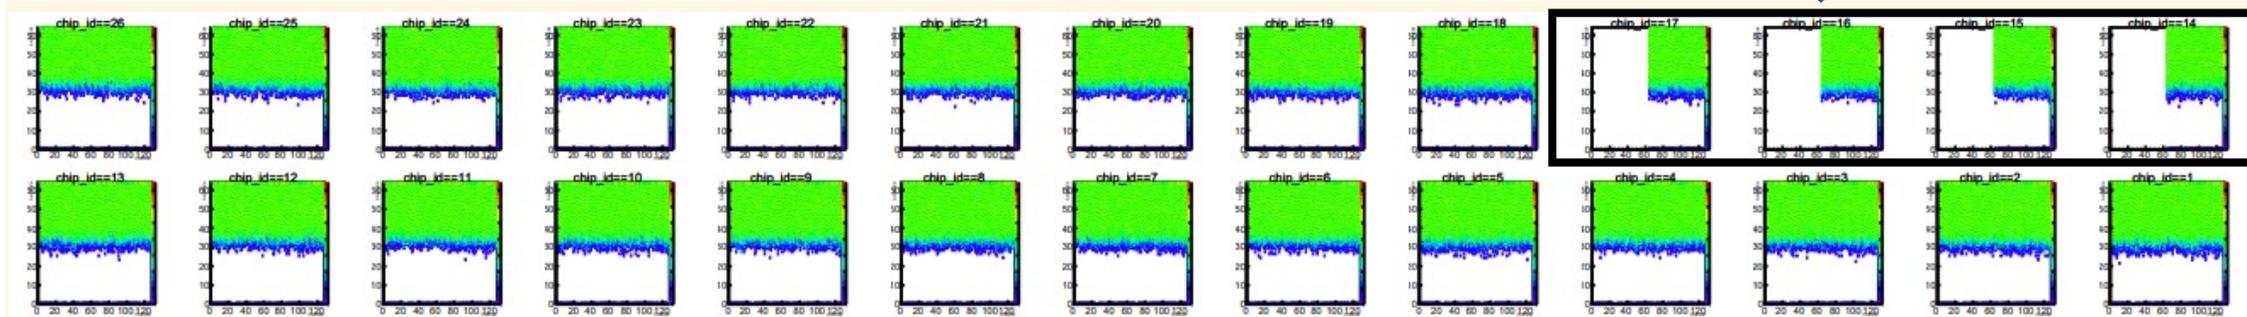
Typically, missing data strip#0~64 of Chip 14 ~17

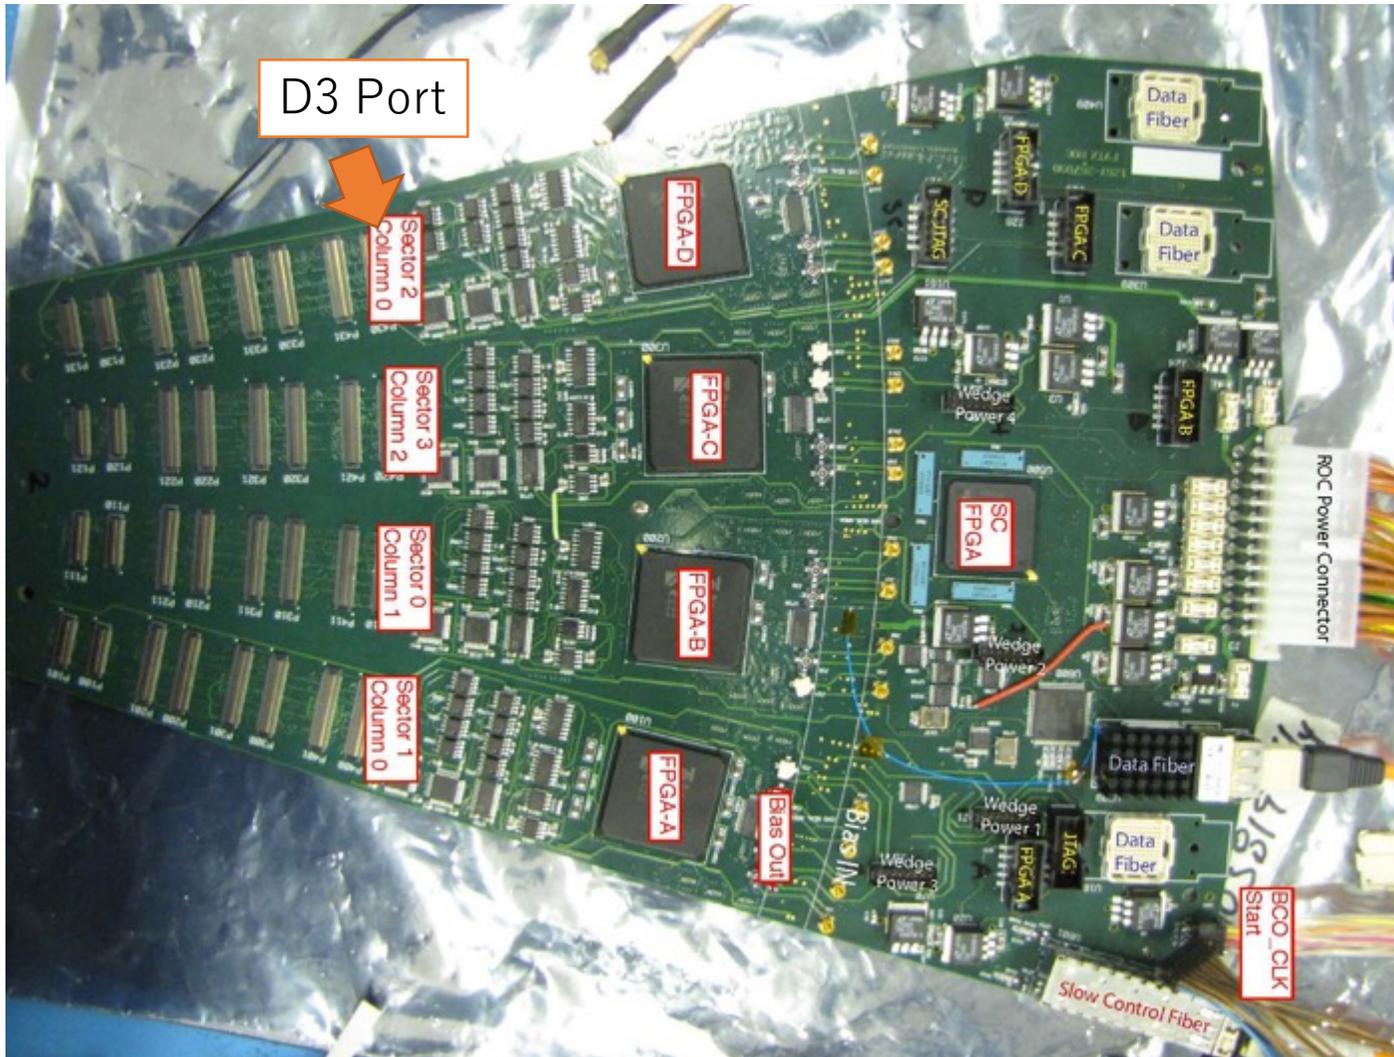
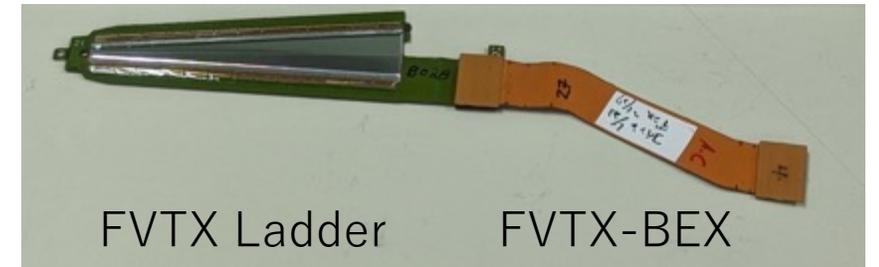
Boundary Conditions

- The partial data drop won't be observed in D-ports with FVTX ladder + FVTX BEX.
- More frequency fails with BEX+ μ -Coax compared to w/o BEX.
- Increasing LVDS current from 2mA (default) to 8mA doesn't help. (hard to explain the phenomena by signal degradation in the transmission line.)

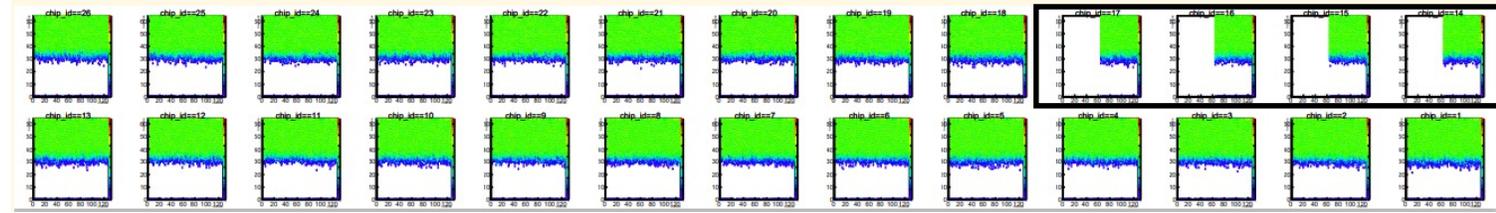
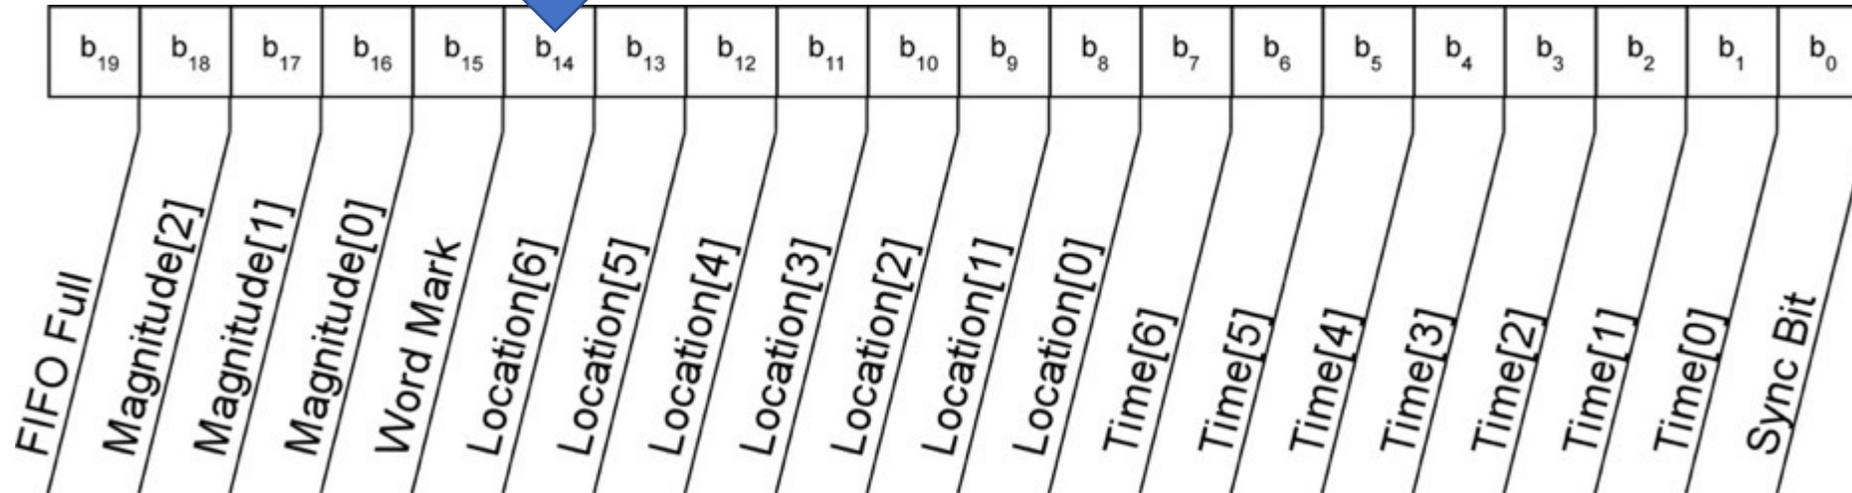
1: Strip #64 ~ 127
0: Strip #0 ~ 63

Note that in time order, the Sync bit comes out first and the FIFO full bit comes out last.

- If we observe data pattern $b_{14} = \text{false}$, then the problem is in down stream, i.e. data is healthy. The problem is in the ROC.
- If we don't observe data pattern always $b_{14} = \text{true}$, then the problem is in upstream. Most likely the initialization failure of FPHX chip. Slow control transmission issue of μ -Coax?
