# Production Status

RIKEN/RBRC

# INTT Production Status

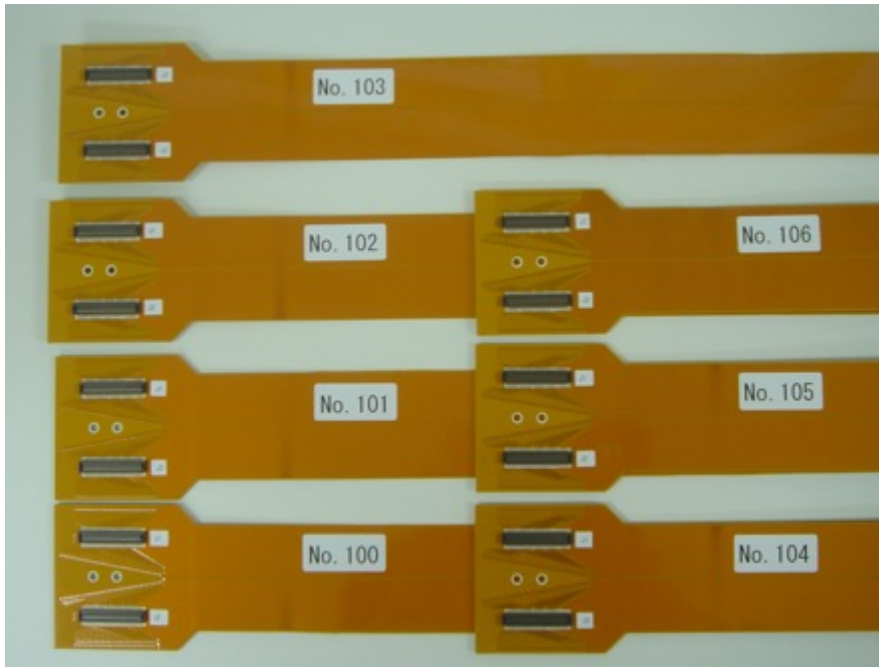
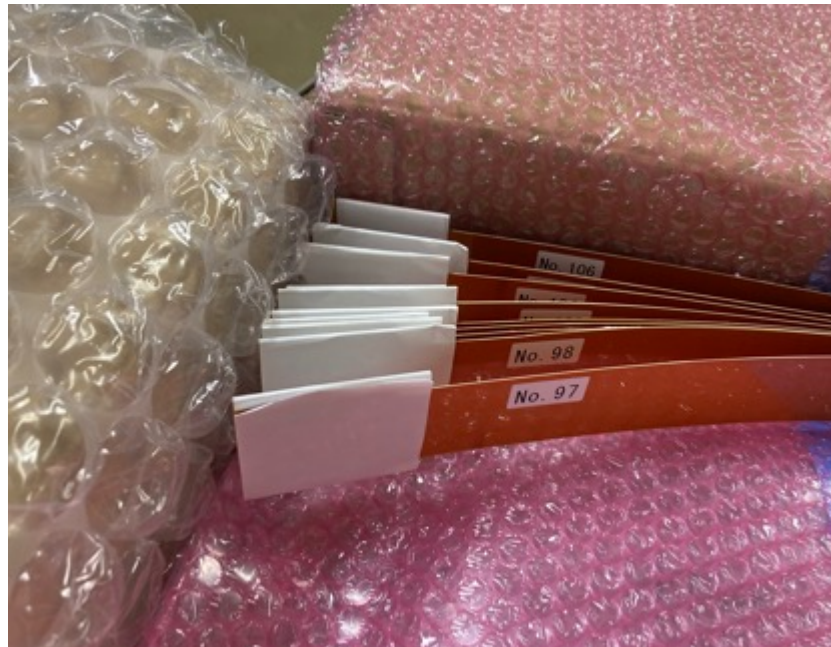
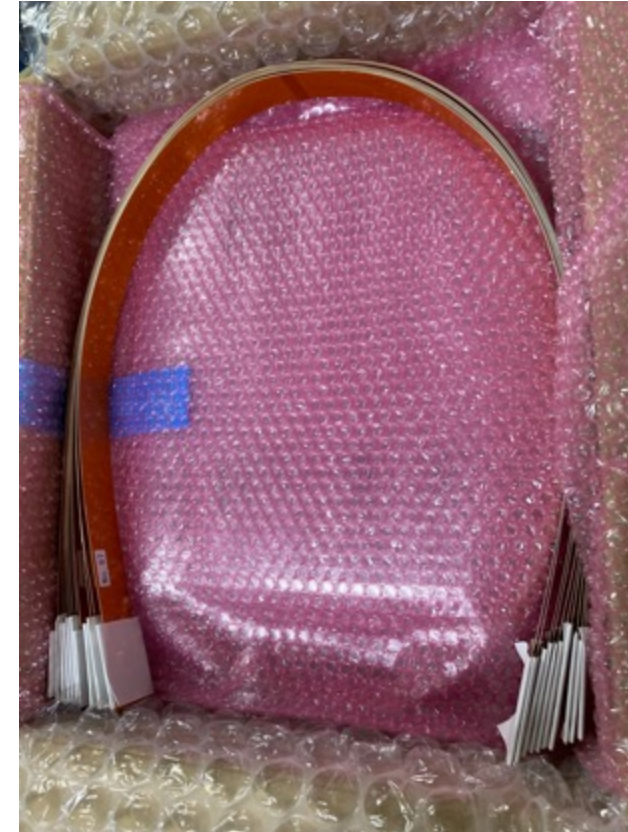
# 3<sup>rd</sup> batch bus extender LOT-1

- There are 46 (serial No. 61 ~ 106) good BEX were delivered to RIKEN on June 21<sup>st</sup> and picked up for export on 22<sup>nd</sup> as scheduled.
- Expected delivery to BNL is June 28<sup>th</sup>.

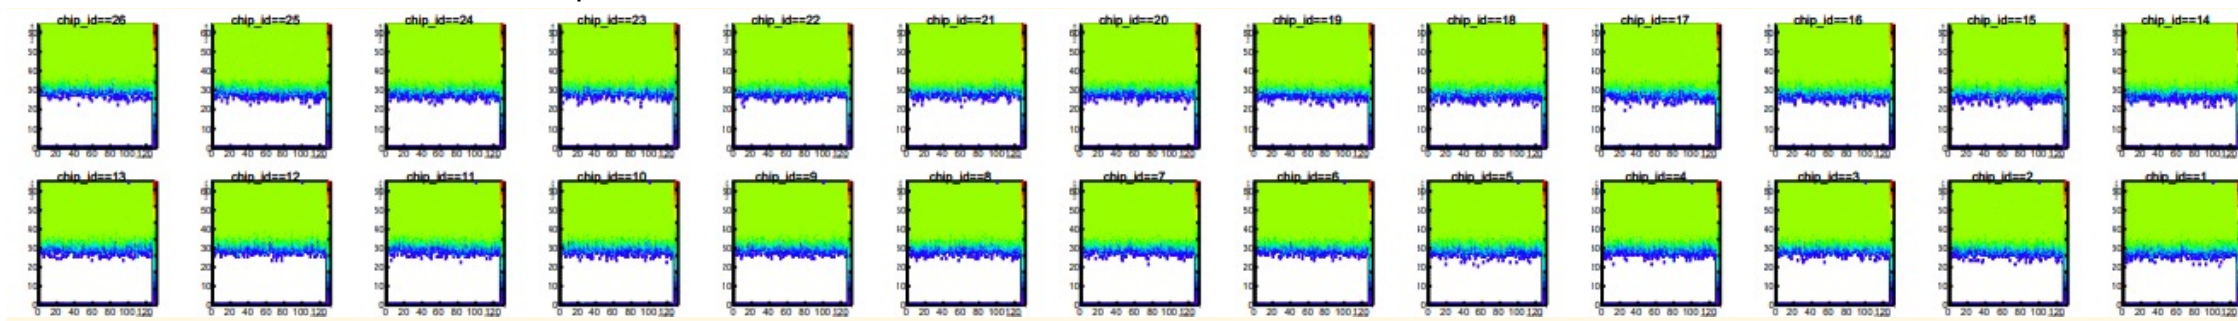
Occurs particularly in D-port of ROC.  
Worst in D3 port.

Partially dropped data observation in D3 port

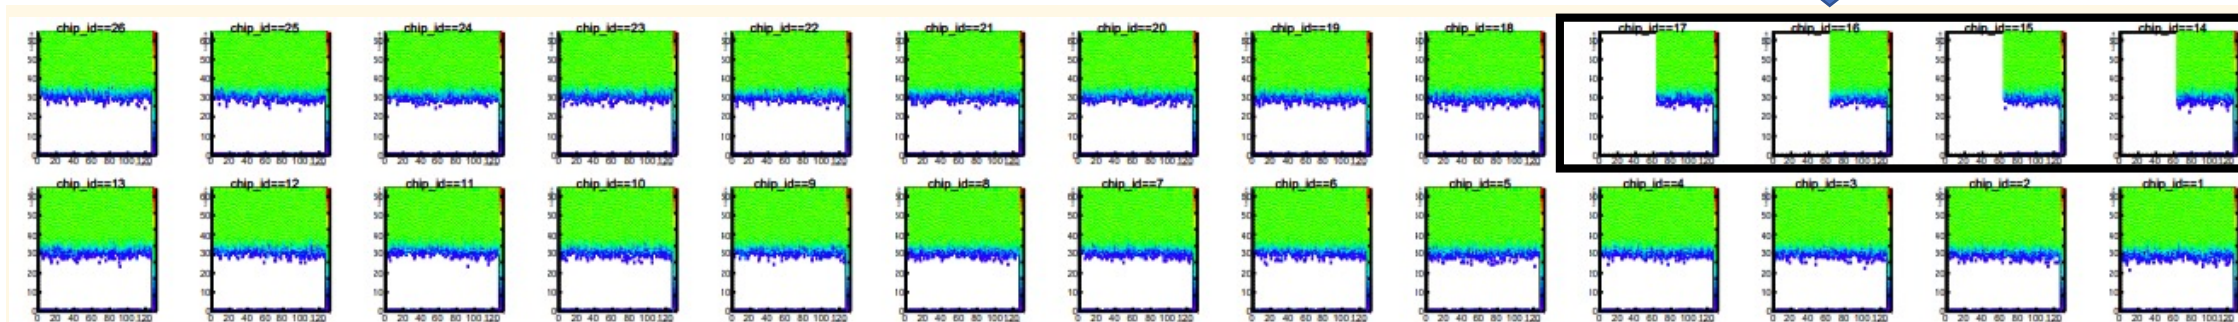
Typically, missing data strip#0~64 of Chip 14 ~17

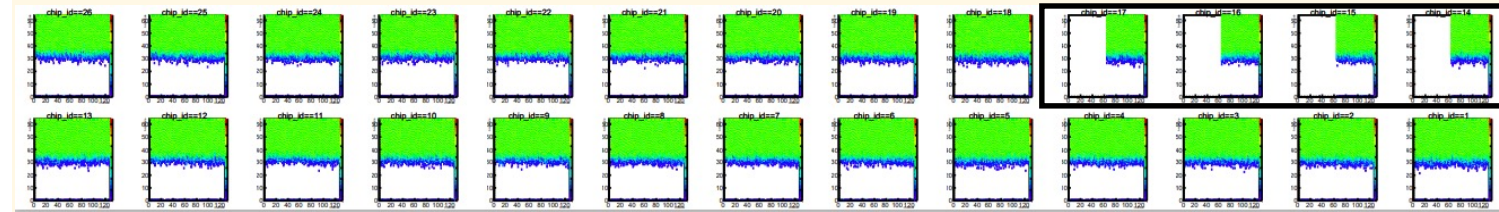
# Strategy

1: Strip #64 ~ 127  
0: Strip #0 ~ 63

Note that in time order, the Sync bit comes out first and the FIFO full bit comes out last.

- If we observe data pattern  $b_{14} = \text{false}$ , then the problem is in down stream, i.e. data is healthy. The problem is in the ROC.
- If we don't observe data pattern always  $b_{14} = \text{true}$ , then the problem is in upstream. Most likely the initialization failure of FPHX chip. Slow control transmission issue of  $\mu$ -Coax?

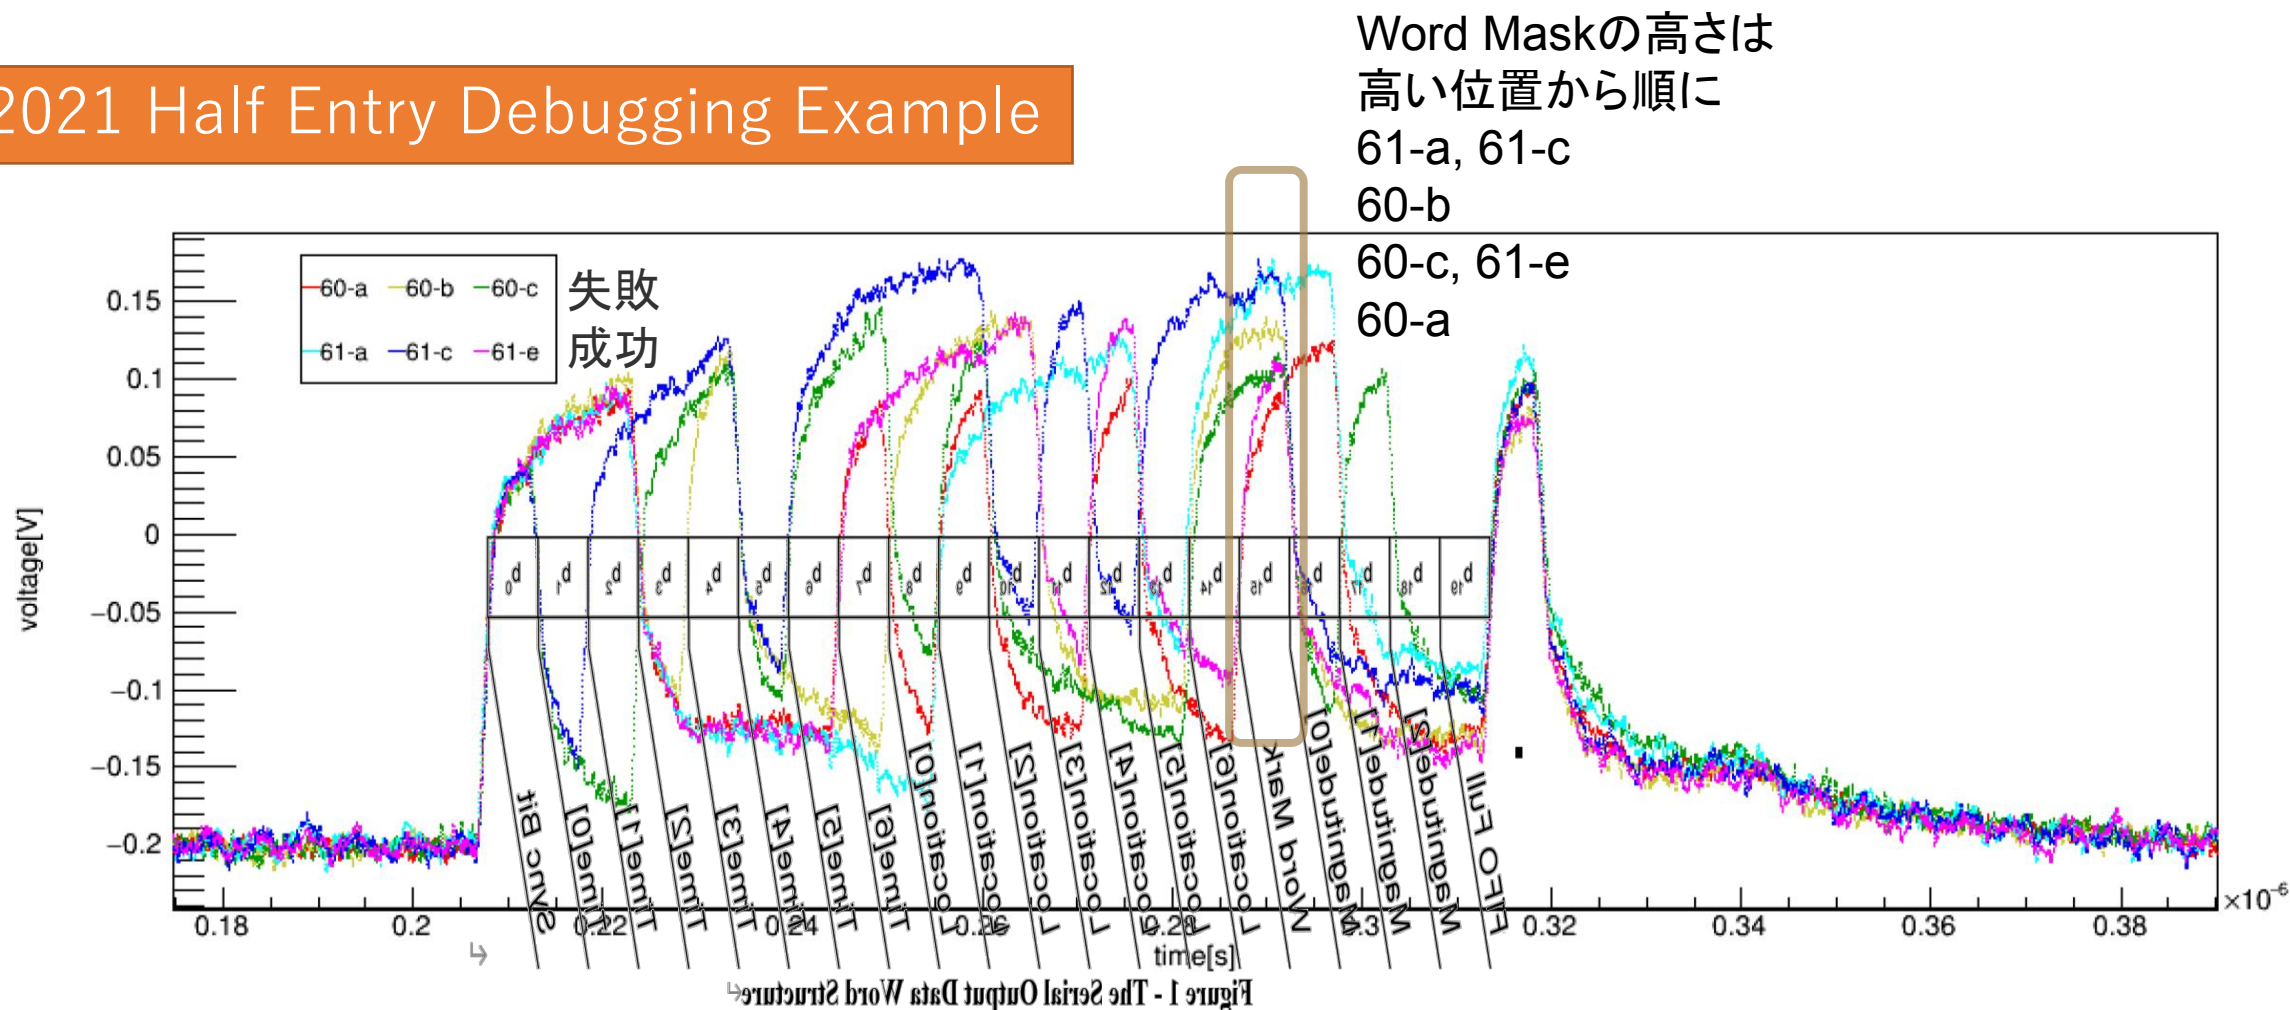
## 2021 Half Entry Debugging Example

前回の20bitデータ測定(今回の条件ではこれよりも信号がはっきりしているはず。)

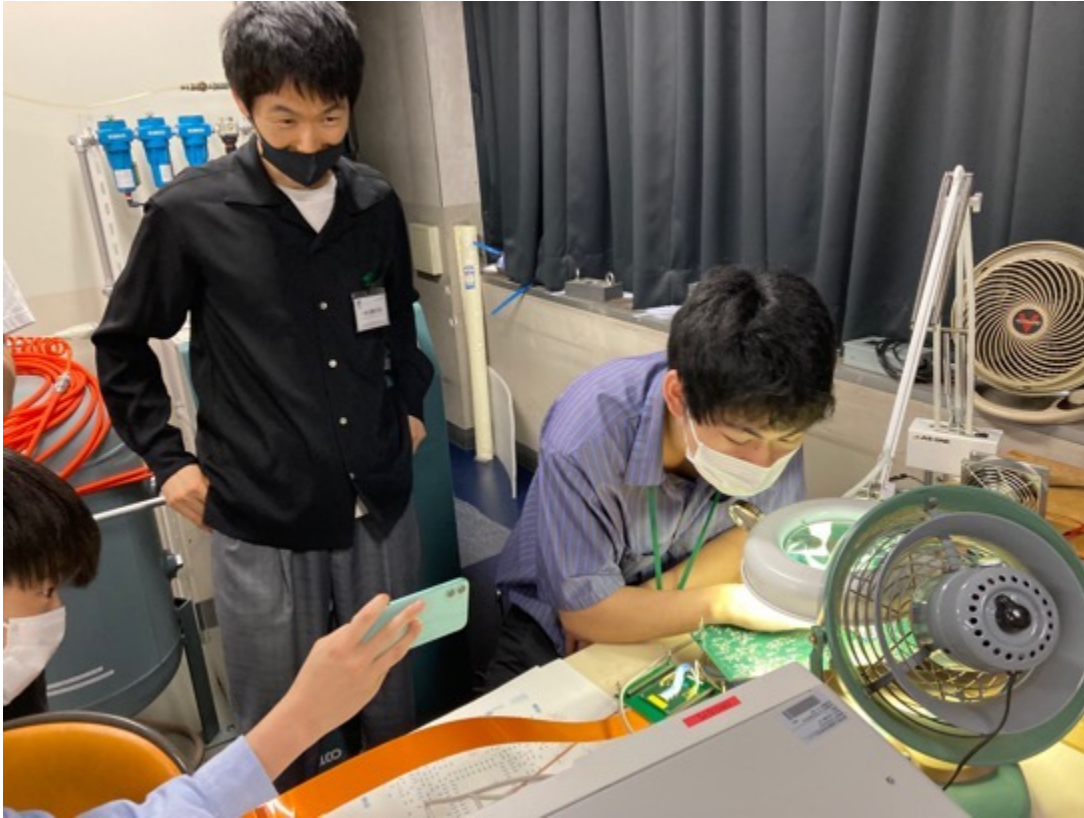
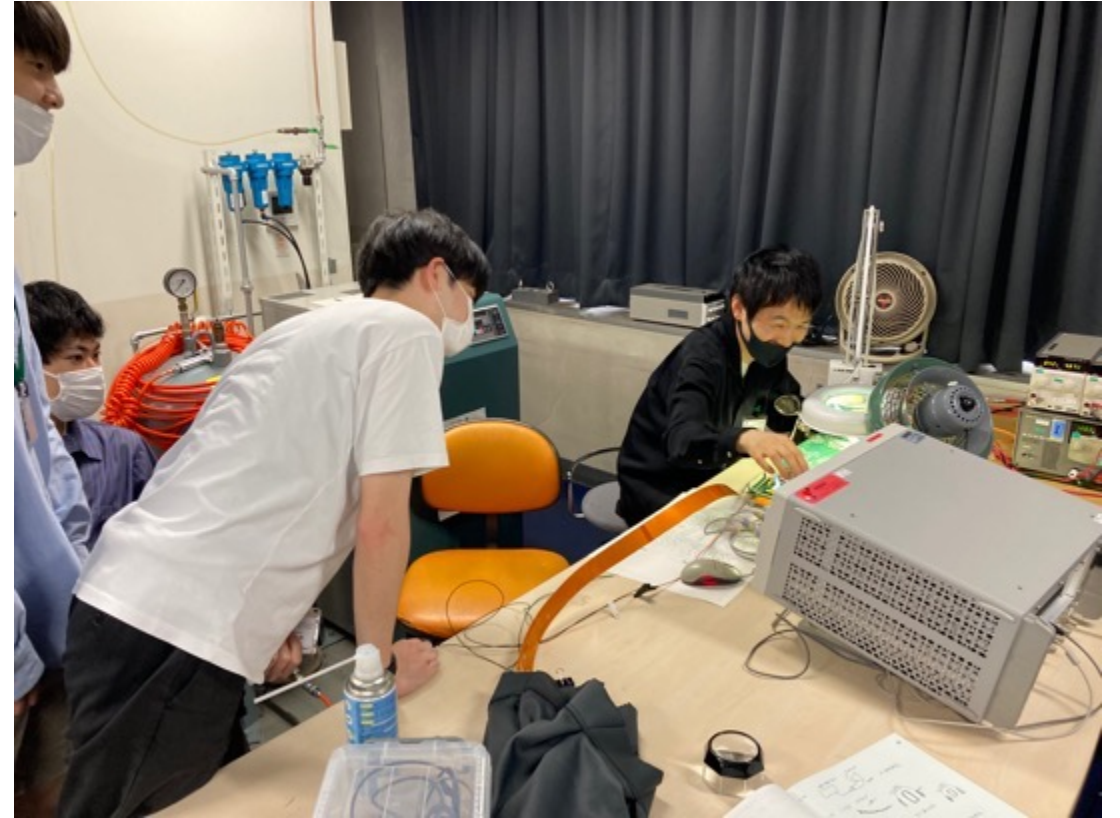
# Signal Observation @ D3 Port (1)

With BEX + 25cm Micro-Coax Conversion Cable

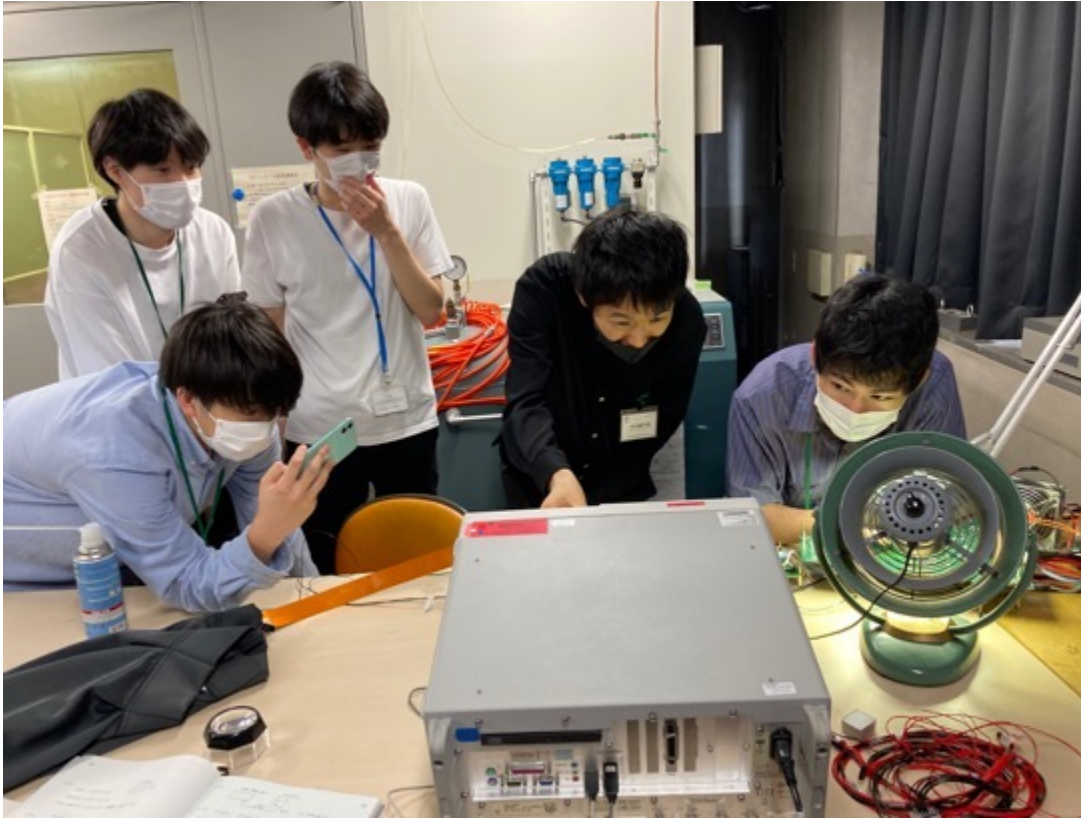
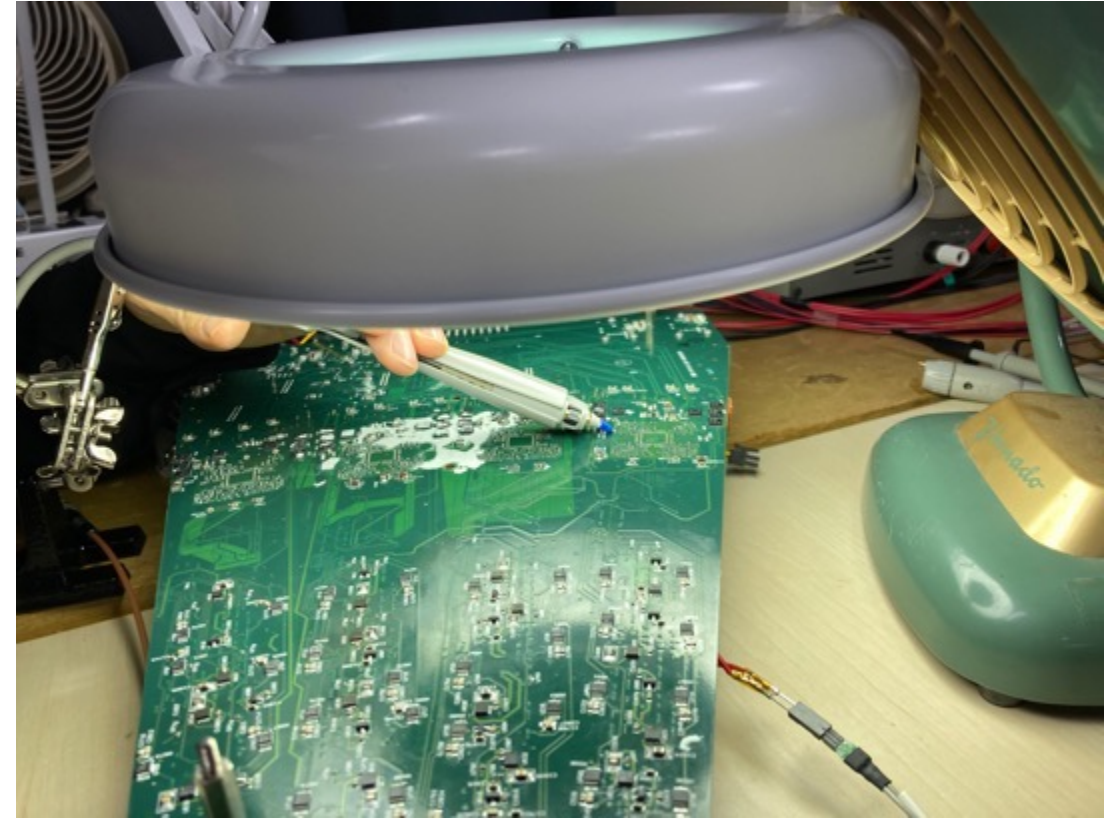
# Signal Observation at D3 port (2)

With BEX + 25cm Micro-Coax Conversion Cable

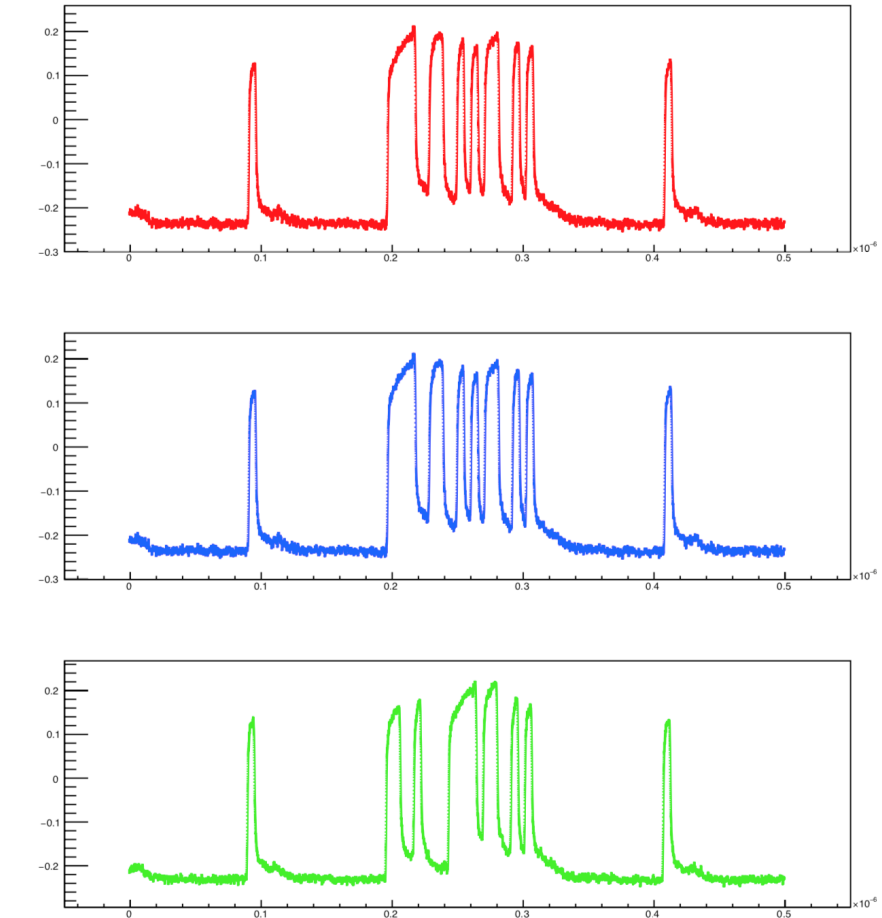
# Observed Wave Form

Plot by Hikaru Imai
