Quality control assessment of silicon detector construction using deep learning

Kamal Lamichhane
Texas Tech University
kamal.lamichhane@ttu.edu

CPAD workshop 2022
Nov 29 - Dec 02, 2022

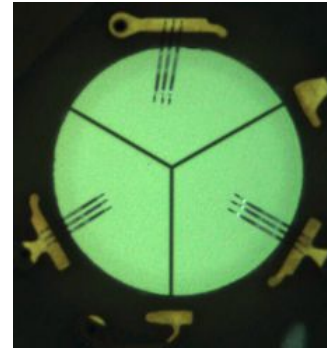
HGCal Silicon module

Electronics circuit board (aka hexaboard) w/
HGCROC ASIC to read signal from silicon sensor

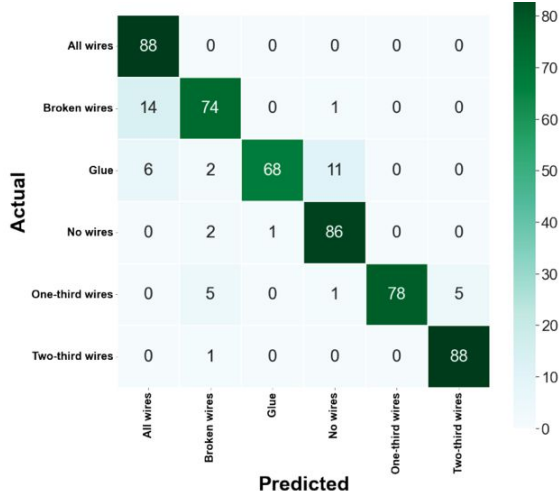
Image classification with CNN and MobileNet

- Multiclass classification:
 - One vs the rest: mutually exclusive.
 - The off-diagonal entries are due to the multilabel features.

Summary of the classification report for the multi-class classification.

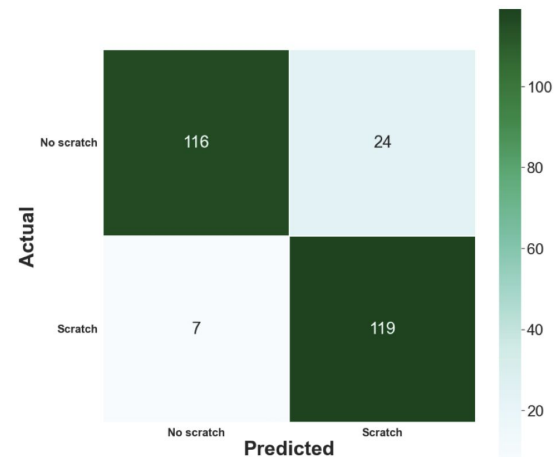
QC of silicon surface

- Scratches, chipped edges, dusts in silicon sensor surface might contribute to the early breakdown (electrical) for sensor.
- A good observation of a silicon sensor surface corresponds to inspecting ~1000 of such images (front and back) shown.
- More than 25,000 silicon sensors will be produced for CMS HGCaI.
- Here also, computer vision is advantages to perform the QC testing of the sensor surface.
- A binary classification (No scratch vs scratch) approach was implemented. The model performance corresponds to:
 - False Positive: 9%, False Negative: 3%
 - In a QC task, the goal is to minimize the false negative prediction.
- Another approach of using autoencoder for anomaly detection is in progress.
