CeC status - 6.11.24

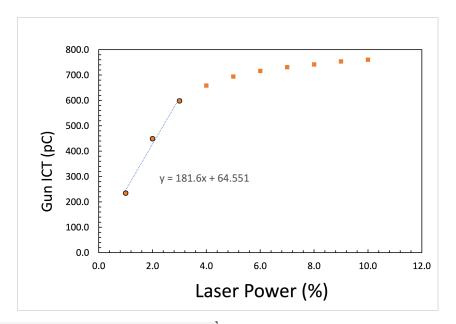
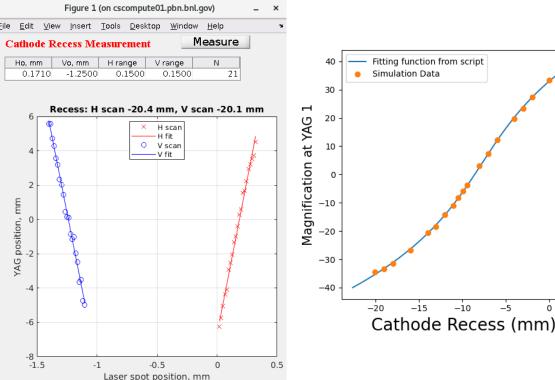
- Multi-alkali cathode has been installed and running with QE ~ 0.4-0.5%
- We experienced low saturation level which leads to low extracted charge from the cathode (cannot reach 1.5 nC – nominal)
- Larger cathode recess (lower surface field) measured presents a possible explanation.

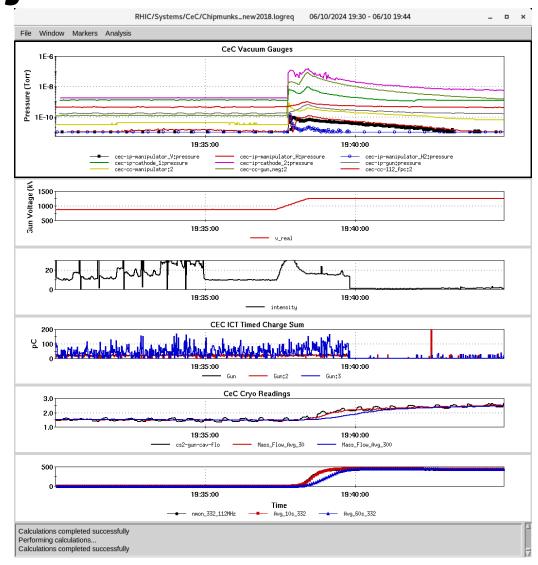
Cathode position adjustment

- Cathode position was adjusted during access (6/10). Position changed ~ +8 mm (deeper into the gun).
- Large vacuum burst happened, and QE dropped significantly.
- RF calibration changed (1.4 MV readback, 1 MV real) and needs to be modified.
- Plan to replace blank cathode during short access to check gun performance (conditioning).
- Replace remaining cathode during next maintenance.

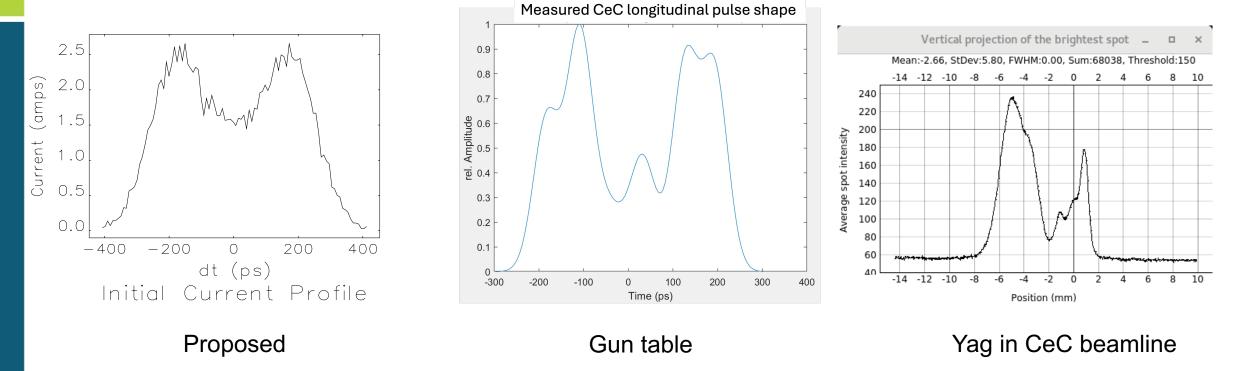
Laser shaping and 500 MHz

- Beamlet intensity is different from design (preliminary arrival time is correct). Work in better controlling individual beamlet is underway.
- 500 MHz AESRC was done and pre-start action item is being addressed.
