CeC status, 9/23/25

APEX summary

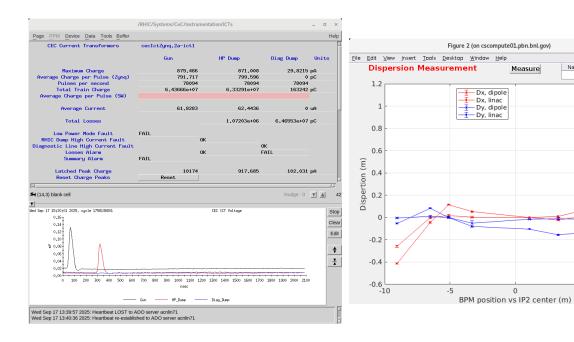
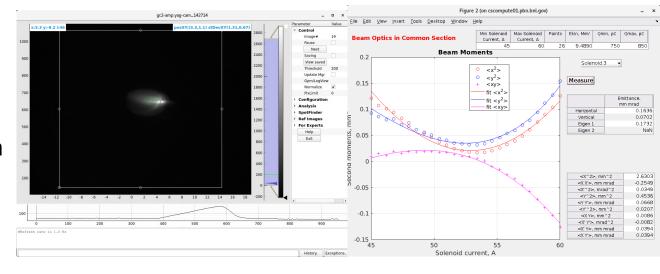
- Propagate high current CW beam to final dump with low loss (1 uA) with relaxed solenoid settings in common section.
- Match beam to relaxed lattice with low dispersion (< 0.1 m) leaking into common section (achromat).
- Beam on common section yag indicates there is some mismatch (not round, long energy tail). Emittance using solenoid scan was performed.

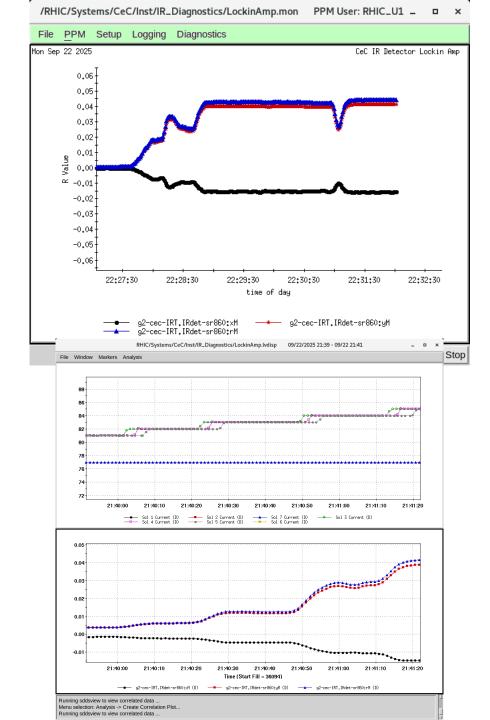
IR signal in common section (to see PCA)

- No signal was seen during APEX.
 Suspicion on IR detector errors due to power dips.
- Later when using strongly compressed beam (increase bunching voltage), IR signal can be observed.
- IR signal has correlation with common section solenoid strength (stronger solenoids higher IR signal).
- Attempt to lower bunching voltage to nominal setting was blocked by CeC and RHIC alarm. Investigation going on.
