Middle Term Task Lists

FEM-IB Debugging

Debugging Plan of 2nd FEM-IB in Taiwan

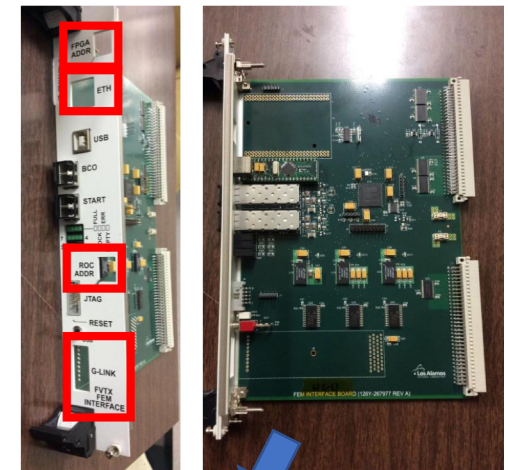
FEM INTERFACE BOARD (126Y-267977 REV A)

bad FEM IB 1

Things not attached

(In the test at NWU, we didn't use any NWU's things for below places.)

- FPGA ADDR
- ETH
- ROC ADDR
- G-LINK
