# TAKE FIVE for Safety Recent Event

## Unknown Failure of AGS Tune Meter Kicker

SCBNL: E-01928

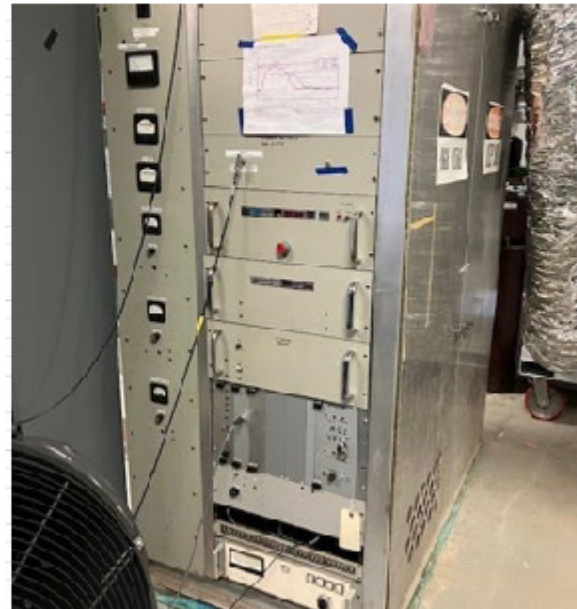
**Description & Categorization Level:** On August 16, 2024, around 6pm, repairs on the AGS tune-meter were completed and final tests were being performed in Building 913A known as the AGS A10 house. The power supplies were closed and placed in an operational state. After handover to the control room for final tests, the reference voltage on the AGS tune-meter jumped and two loud bangs were heard near the power supply. There was no chance for electrical exposure as the power supply cabinets were closed. The power supplies were then placed under LOTO and visually inspected. No obvious damage was found and initial tests suggest a malfunctioning relay. After consulting with supervision, the decision was made to pause work for the weekend, deenergize the systems, and regroup Monday morning. All procedures and safety requirements were properly in place and there was no possibility of personal injury. There are no injuries associated with this event.

**Potential Cause(s):** When replacing the charging power supply, a voltage divider circuit was not reinstalled in the controls, changing the calibration of the remote reference. This commanded the supply to charge up to more than double the required voltage. The air insulation broke down at ~27 kV.

Supply was LOTO'd and put into an electrically safe condition. After a review by Laboratory safety, trouble shooting of the supply began.
